A STUDY OF PUBLIC SCHOOL BUILDINGS IN MANITOBA

DAVID BUTTERFIELD

1994

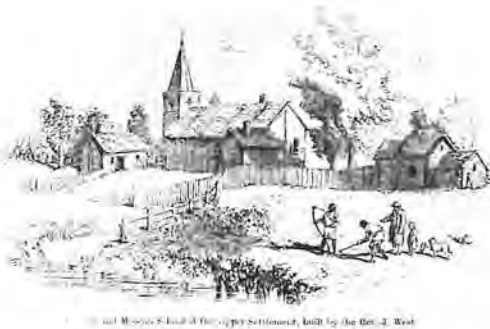
Figure 2. St. John's Anglican Church and school, ca. 1830. The tiny log school building sits on the right side of the illustration. Demolished. (PAM)

In 1849 there were twelve schools operating at Red River attended by almost 500 students; by 1870 there were 33 schools, almost evenly divided between Protestant and Roman Catholic parishes.⁵ While most schools were actually held in homes, churches, convents (Fig. 1) or other facilities that were not always conducive to learning, there were frequent efforts to provide purpose-built facilities throughout the settlement (Figs. 2 and 3).

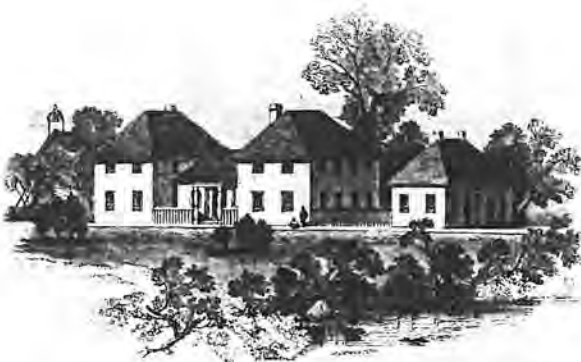
Figure 3. Red River Academy in the Parish of St. John's, 1852. The collection of three small buildings shows the influence of Georgian architectural styling, with the hipped roofs and symmetrical facades. Demolished. (PAM)

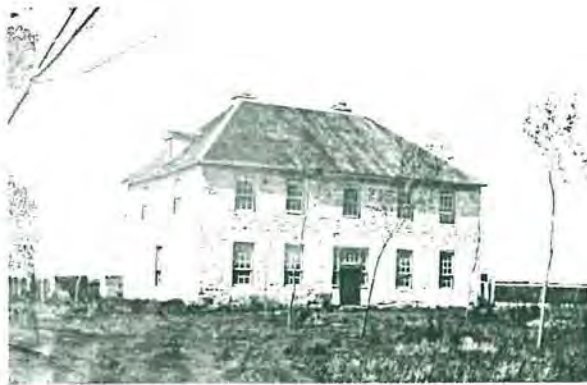
Figure 4. Residence section for Miss Davis' School for Girls, 1857-58. Classes were held in a wood frame building behind the main structure. (PAM)

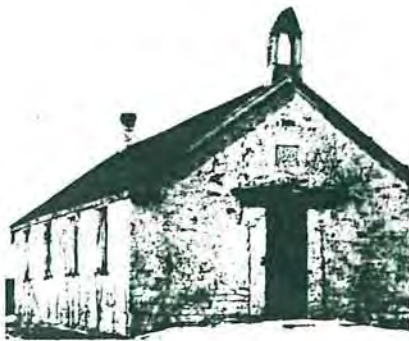
Figure 5. Kildonan (West) School, now known as Nisbet Hall, built in 1864. With its small tower, this Presbyterian school has a church-like appearance. (PAM)

The builders of the Presbyterian school at Kildonan drew their architectural inspiration from church precedents (Fig. 5). Built of stone, the building is low, with evenly-spaced windows on each long wall (Fig. 6). Primary level students were taught in a large front space, while secondary level pupils received instruction in a small room at the back.

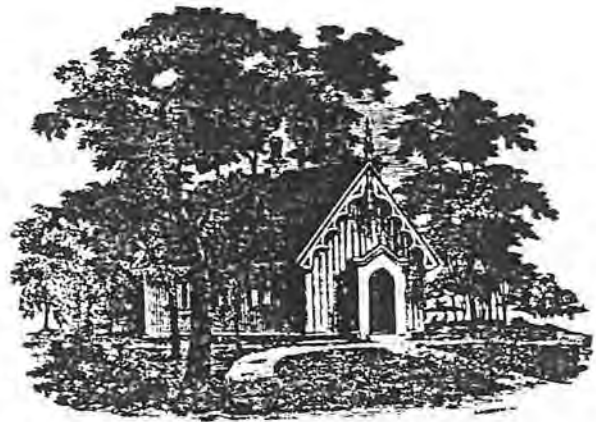
Figure 7. This perspective illustration of a Henry Barnard design shows the Gothic Revival styling so popular during the 19th century. (*School Architecture in Rural Canada Before 1930*, p. 191)

attractive external design -- found great favour throughout North America (Figs. 7 and 8). In Upper Canada (later the Province of Ontario) Egerton Ryerson, the powerful Superintendent of Education during the 1850s and 1860s, took up Barnard's ideas almost with a religious zeal. His influence on eastern Canadian school design was quickly felt in the province of Manitoba, especially with the influx of great numbers of Ontario settlers into Manitoba during the 1870s and 1880s.

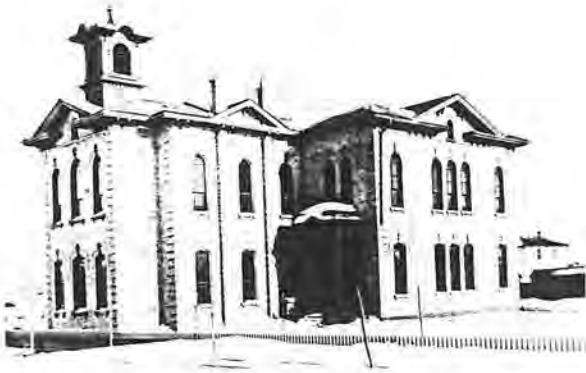
Figure 11. Central School, Winnipeg, 1877. This Italianate design by architect C.A. Barber was the winning entry in a contest established by the English Section of the Board of Education. The building was almost a direct copy of a Barnard design.¹⁰ With the construction of Central School No. 2 (below) as a girls' facility, Central No. 1 became a boys' school. Demolished. (PAM)

The City of Winnipeg now enjoys educational advantages of the highest order. During the past summer [1877] two large and very handsome school houses have been erected. The Central School [Fig. 11] is a T-shaped building, on the plan 28 by 94 feet, built of brick in an American style of architecture, having over one hundred large, well proportioned circular-headed windows.¹⁵

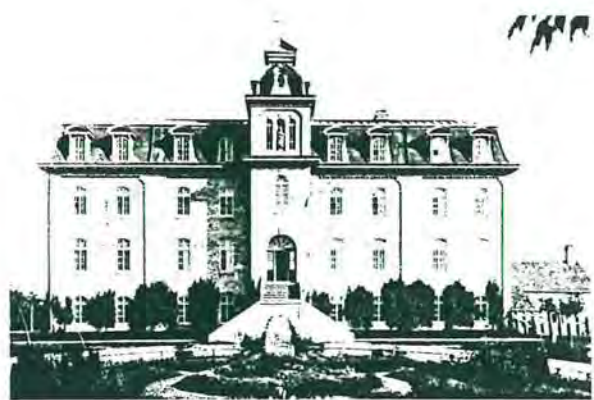
Figure 13. St. Boniface College, 1881, exhibited typical French architectural traits, with its mansard roof, arched dormers and central pavilion. Demolished. (PAM)

The Roman Catholic section of the Board of Education was just as ambitious. And while Tasse felt school buildings should be "plain and modest in design"¹⁶ structures like St. Boniface College (1881) and Provencher School (1886) were nevertheless impressive buildings (Figs. 13 and 14).

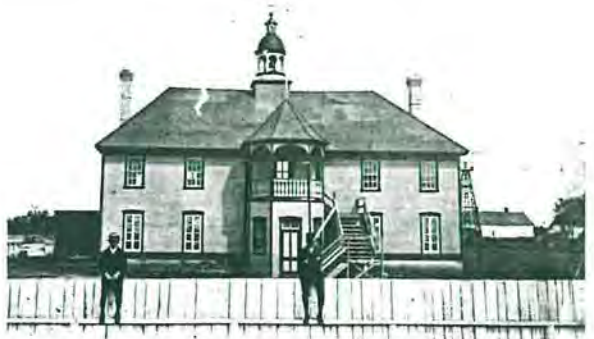
Figure 14. Provencher School, 1886. The stairs may have been used to segregate boys and girls. Demolished. (PAM)

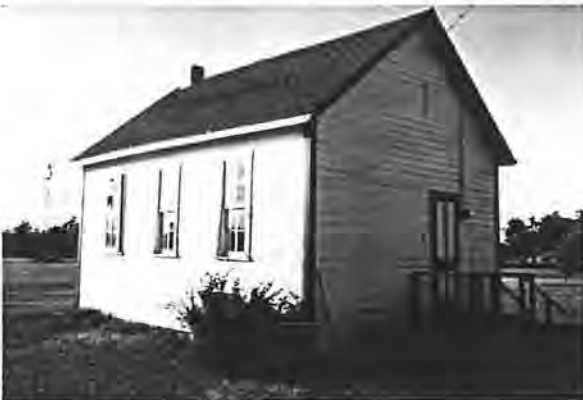
Figure 17. Mount Prospect School, 1882. The simplest of plans, forms and appointments describe this tiny school house.

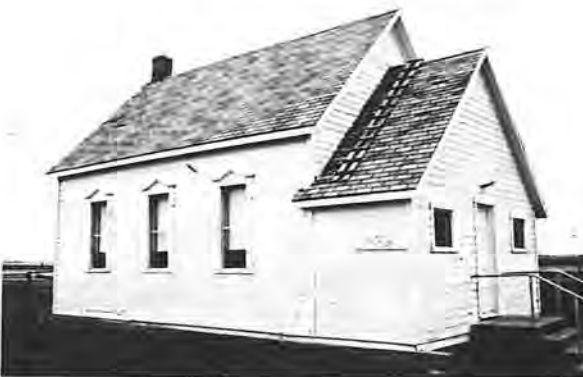
Figure 18. Star Mound School, 1886, features pedimented caps atop the three windows. The broad porch was added at a later date.

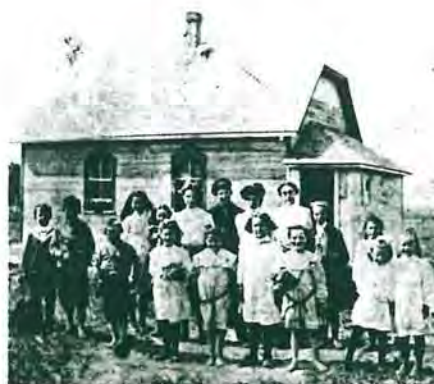
Figure 19. Sandhurst School, 1884. The basic form was here enlivened with a clipped gable roof. Demolished. (Ox Trails to Blacktop, p. 127)

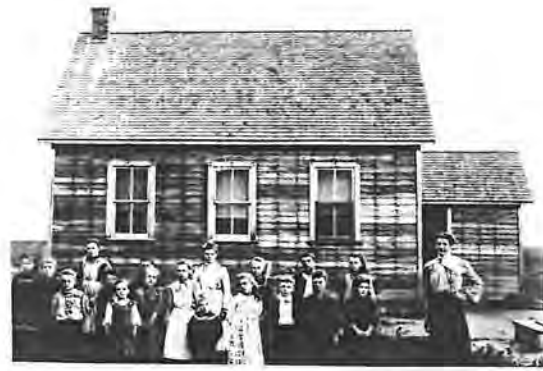
Figure 21. Coates School, 1901. The basic one-room form continued to be used for the majority of rural schools during this period. Demolished. (Our First Century, p. 234)

For the most part, though, the majority of one-room schools built during this period continued to be of the simplest plan, form and appointments; that is, a small rectangle, a gable roof and virtually no embellishments (Fig. 21). The basic characteristic distinguishing school buildings from small farm houses continued to be the use of two or three evenly spaced windows on each long wall.

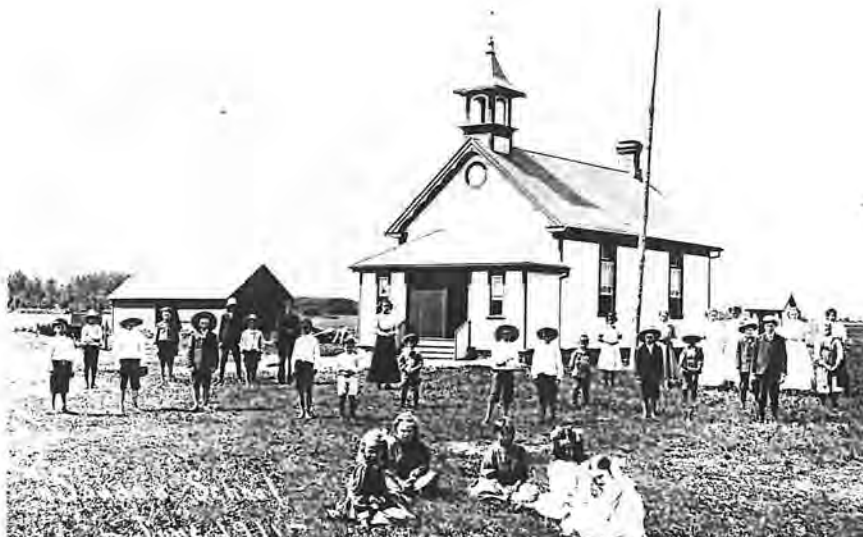
Figure 22. Soudan School, 1899. A fine bell tower and porch distinguished this handsome little building. Demolished. (PAM)

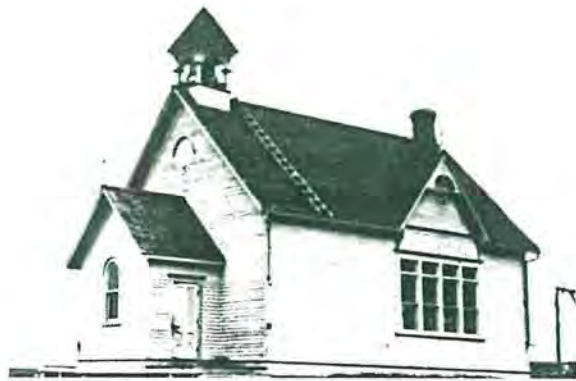
Figure 23. Craiglea School, 1892. The building had a decided church-like appearance, with the grouping of windows beneath a decorated gable. Demolished. (*The Path of the Pioneers*, p. 100)

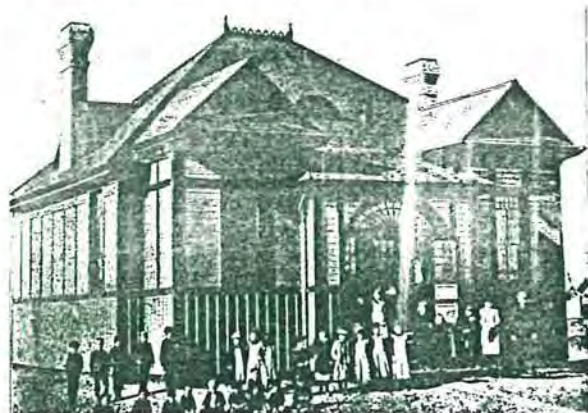
Figure 24. Portage la Prairie School, 1896. This exceptional one-room design was the work of Winnipeg architect George Browne. Demolished. (*Canadian Architect and Builder*, 1896, n.p.)

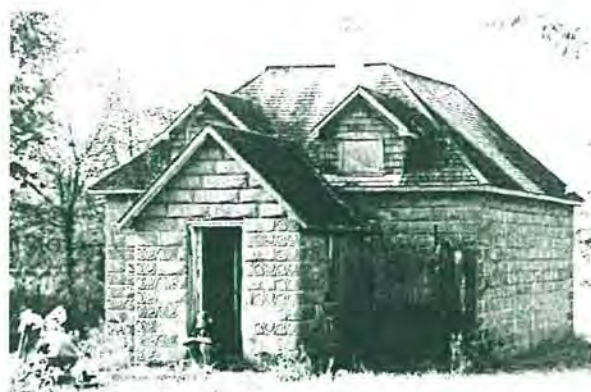
Figure 25. Tenby School, 1895. Built of concrete blocks manufactured on the site, the designer of this school also used a truncated pyramidal roof and twin dormers to create a novel form.

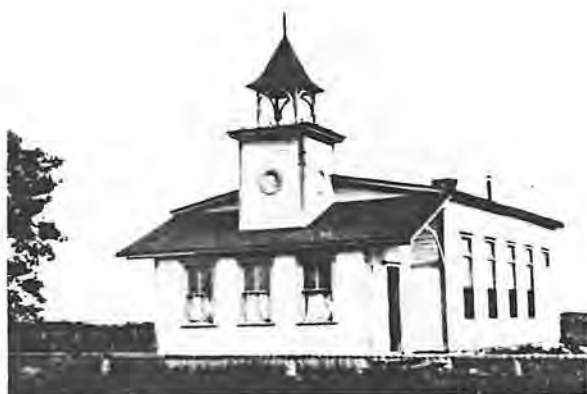
Figure 26. Garnett School, ca. 1895. The combination of roof shapes created a distinctive design, one that became a standard for a few years in the Carman area. Demolished. (Dufferin, p. 173)

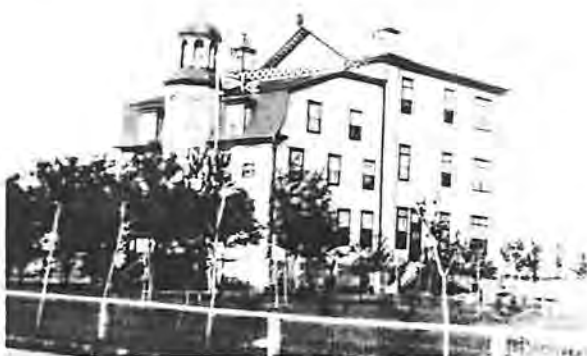
Figure 27. St. Joachim School, ca. 1890. A squat gambrel and highly decorated bell tower distinguished this distinctly French building. Demolished. (PAM)

In French-speaking areas the design of small public schools continued to rely on the mansard or gambrel roof to distinguish them from the prevailing forms (Figs. 27 and 28).

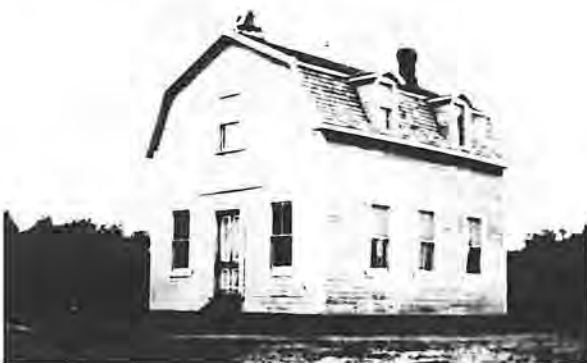
Figure 28. Montcalm School, 1899. A mansard roof reflected the architectural heritage of this French district. Demolished. (PAM)

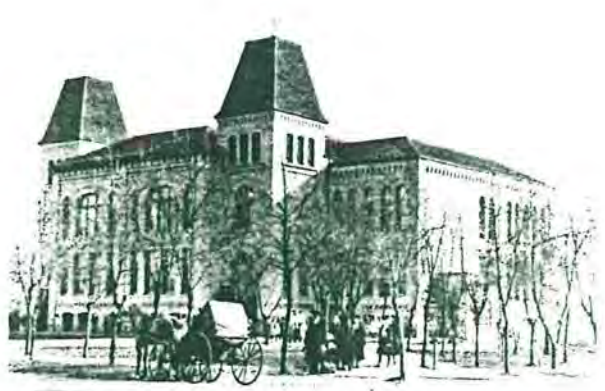
Figure 29. Central School, Brandon, 1892. This ambitious design featured twin towers topped with steep mansard roofs, a popular architectural expression used for large public buildings of the period. Demolished. (Brandon. A Prospect of a City, p. 73)

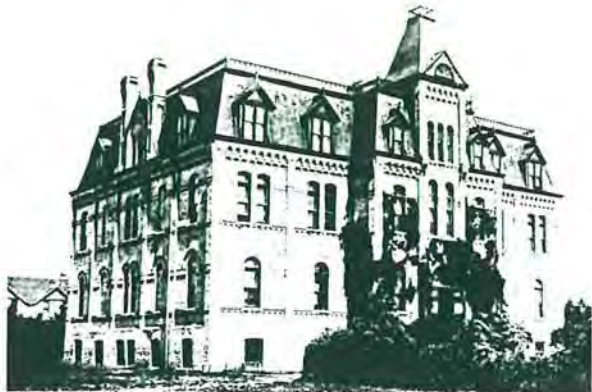
Figure 30. Winnipeg Collegiate Institute, 1892. Again, the mansard roof was used, here to provide extra space, likely for an auditorium. Demolished. (PAM)

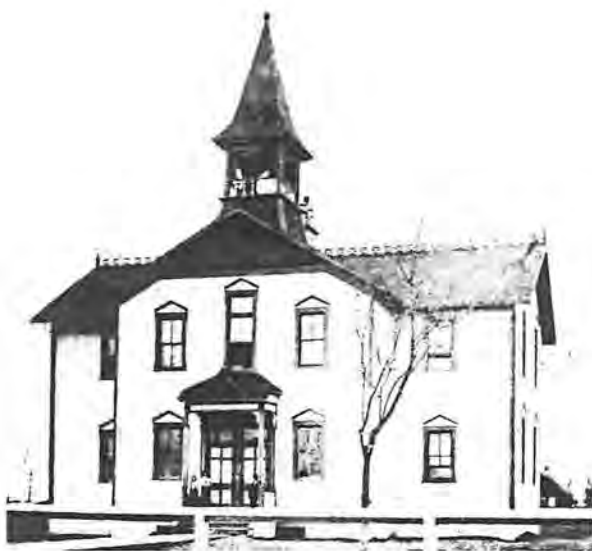
Figure 31. Gretna Public School, 1892. This was an impressive design built of wood and adorned with many picturesque elements, including the bell tower, roof cresting, the interesting window shapes and their playful disposition in the walls. Demolished. (Gretna. Window on the Northwest, p. 121)

Naturally, the physical size, public expense and significance of these buildings demanded a greater architectural sophistication than was deemed necessary for small one-room schools. An architect was often commissioned to prepare drawings, and although the department was still empowered to approve the designs, the local desire to create distinctive -- and often picturesque -- buildings was still prevalent (Figs. 31 and 32).

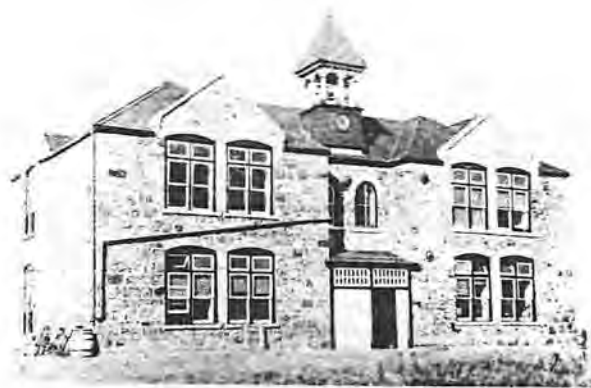
Lower right: *Figure 33. Almonte High School, Almonte, Ontario, 1875. Buildings like this formed the basis for the design of large late-19th century schools in Manitoba. ("The Noblest Monument is the School"; The Urban Public School in Canada Before 1930, p. 63)*

this building type had already been effectively worked out (Fig. 33). Typically, the building was organized around a central staircase, with a standard classroom size (26' x 32') of two to four rooms on each floor. The basic plan was easily adaptable to any of the popular stylistic schemes of the period, Gothic Revival, Romanesque Revival, Italianate or Second Empire.

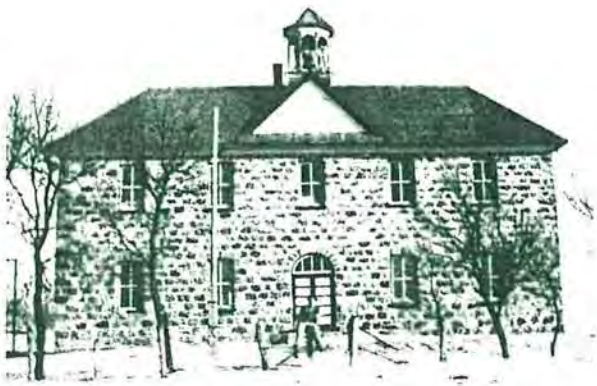
Top: Figure 34. Holmfield School, 1901. The most basic expression of the Georgian style still created a handsome building. Demolished. (By the Old Mill Stream, p. 43)

In Manitoba, the form could be very simple, with only the hipped roof and a central pediment (Fig. 34). Or it could be a very sophisticated expression of the style (Fig. 35). More often it was reworked with the addition of a central pavilion, a picturesque bell tower and sometimes other stylistic influences, especially Romanesque Revival or Italianate (Fig. 36).

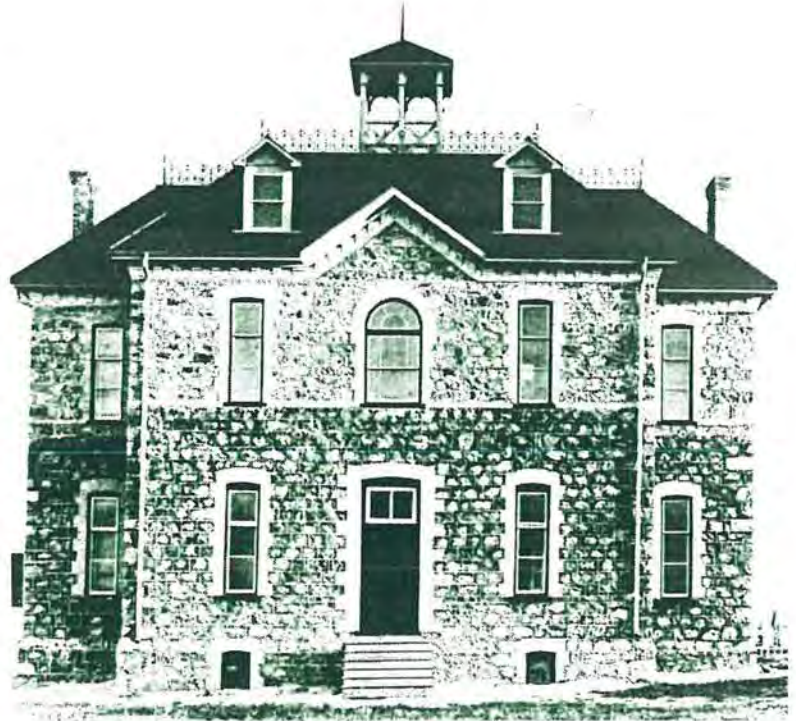
Right: Figure 35. Deloraine School, 1893. One of the most handsome rural school designs from this period stood for only eight years, succumbing to fire in 1901. (Deloraine Scans a Century, p. 127)

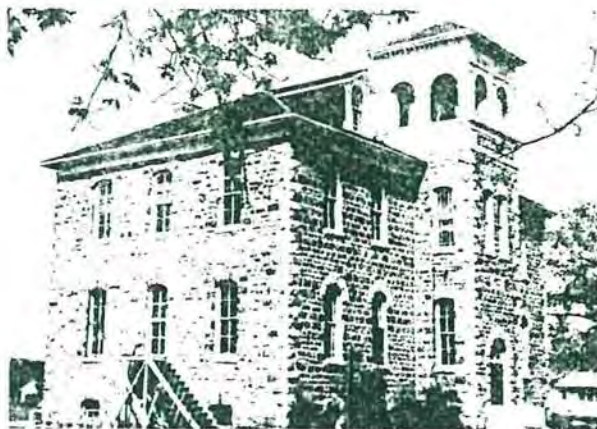
Lower Left: Figure 36. Boissevain School, 1894. Subdued Italianate influences were expressed in the design of the tower and the window caps. Demolished. (PAM)

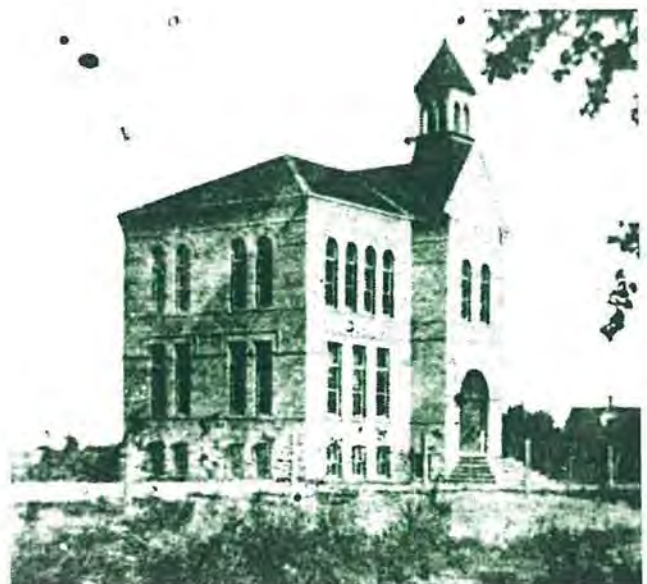
Lower Right: Figure 37. Oakwood School, Oak Lake, 1898. Like several others, this building was designed to be enlarged with the addition of a wing on the right side. (Ox Trails to Blacktop, p. 122)

Another fairly common design that came into use towards the end of the period featured a corner tower (Fig. 37). The dramatic form created by the corner tower was intended only as a temporary measure. As the student population of the community increased, it was anticipated that a second wing would be added to the building and the tower would be transformed into the central focus of a symmetrical design.

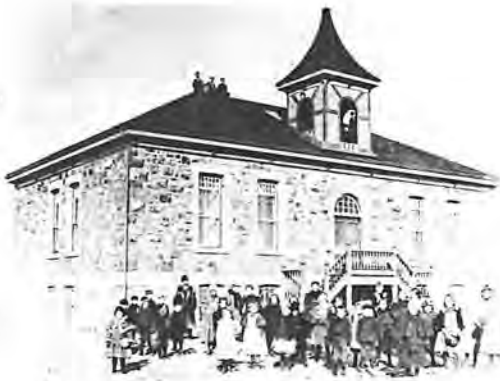
Below: Figure 39. Morden Collegiate, 1894. A handsome building indeed, but the use of small windows arrayed on all sides of the classrooms created internal lighting problems in many large schools. Demolished. (*Morden Centennial*, p. 83)

Perhaps the greatest concern evinced by inspectors about these buildings focused on their fenestration. Like their one-room counterparts, there was a concern that there were too few windows. In many schools the openings were too tall and narrow, admitting only a modest amount of light (Fig. 39).

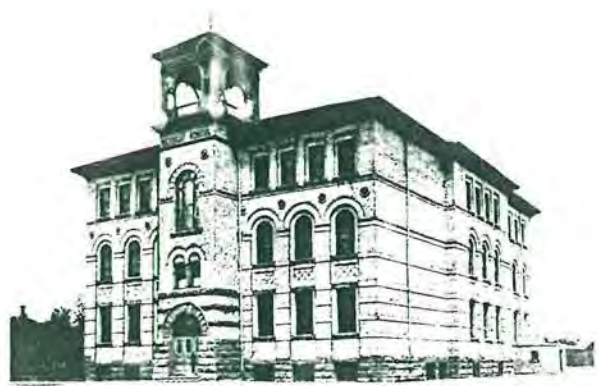
Above: Figure 40. Norquay School, Winnipeg, 1892. The basic design of this school, prepared by George Browne, was to be used for several others between 1890 and 1902. Demolished. (PAM)

Twelve of these schools were built between 1892 and 1902, to house 7,000 students.²⁶ The first of them, Norquay, was designed by George Browne and was to be the standard used for other buildings (Fig. 40). The schools certainly differed in appearance, designed as they were by at least seven different architects, but there were some constants, largely because Mitchell and Superintendent Daniel McIntyre determined the general layout.²⁷

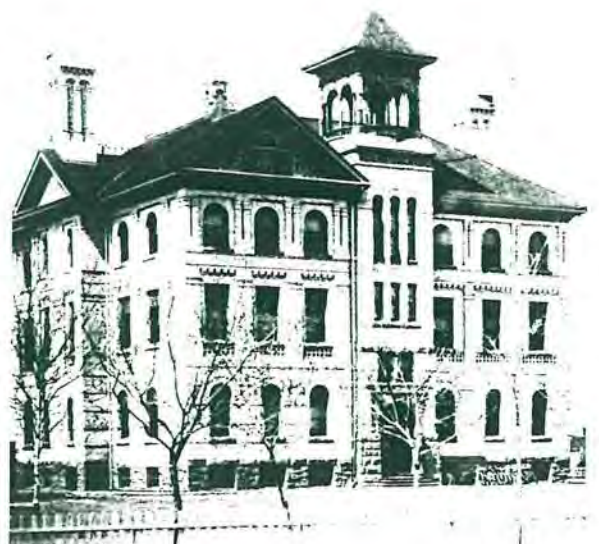
Below Right: Figure 42. Mulvey School, Winnipeg, 1893. Another of George Browne's designs, this building featured fine detail brickwork and an impressive array of window shapes. Demolished. (PAM)

The schools were all three storeys in height with a central tower and shallow hipped roof, and were planned on a twelve-room module, with a fairly constant classroom size (24' x 32') (Fig. 41). Each school was an exceptional architectural project, solid, impressive, but often also richly decorated, even fanciful, producing an inviting impression for the students (Figs. 42, 43

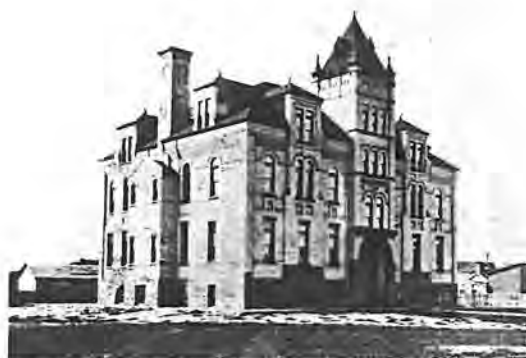
Above: Figure 43. Dufferin School, Winnipeg, 1895. An exciting design produced by C.H. Wheeler featured pinnacles and dormers, decorative brickwork and a variety of openings. Demolished. (PAM)

and 44). Increasingly, a school building's exterior was being seen as explicitly part of the school's total didactic role, as implied in the Board's annual report for 1899:

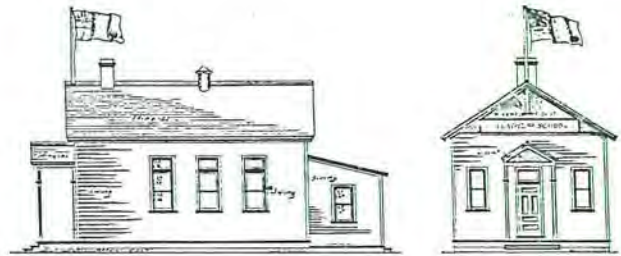
Figure 46. Design for Frame School Building, No. 1, 1903, the first of architect Samuel Hooper's standardized schemes prepared for the Department of Education. Side and front elevations. (*The Western School Journal*, 1906, p. 203)

Design No. 1 was the simplest, cheapest and most commonly built (Fig. 46). Design No. 2 was larger, with a projecting entrance, round-arched door and a bell tower whose delicate, arched framework had been used for years throughout eastern Canada and the United States to distinguish schools from other small public buildings (Figs. 47 and 48). Design No. 3 was the most ambitious. It also was the least likely to be built. A corner tower (with the same decorative treatment as No. 2) and the strong form created by a pyramidal roof were the distinguishing features of the scheme (Fig. 49).

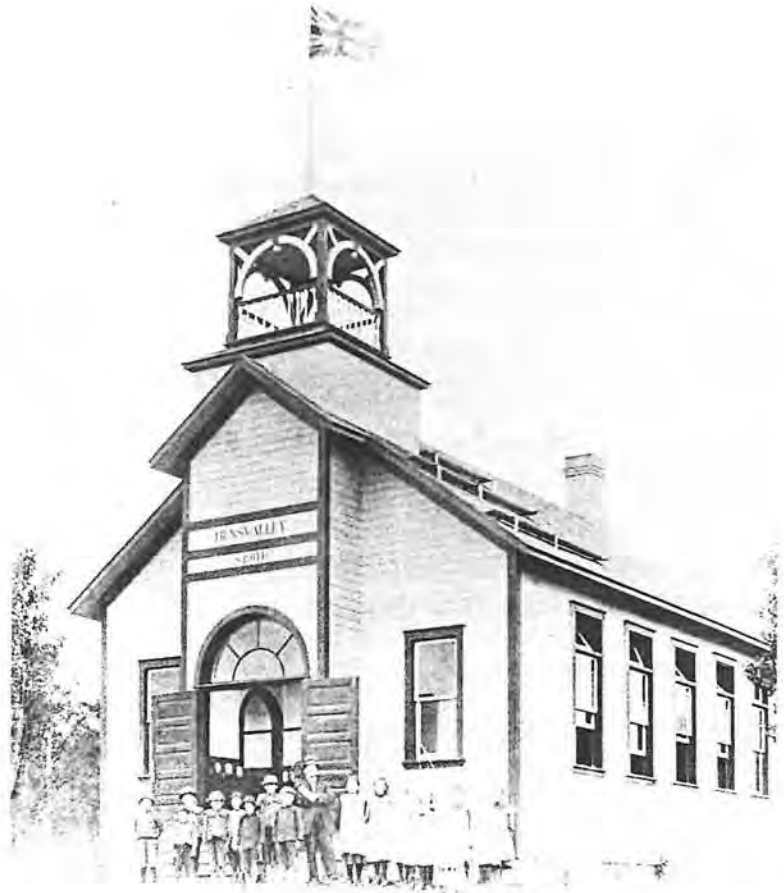
Figure 53. Carrick School, 1914, an example of the cottage-style one-room school that was the most popular standardized design, used from 1912 until the mid-1920s. The use of the awning was a local inspiration. (Between Mountain and Lake, p. 249)

This new school building had much to recommend it, in the eyes of the authorities, over the Hooper designs. It was more informal, with a hipped roof and dormer; in effect, it looked more like the bungalows and cottages then coming into popularity for domestic design (Fig. 53). More significantly, however, was the window treatment.

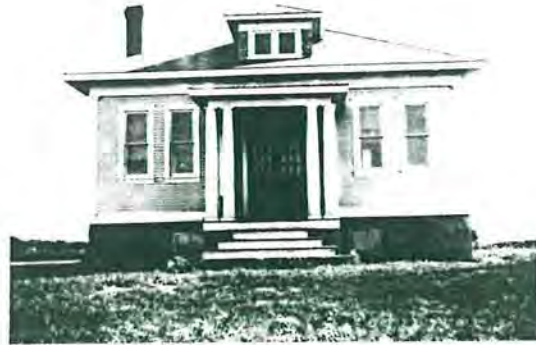
Figure 54. Lily School, ca. 1915. With its porch and classical details, this school is a fine example of a common variation that was adapted from the typical cottage design. (PAM)

Occasionally, the basic scheme might be adapted with more picturesque results. A porch was often incorporated and classical details were sometimes added (Fig. 54). In these cases, the window bank was located on the back of the building.

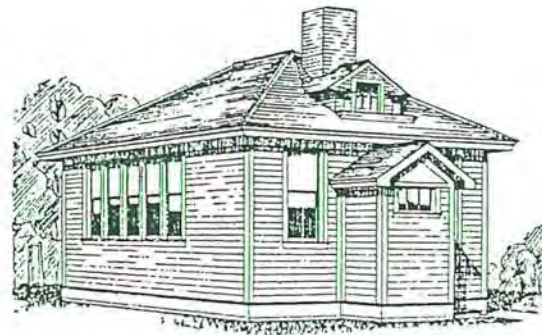
Figure 55. Eaton's Department Store catalogues included this cottage-style design beginning in 1917. (T. Eaton Co. Catalogue, 1917-18, p. 202)

It also was common, before the onset of World War I, for private firms and entrepreneurs to provide free plans for inexpensive rural schools that resembled this cottage-style school. The T. Eaton Company and the United States-based Waterman and Waterbury Company were the most ambitious in their marketing (Fig 55), although it is unclear how many school districts in Manitoba used their plans.

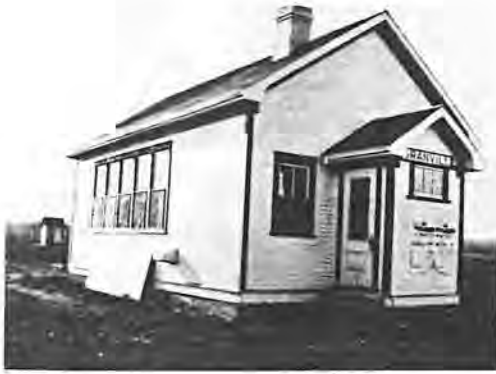
Figure 56. Granville School, 1918, the simplest example from a set of standardized designs used after 1918. Demolished. (*Between Mountain and Lake*, p. 29)

The basic example featured a small storm porch with a ribbon board for the school name, the now-obligatory window bank and a gable roof with a slightly flared eave (Fig. 56). The second version was larger, with the same distinctive bellcast roof. It also featured cloakrooms lighted by a side window. A broad enclosed storm porch featured a simple arrangement of two square windows and a central door, usually all protected by a long canopy (Fig. 57). The third scheme, only rarely built, had a raised basement and a larger cloakroom that included

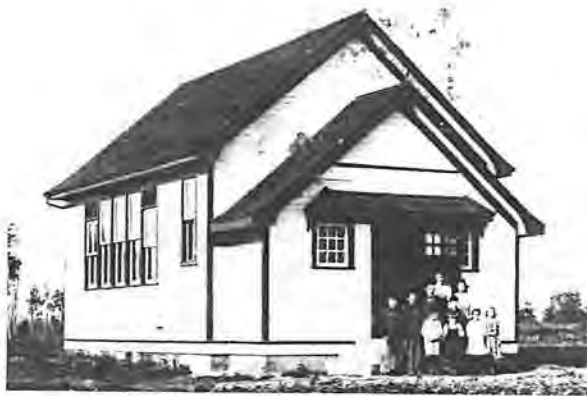
Figure 57. Bruan School, 1918, the second variation of this standardized set. Demolished. (*On the Sunny Slopes of the Riding Mountain*, Vol. 1, p. 85)

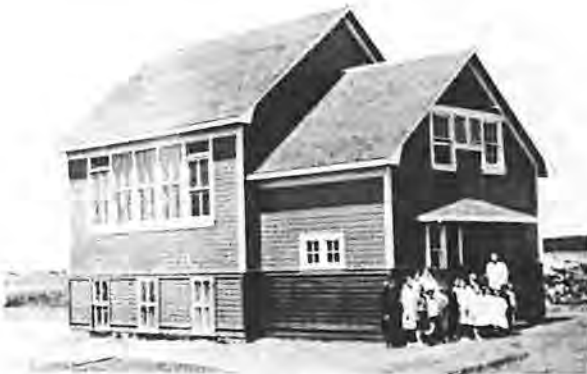
Figure 58. Balmerino School, 1919. The third, and largest, of this standardized set. Demolished. (*Ellice*, p. 75)

additional space for a teacher's office above, and a slightly different facade treatment (Fig. 58).

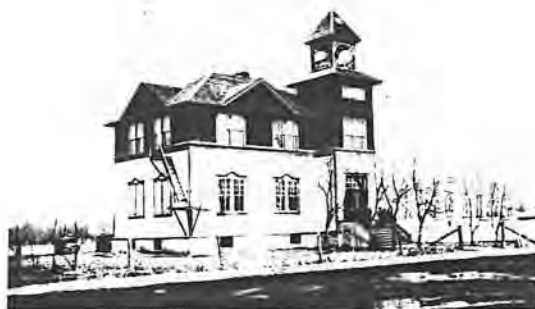
Figure 63. Roblin Primary School, 1912. In plan a derivation of Samuel Hooper's Design No. 3, this standardized scheme was enlivened by the use of contrasting wood cladding and pedimented windows. (Shell River Municipality. *Century One*, p. 260)

A few smaller schemes were developed especially for consolidated school districts. One of them, used for several four-room buildings, was low and broad, its design implying a connection to its immediate rural environment (Fig. 61). Another four-room design, this one standardized, was a derivation of the typical blocky designs (Fig. 62). A second standardized design, used both for consolidated and urban schools, was, despite the department's current interest in fire prevention, of wood frame construction (Fig. 63). Other designs for consolidated schools still revealed the hand of a local architect working without direct control from the department (Fig. 64).

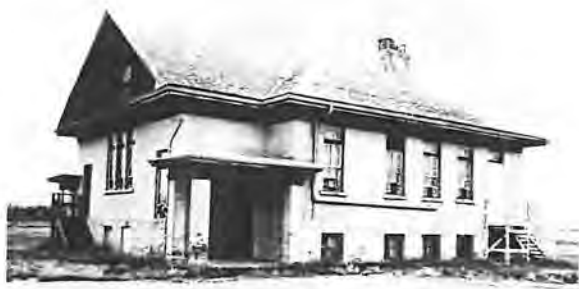
Figure 61. Justice Consolidated School, 1913. A few rural schools were built with this lowslung design.

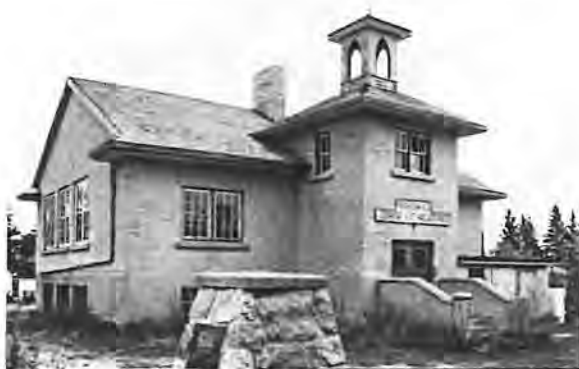
Figure 64. Cameron Consolidated School, 1916. Many larger schools were still built according to picturesque designs.

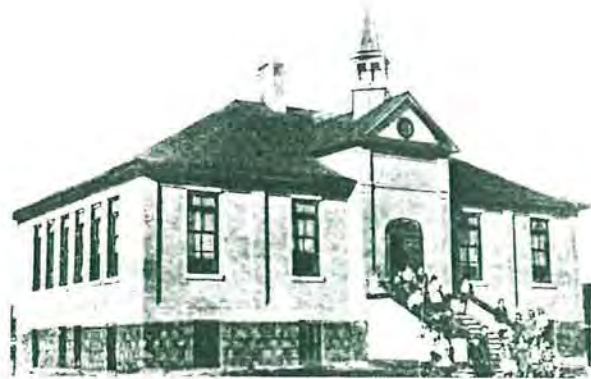
Figure 65. North End School, Neepawa, 1908. A typical two-room school recalled designs of the 1890s. Demolished. (Neepawa. *Land of Plenty*, p. 318)

The construction of two-room schools followed a similar pattern. The designs for many of these buildings continued to rely on the plan and decorative character developed in the 1890s, and were, for the most part, unique (Fig. 65). At the same time, there were a few two-room buildings constructed with a recognition of new developments, especially for larger window openings (Fig. 66).

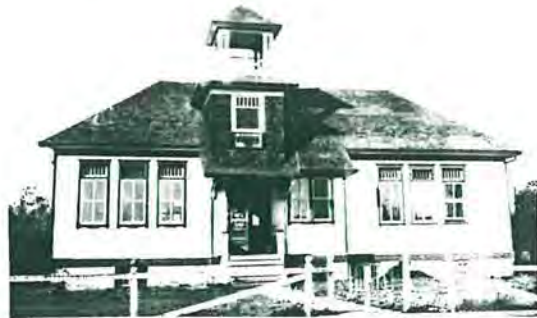
Figure 66. Phoenix School, ca. 1910, featured a Hooper-like bell tower and grouped window openings. Demolished. (PAM)

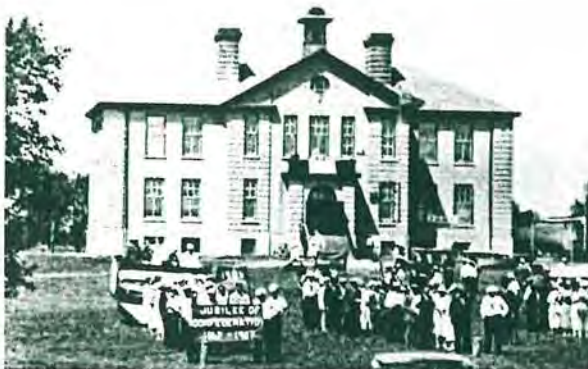
Figure 67. Alexander School, 1911. The school had the elongated plan in vogue by 1910, but still featured separated window openings. Demolished. (Whitehead *Wanderings*, p. 14)

larger schools, of a distinctly new plan. Developed in opposition to the typical square plan of the 1890s, with its central staircase, the new scheme was an elongated rectangle, with corridors linked to a transverse stairblock. The basic impetus for the new plan was to ensure easy egress for students in case of fire. Many of these schools continued to be built with small individual windows (Fig. 67), but by the end of the period, and with the widespread availability of iron beams that could carry the weight, there was an increasing adoption of the bank window design (Fig. 68).

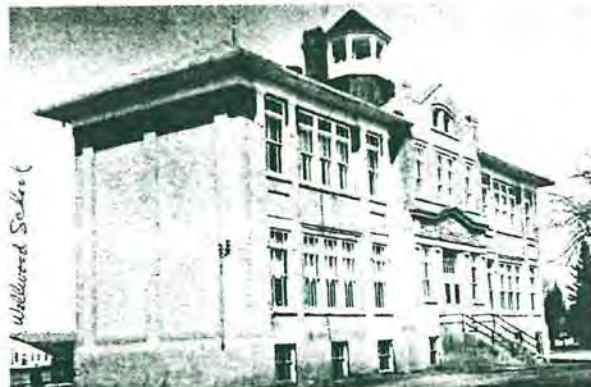
Figure 68. Welwood Consolidated School, 1917. A state-of-the-art school in a rural setting. Demolished. (Carberry Plains. *Century One*, p. 206)

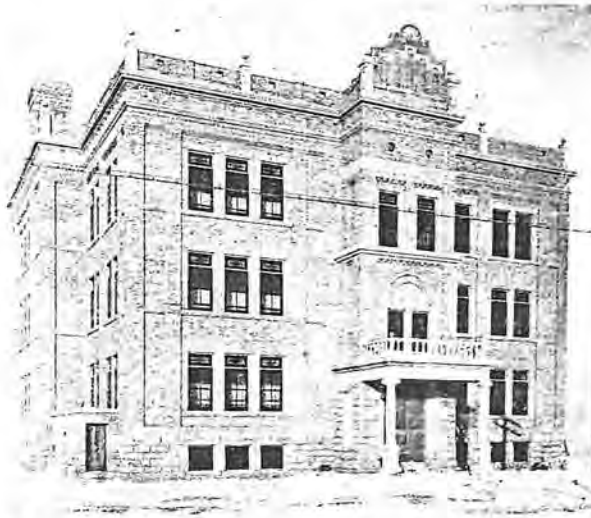
Figure 69. John M. King School, Winnipeg, 1905. An example of Mitchell's later three-storey designs, this featured several elements that were to become familiar on most of his school buildings: a decorative gable on the tower and a detailed roof parapet. Demolished. (Building Department, Winnipeg School Division No. 1)

entrance towers, where his affection for decorative gables found expression (Fig. 69).

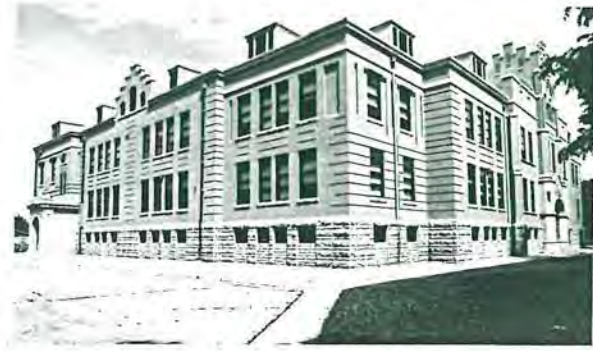
Figure 71. Isaac Brock School, Winnipeg, 1913. The largest school of its type (and costing \$250,000), this school shows Col. Mitchell's attention to Gothic Revival styling, especially seen in the composition and detailing of the tower.

The first project undertaken, in 1907, was Luxton School. Compared to an earlier building like Isbister, Luxton School was larger (and with an addition in 1915, very much larger) (Fig. 70). However, by the time that Isaac Brock School was constructed in 1913, this type of school had reached enormous proportions (Figs. 71 and 72). Almost four Isbisters could be contained in Isaac Brock.

As the designs increased in size, the main facade became elongated and Mitchell used a variety of treatments to create visual interest across the huge expanses of brick and glass. This could be accomplished with projecting and recessed bays, tall towers, elaborate entrance porticos, staircases and decorative brickwork (Fig. 73). He continued to rely on the gable to punctuate the towers and rooflines, although the influence of the Romanesque Revival and Late Gothic Revival also gained favour. Wall buttresses, blind arcades, crenellations, corbel tables, as well as decorated windows were all used on a building like Isaac Brock.

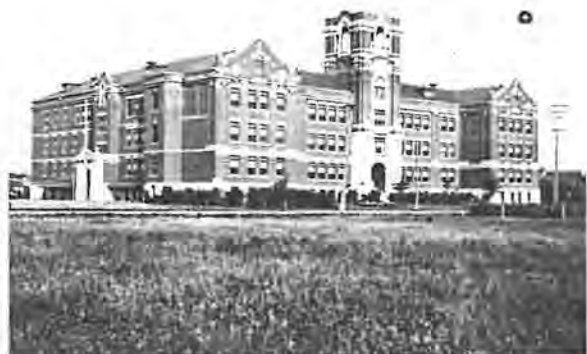
Figure 74. Kelvin Technical High School, Winnipeg, 1910. This and St. John's Technical High School were identical, and the only examples of Mitchell's designs to be carried out in red brick. Demolished. (PAM)

Winnipeg was the first city in western Canada to construct technical schools, and it ambitiously undertook two projects in 1910. One school -- St. John's -- was for the north end; the other, named Kelvin, was constructed for students in the south end. The designs, by Col. Mitchell, were identical (Fig. 74), thus saving the board a huge amount of money.

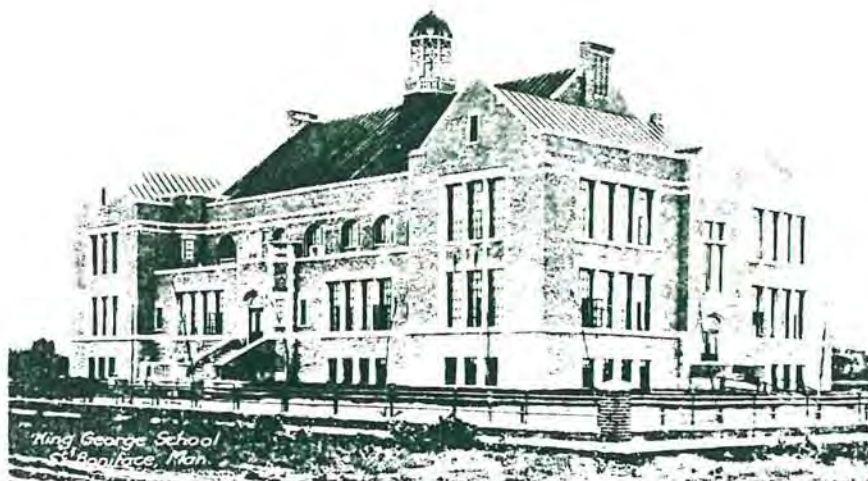
Figure 76. King George V School, Winnipeg, 1915, an exceptional building designed by H. Greene. (PAM)

St. Boniface had been an established community for years, and while most of its best educational facilities had remained separate from the public system, there were several large public schools built during this period. The most sophisticated, architecturally, was designed by H. Greene in 1915. With its complex plan and fine details, King George V School was certainly an architectural rival to any of the schools being constructed in Winnipeg School District No. 1 at that time (Fig. 76).

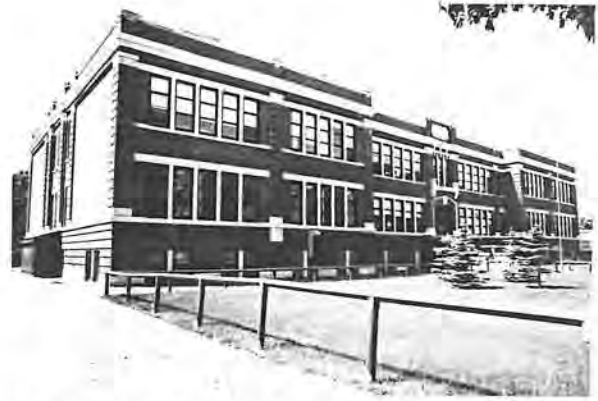
Figure 77. Linwood School, Winnipeg, 1913. For this school in St. James, architect A. Melville used the familiar two-storey massing, but with a more modest detail expression.

A building like Linwood School in St. James clearly reflects the long low plan of two storey height seen in the city of Winnipeg (Fig. 77). However, the architect for Linwood, A. Melville, working on a much smaller budget, produced a simple external treatment enlivened by the use of contrasting red brick and light grey concrete, with some minor Gothic Revival detailing at the entrance. A more thorough investigation of the possibilities of Late Gothic Revival was used by the architect on two of East Kildonan's large schools from this period. Both constructed in 1915, Lord Kitchener and Lord Wolseley schools were built on slightly different plans, but otherwise shared a nearly identical external treatment (Fig. 78).

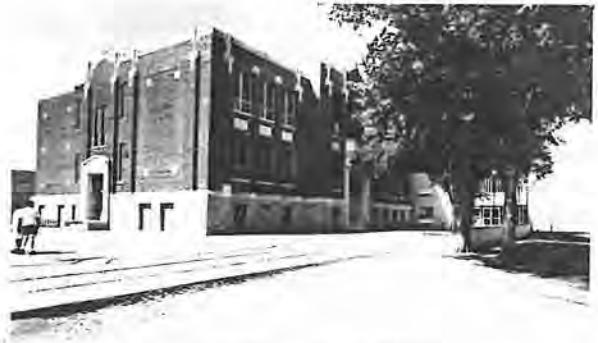
Figure 78. Lord Kitchener School, Winnipeg, 1915. A variety of Gothic Revival details, and handsome concrete inset panels, were used to enrich this compact design.

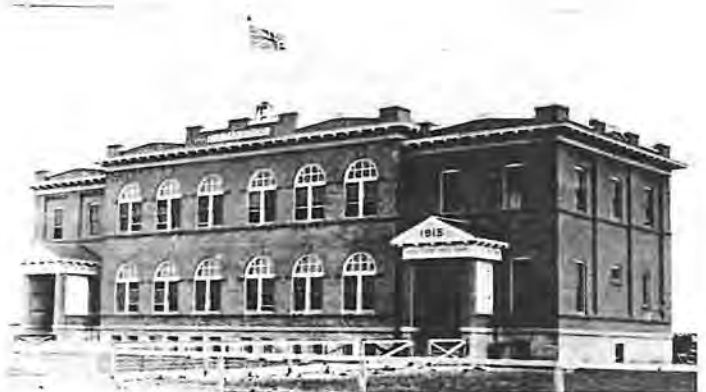
Figure 79. The Pas School, 1915, designed by architect G.N. Taylor. Demolished. (PAM)

With the advance of settlement into the northern reaches of the province between 1903 and 1918 came the need for substantial school accommodation. Thus, for example, only three years after the community at The Pas was incorporated as a town in 1912, a new -- and large -- public school was constructed (Fig. 79).

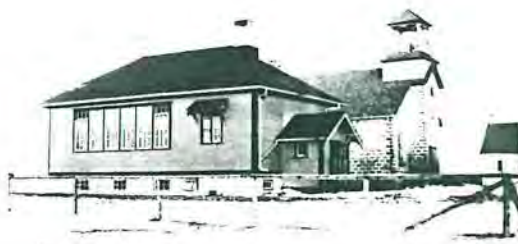
Figure 80. Niverville Schools, ca. 1928. An instructive comparison of the change in architectural sensibilities shows (on the right) a Hooper design from 1912 and (on the left), a standardized design of the 1920s adapted from a popular cottage-style scheme from 1912 (Fig. 53). Both demolished. (PAM)

In fact, two of the schemes (Figs. 80 and 81) were only variations on the popular cottage-style design introduced in 1912. The other two 1920s designs offered a slightly different form, with entrances set alongside the window bank and sheltered by an extension of the gable roof (Figs. 82 and 83). A design introduced in the mid-1930s combined the hipped roof of other standardized designs with the side entrance of these later schemes (Fig. 84).

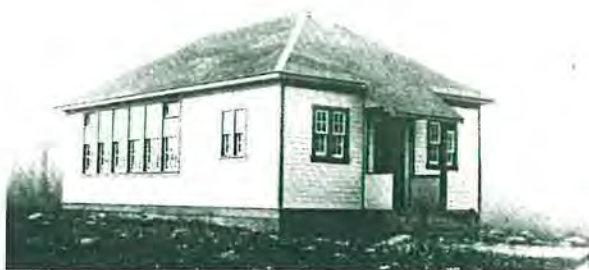
Figure 81. Cork Cliff School, 1929. A second variation on the cottage-style design that was used in the 1920s is distinguished by a small porch protected by an extension of the roof. (Reflections from Little Muddy River, p. 77)

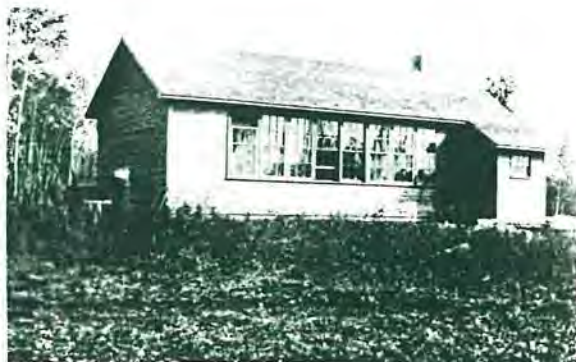
Figure 82. Lake Audy School, 1931. The basic rectangular form, with the bank of windows, is made almost sleek with an entrance set parallel to the building. (Pioneers and Progress, p. 54)

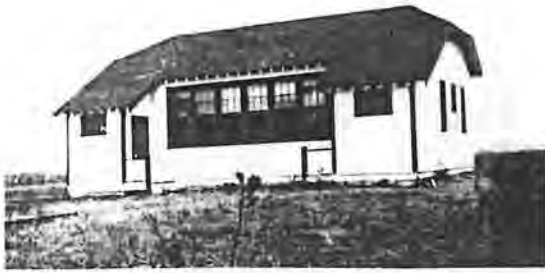
Figure 83. Prestwick School, 1935. The new entrance configuration seen earlier was here adapted to provide entry on one side for girls, on the other for boys. Demolished. (*Then to Now*, p. 75)

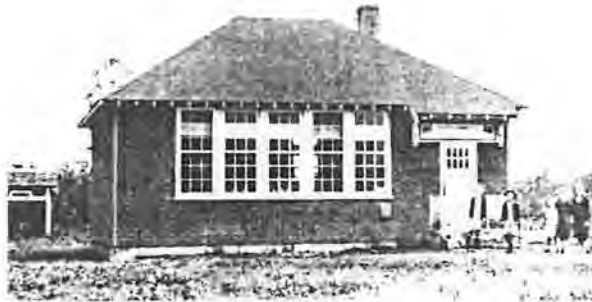
Figure 84. Gravelridge School, 1938. This up-to-date one-room structure featured insulbrick siding, for fire protection. Demolished. (*Schools - Our Heritage*, p. 77)

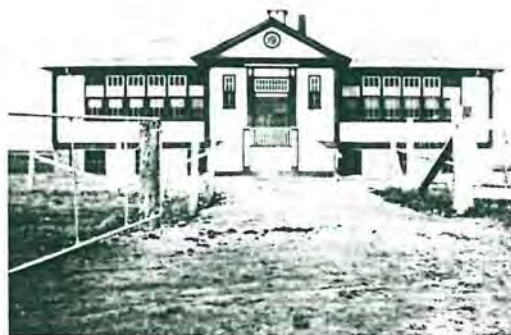
Figure 86. Mountainside Consolidated School, ca. 1935. One of the typical two-room designs popular in the 1920s and 30s featured a classically-inspired pediment over the entrance. (PAM)

In most of the standardized schemes a long hipped roof created the dominant form, with a pedimented entrance providing a sense of gracefulness, while the now common window bank established a rectilinear pattern on the facade (Figs. 86 and 87). Another popular scheme featured the same roof shape, but combined it with a less formal hip-roofed entrance and window banks on the end walls (Fig. 88).

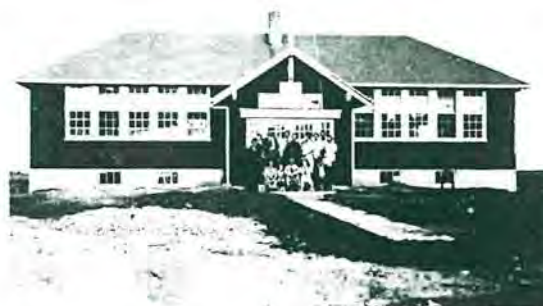
Figure 87. Osborne School, 1938. Here, the gabled entrance to a standardized two-room design had detail work more commonly seen on domestic bungalows. Demolished. (Down Memory Lane, p. 100)

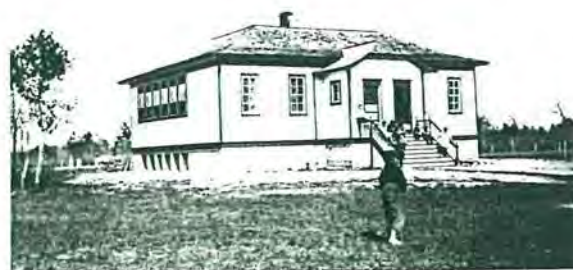
Figure 88. Woodlands Consolidated School, 1920. Another popular two-room design used throughout this period. Demolished. (Yesteryears, p. 85)

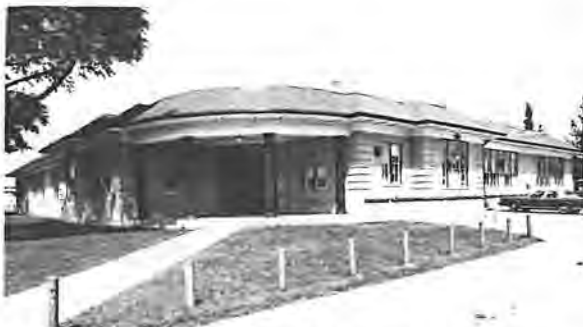
Figure 89. Greenway #2 School, Winnipeg, 1919. One of Col. Mitchell's modest one-storey schools, this building is distinguished by a curving roof over the entrance.

A set of new designs, of much more modest size, styling and cost (\$100,000⁴⁴) were approved and by the end of 1920 eleven new schools had been constructed. Four of these buildings were the work of Col. Mitchell (Figs. 89 and 90). However,

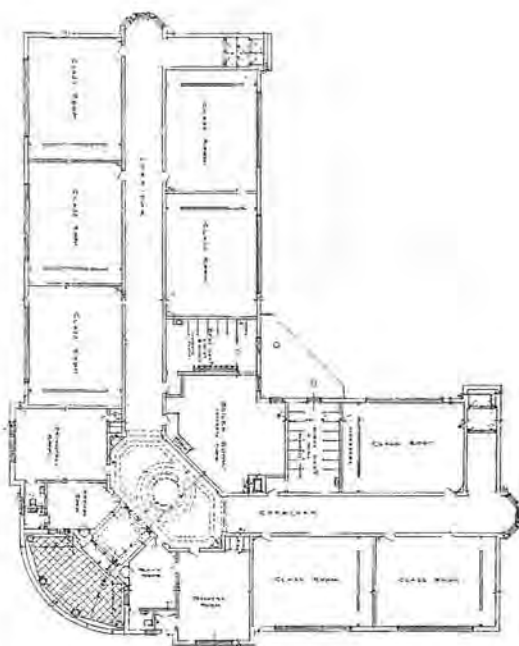
Figure 90. Greenway #2 School, Winnipeg, floor plan. The design, which was clearly organized to accept additions as the population changed, was reflective of the uncertain conditions of the time. (Building Department, Winnipeg School Division No. 1)

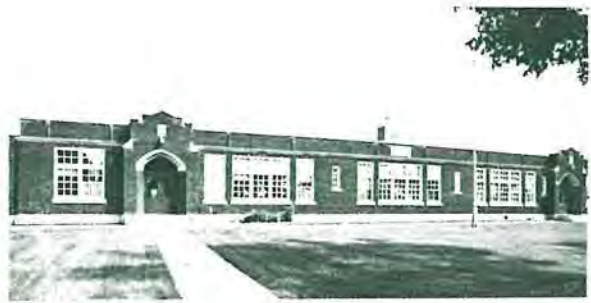
Figure 92. Sir Sam Steele School, Winnipeg, 1921. With its long low profile, this is a good example of Semmens' modest one-storey school designs.

A second, simpler type, dispensed with the two-storey section and made the most of a very long single storey silhouette, and a very simple interpretation of Collegiate Gothic (Fig. 92). Architectural delight was reserved for the entrances, where a variety of Gothic Revival details were used. This type of school was also popular throughout the city's other school districts, where a variety of other architects created similar buildings (Fig. 93).

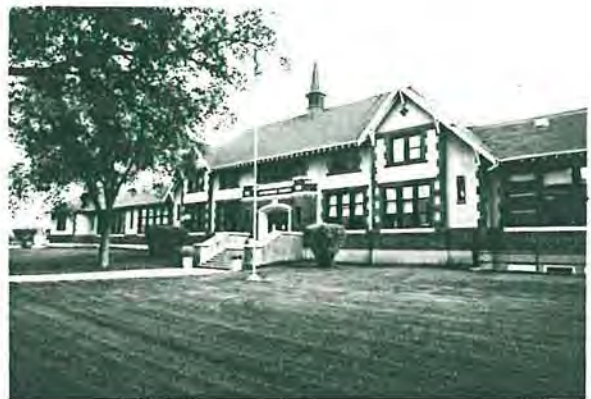
Figure 93. Assiniboine School, Winnipeg, 1920. A slightly different expression of Collegiate Gothic, by an architect for the St. James School Board, combines a hipped roof, a steeple, bungalow-style brackets and broad expanses of stucco.

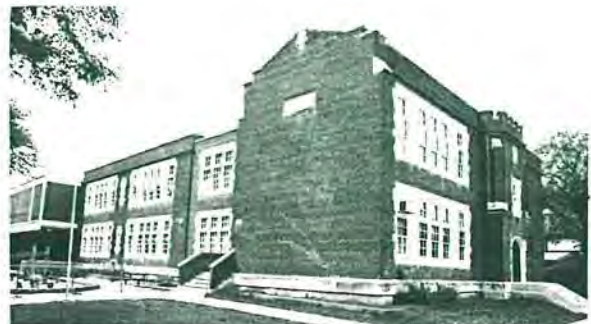
Figure 94. Grosvenor School, Winnipeg, 1922. An example of Semmens' two-storey designs, this one carried out in the spirit of Collegiate Gothic.

The third basic design scheme provided for a two-storey structure, and was typically a more fully realized expression of the style. In these cases, Semmens usually worked out a T-, H- or U-shaped plan that created the projecting wings where a stark profile and crisp stone details were used for the clear delineation of Collegiate Gothic forms and details (Fig. 94).
