A STUDY OF PUBLIC SCHOOL BUILDINGS IN MANITOBA

DAVID BUTTERFIELD

1994

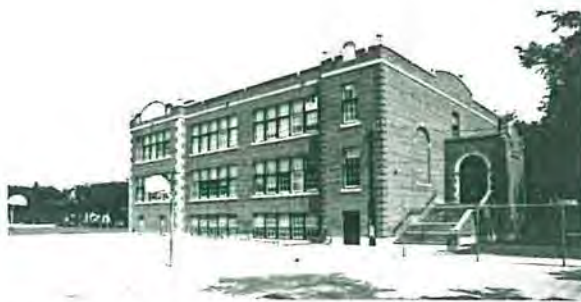
Figure 97. Queenston School, Winnipeg, 1931. W.A. Martin's design was informed with a certain architectural wit, like the juxtaposition of differing quoin designs on the two end bays.

Semmens' tenure as the school district's architect ended in 1925 and a range of other designers was used through the last half of the 1920s and for the few buildings constructed in the 1930s. W.A. Martin was selected for several of these commissions. Martin's designs were generally more blocky than were Semmens', with a modesty of shape, detail and even colour. Projecting wings were nearly flush to the main wall surface; gently arched gables and name plates were used for decorative appeal, while the combination of buff-coloured brick and soft grey concrete details produced quiet, elegant buildings (Fig. 97).

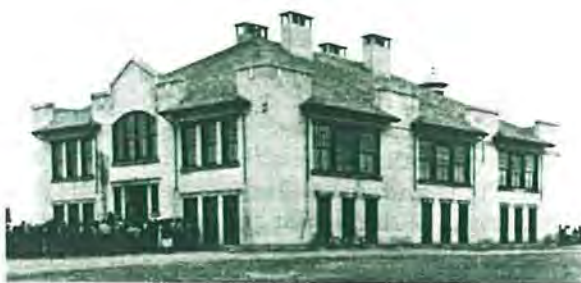
Figure 98. Roblin School, ca. 1920. One of the most striking designs from this period, this building recalled the continued local efforts to produce schools of distinction. Destroyed by fire. (Shell River Municipality. *Century One*, p. 314)

The developments in Winnipeg were to have immediate influence on school designs throughout the urban centres of the province. Although there continued to be exceptions (Fig. 98), the few new schools that were constructed in the province's smaller urban centres

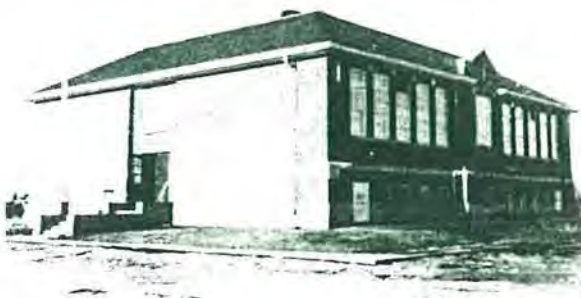
Figure 99. Brookdale Consolidated School, 1924. Long and low, with a shallow hip roof, the building was distinguished by a modest gabled entrance. (Carberry Plains. *Century One*, p. 242)

Thus, buildings tended to be low and horizontal, of red brick and with Late Gothic Revival or even occasionally Georgian Revival styling (Figs. 99 and 100). Brick or concrete external detailing generally replaced the pre-World War I preference for expensive carved stone. Inside, these new schools were equipped with internal fittings and appointments of the highest standards. The inclusion of gymnasias was a key advance. This was a response to war time needs; recruiting officers found that young men were generally in poor physical condition. And in larger communities like Brandon, Portage la Prairie and Dauphin, there were typically more sophisticated expressions of the stylistic variables possible (Fig. 101).

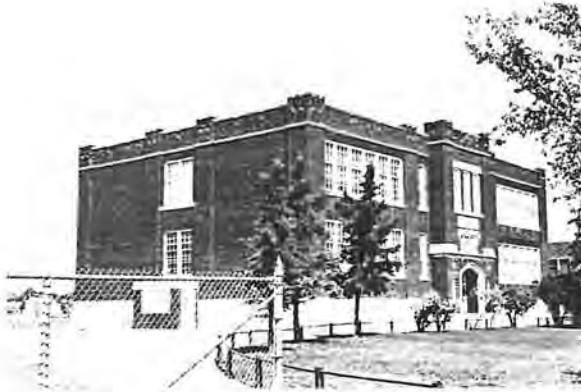
Figure 100. Earl Oxford School, Brandon, 1928. Col. J.N. Semmens, the architect for most of Winnipeg's schools of the early 1920s also designed several school buildings in Brandon, in a similar style: a restrained interpretation of Collegiate Gothic in red brick.

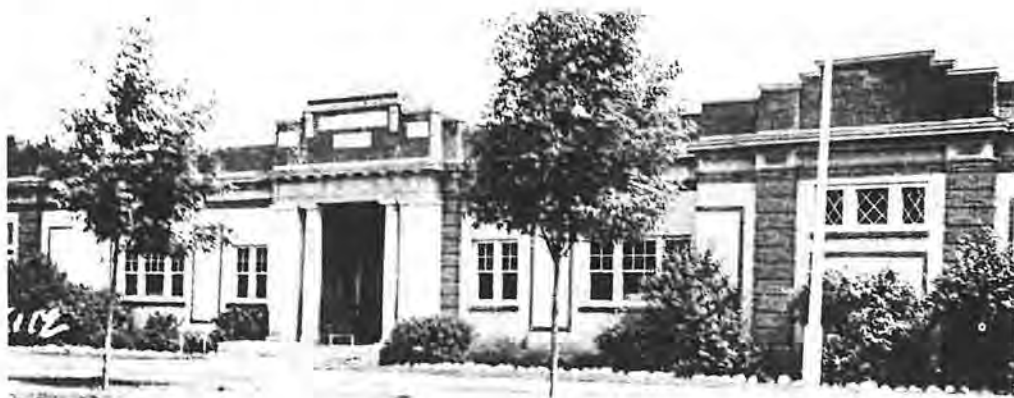
Figure 101. Smith Jackson School, Dauphin, 1921. Dramatically long, the building was enlivened with the red brick and stark white Classical details used in Georgian Revival designs. Demolished. (Dauphin Valley Spans the Years, p. 88)

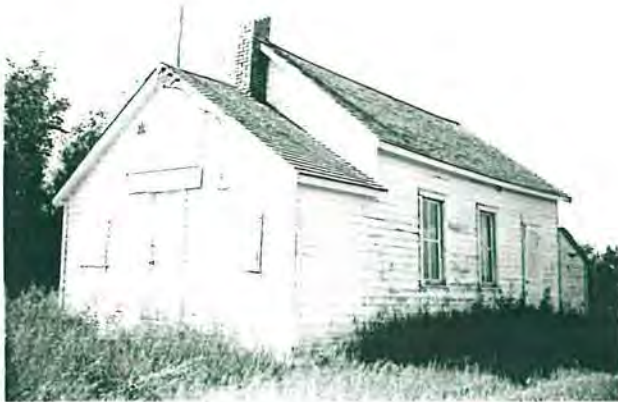
ARAWANA

LOCATION: SE 19-10-28W
MUNICIPALITY: Wallace
DATE BUILT: 1897
ARCHITECT:
BUILDER:
CONSTRUCTION: wood frame/siding
PRESENT USE: vacant
COMMENTS:

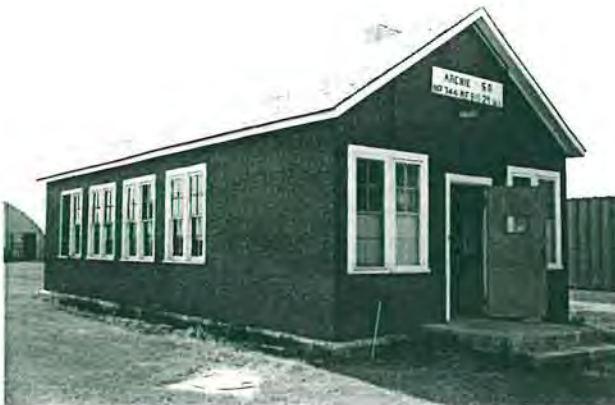
ARCHIE

LOCATION: Elkhorn
MUNICIPALITY: Archie
DATE BUILT: 1896
ARCHITECT:
BUILDER:
CONSTRUCTION: wood frame/stucco
PRESENT USE: museum
COMMENTS:

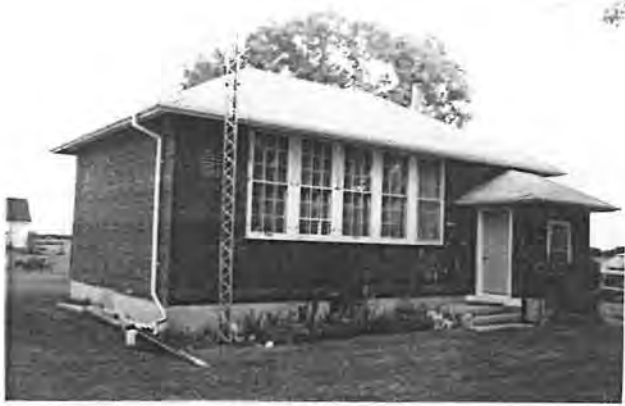
ARMISTICE

LOCATION: Teulon
MUNICIPALITY: Rockwood
DATE BUILT: ca. 1920
ARCHITECT:
BUILDER:
CONSTRUCTION: wood frame/siding
PRESENT USE: museum piece
COMMENTS:

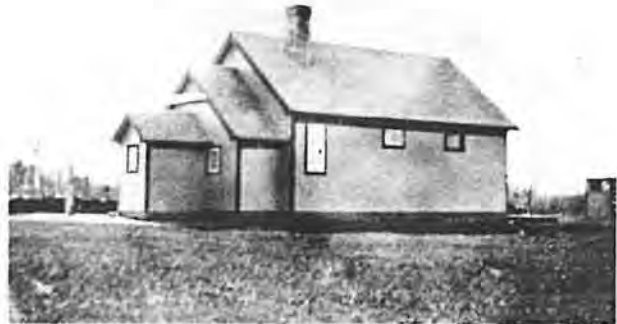
ARONDALE

LOCATION: 21-9-6E
MUNICIPALITY: Tache
DATE BUILT: ca. 1927
ARCHITECT:
BUILDER:
CONSTRUCTION: wood frame/shingles
PRESENT USE: residence
COMMENTS: still on its original site

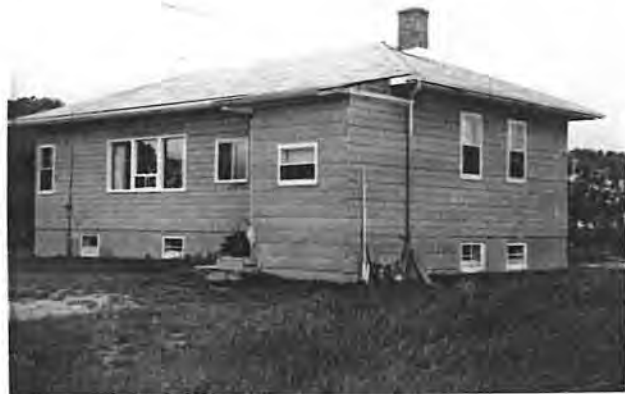
ARROW RIVER

LOCATION: NW 31-13-25W
MUNICIPALITY: Miniota
DATE BUILT: 1919/1929
ARCHITECT:
BUILDER:
CONSTRUCTION: wood frame/siding
PRESENT USE: cattle shed
COMMENTS: original 1919 structure
enlarged with second room in 1929
BIBLIOGRAPHY: 121, pp. 56-57

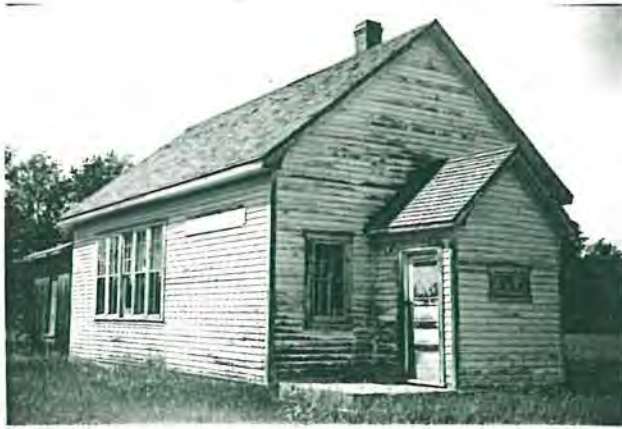
ASQUTH

LOCATION: SE 1-33-21W
 MUNICIPALITY: Mountain
 DATE BUILT: ca. 1920
 ARCHITECT:
 BUILDER:
 CONSTRUCTION: wood frame/siding
 PRESENT USE: community centre
 COMMENTS: still on its original site

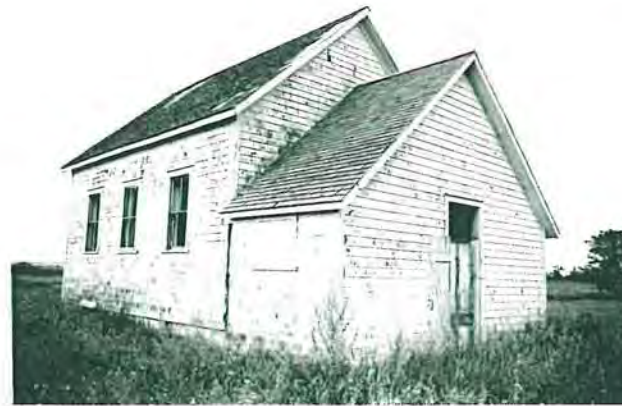
ASSINIBOINE

LOCATION: NW 27-10-21W
 MUNICIPALITY: Whitehead
 DATE BUILT: ca. 1910
 ARCHITECT:
 BUILDER:
 CONSTRUCTION: wood frame/shingles
 PRESENT USE: vacant
 COMMENTS:

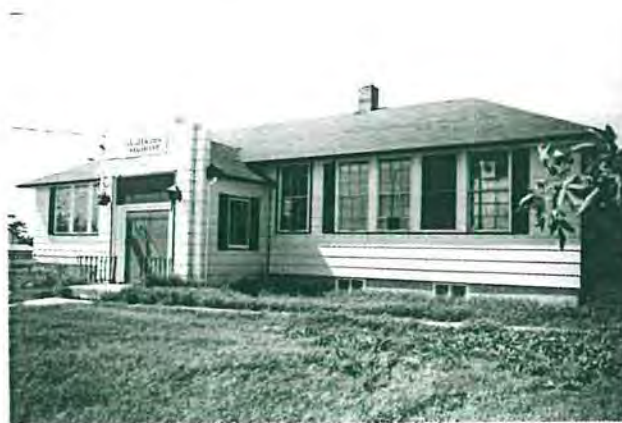
AUBIGNY

LOCATION: NW 3-6-2E
 MUNICIPALITY: Morris
 DATE BUILT: ca. 1920
 ARCHITECT:
 BUILDER:
 CONSTRUCTION: wood frame/siding
 PRESENT USE: vacant
 COMMENTS:

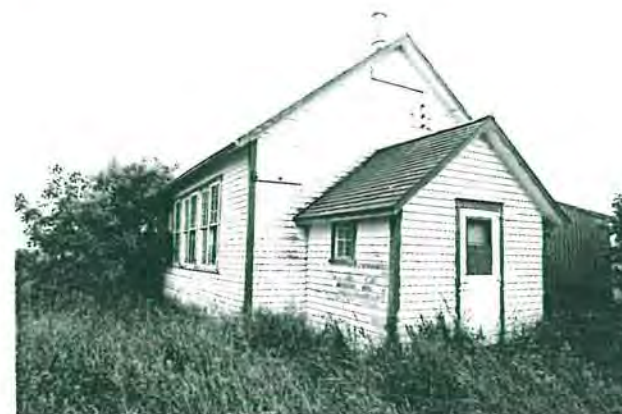
AUBURN

LOCATION: SW 4-13-15W
 MUNICIPALITY: Langford
 DATE BUILT: ca. 1905
 ARCHITECT:
 BUILDER:
 CONSTRUCTION: wood frame/siding
 PRESENT USE: shop
 COMMENTS:

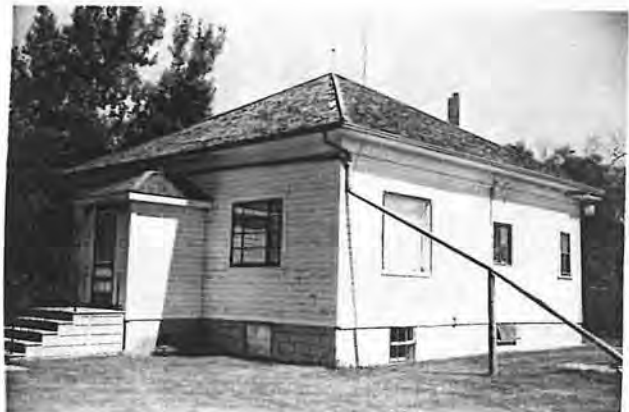
BARDAL

LOCATION: SW 15-8-29W
MUNICIPALITY: Pipestone
DATE BUILT: 1927
ARCHITECT:
BUILDER: Charles Webster
CONSTRUCTION: wood frame/siding
PRESENT USE: vacant
COMMENTS:

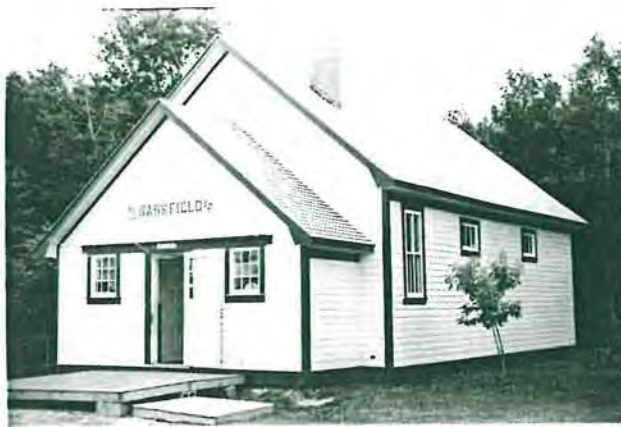
BARKFIELD

LOCATION: SW 20-4-5E
MUNICIPALITY: de Salaberry
DATE BUILT: 1919
ARCHITECT:
BUILDER:
CONSTRUCTION: wood frame/siding
PRESENT USE: Mennonite Village Museum
COMMENTS:

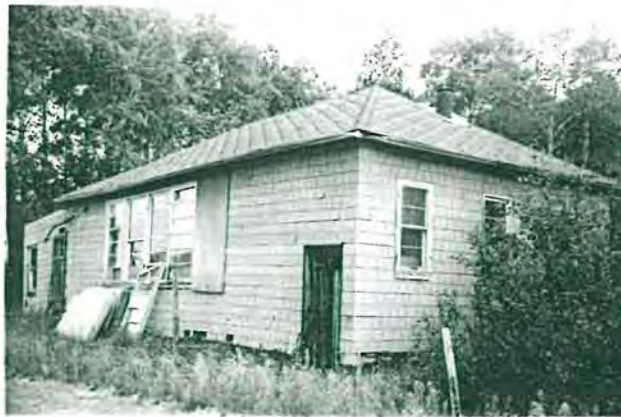
BARRON

LOCATION: SW 17-9-8W
MUNICIPALITY: South Norfolk
DATE BUILT: ca. 1925
ARCHITECT:
BUILDER:
CONSTRUCTION: wood frame/shingles
PRESENT USE: storage
COMMENTS:

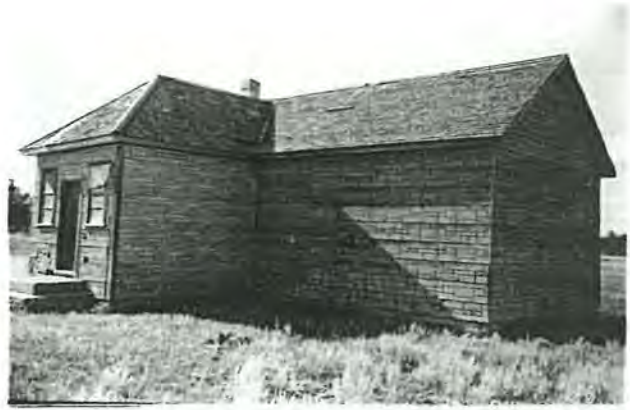
BIELD

LOCATION: NW 2-26-27W
MUNICIPALITY: Hillsburg
DATE BUILT: 1913
ARCHITECT:
BUILDER:
CONSTRUCTION: wood frame/siding
PRESENT USE: residence
COMMENTS: the original front tower
has been removed
BIBLIOGRAPHY: 151, p. 260

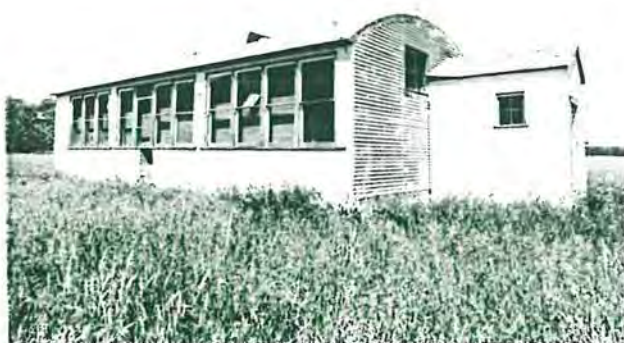
BLAKE

LOCATION: NW 10-15-12W
 MUNICIPALITY: Lakeview
 DATE BUILT: 1950
 ARCHITECT:
 BUILDER:
 CONSTRUCTION: wood frame/metal
 PRESENT USE: granary
 COMMENTS: a rare example featuring
 corrugated metal siding; original
 site
 BIBLIOGRAPHY:

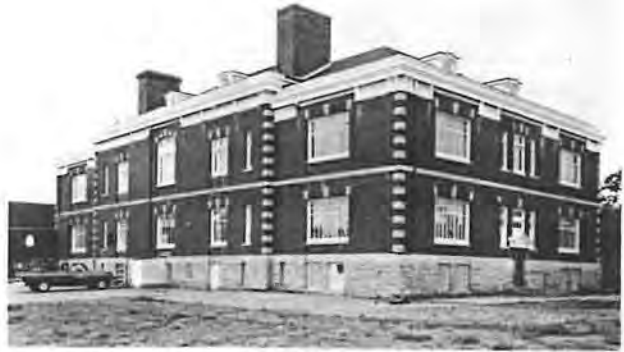
COLLEGIATE INSTITUTE

LOCATION: 527 Louise Ave.
MUNICIPALITY: Brandon
DATE BUILT:
ARCHITECT:
BUILDER:
CONSTRUCTION: brick
PRESENT USE: school
COMMENTS: ambitious design,
abounding in fine detail work
BIBLIOGRAPHY:

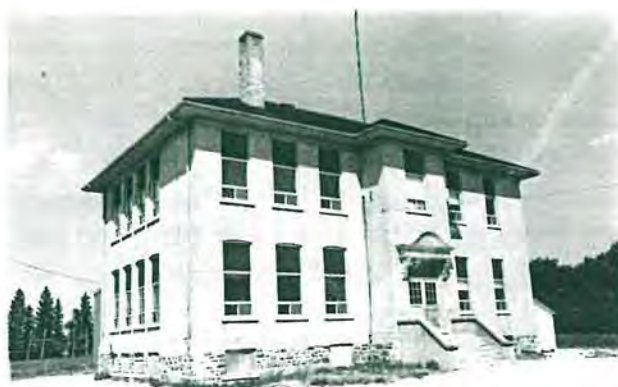
BRANDON HILLS

LOCATION: NW 16-9-18W
 MUNICIPALITY: Cornwallis
 DATE BUILT: 1915
 ARCHITECT:
 BUILDER:
 CONSTRUCTION: brick
 PRESENT USE: community centre
 COMMENTS: still on its original
 site
 BIBLIOGRAPHY: 27, p. 184

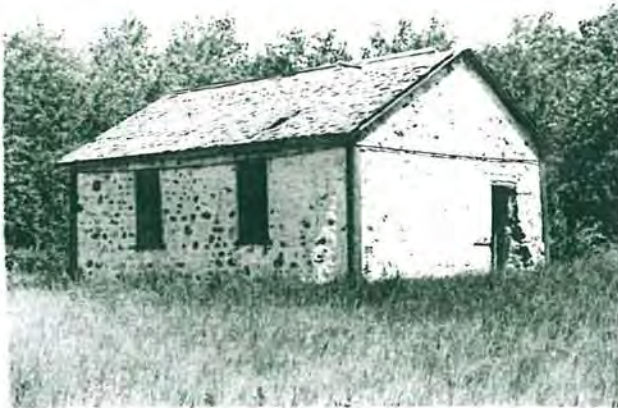
BROWNLEA

LOCATION: NE 20-4-19W
 MUNICIPALITY: Morton
 DATE BUILT: 1902
 ARCHITECT:
 BUILDER: Mr. King
 CONSTRUCTION: wood frame
 PRESENT USE: vacant
 COMMENTS: the building features fine cornice details at the eaves; original site
 BIBLIOGRAPHY: 18, pp. 154-55

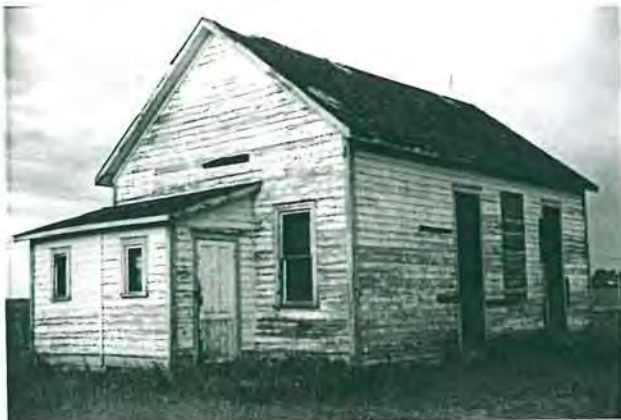
BRUCE

LOCATION: SW 34-14-1E
 MUNICIPALITY: Rockwood
 DATE BUILT: 1884
 ARCHITECT:
 BUILDER:
 CONSTRUCTION: stone
 PRESENT USE: abandoned
 COMMENTS: a rare and early example of stone construction
 BIBLIOGRAPHY:

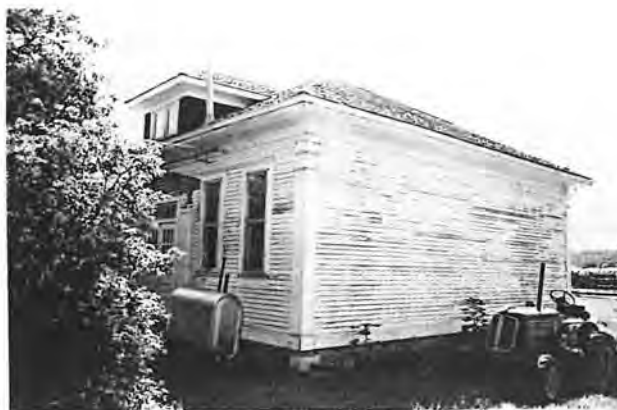
BUNCLODY

LOCATION: SW 6-7-19W
MUNICIPALITY: Oakland
DATE BUILT: ca. 1915
ARCHITECT:
BUILDER:
CONSTRUCTION: wood frame/siding
PRESENT USE: workshop
COMMENTS: the building features minor classical detailing on the front
BIBLIOGRAPHY:

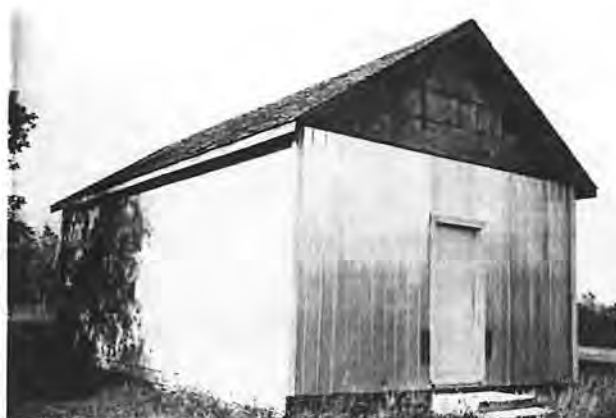
BUTTERFIELD

LOCATION: SW 15-2-29W
MUNICIPALITY: Edward
DATE BUILT: 1906
ARCHITECT: Samuel Hooper
BUILDER: W. Tooke
CONSTRUCTION: wood frame/metal
PRESENT USE: granary
COMMENTS: a Hooper #2, with the character obliterated by renovations
BIBLIOGRAPHY: 52, pp. 142-44

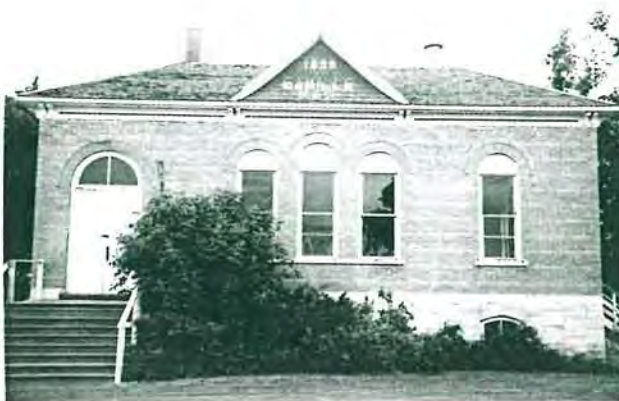
CAMERON

LOCATION: SE 29-15-18W
 MUNICIPALITY: Minto
 DATE BUILT: 1919
 ARCHITECT:
 BUILDER: A.E. Dobson
 CONSTRUCTION: brick
 PRESENT USE: storage
 COMMENTS: an exceptional and unique design
 BIBLIOGRAPHY: 34, pp. 148-49

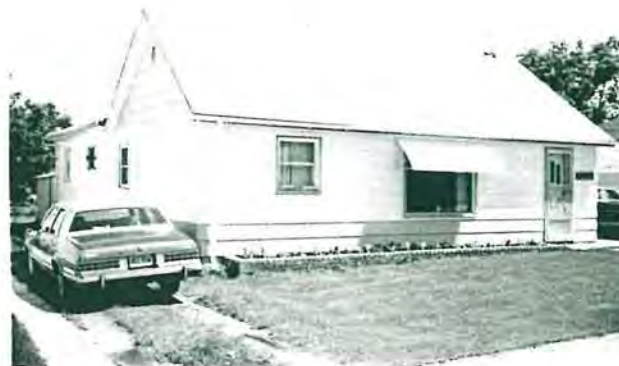
DE CLARE

LOCATION: SE 10-15-29W
MUNICIPALITY: Archie
DATE BUILT: 1885
ARCHITECT:
BUILDER:
CONSTRUCTION: wood frame/siding
PRESENT USE: residence
COMMENTS:

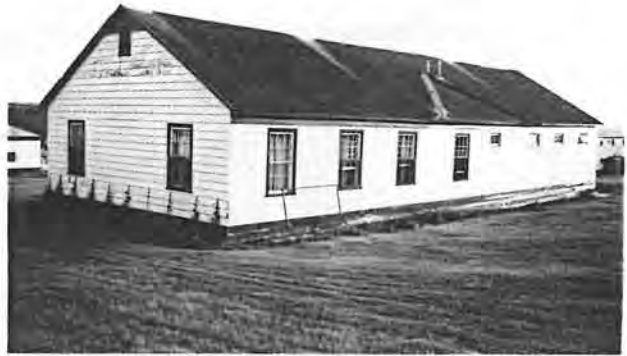
DEER CREEK

LOCATION: SW 12-1-6W
MUNICIPALITY: Stanley
DATE BUILT: 1906
ARCHITECT:
BUILDER:
CONSTRUCTION: wood frame/siding
PRESENT USE: granary
COMMENTS:

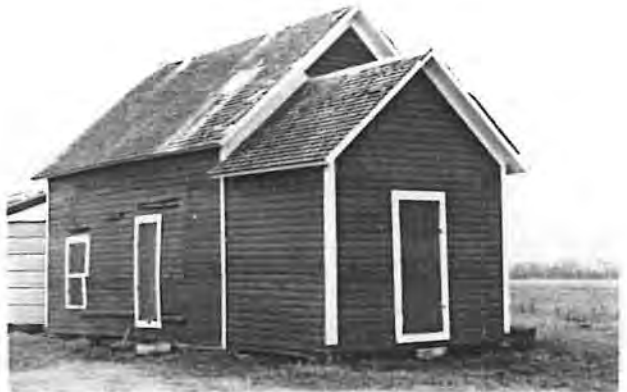
DEER RANGE

LOCATION: SE 13-12-13W
MUNICIPALITY: North Cypress
DATE BUILT: ca. 1910
ARCHITECT:
BUILDER:
CONSTRUCTION: wood frame/siding
PRESENT USE: vacant
COMMENTS: still on its original site
BIBLIOGRAPHY:

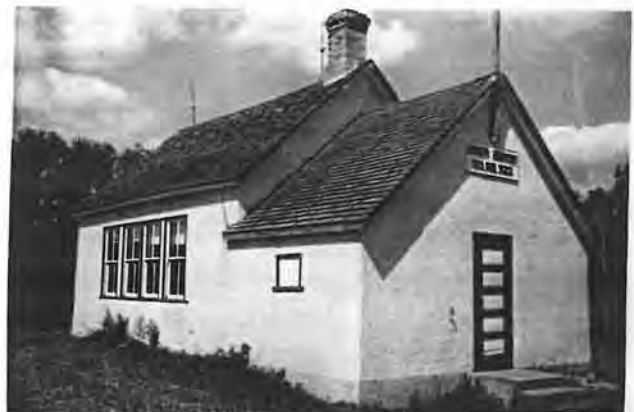
DE LAMENAI

LOCATION: SE 19-24-14W
MUNICIPALITY: Ste. Rose
DATE BUILT: 1917
ARCHITECT:
BUILDER:
CONSTRUCTION: wood frame/stucco
PRESENT USE: residence
COMMENTS:

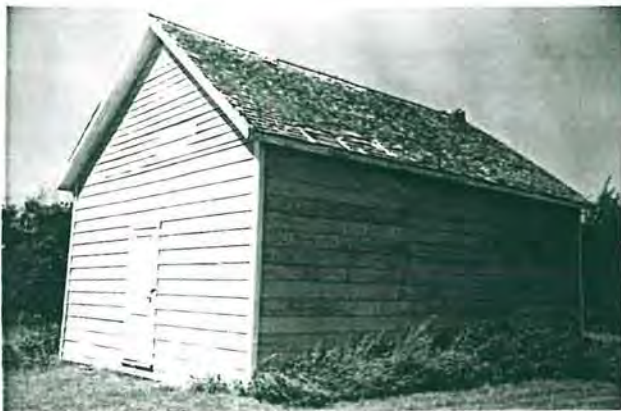
DELTA

LOCATION: NE 2-5-16W
 MUNICIPALITY: Strathcona
 DATE BUILT: 1893
 ARCHITECT:
 BUILDER:
 CONSTRUCTION: wood frame/siding
 PRESENT USE: granary
 COMMENTS:

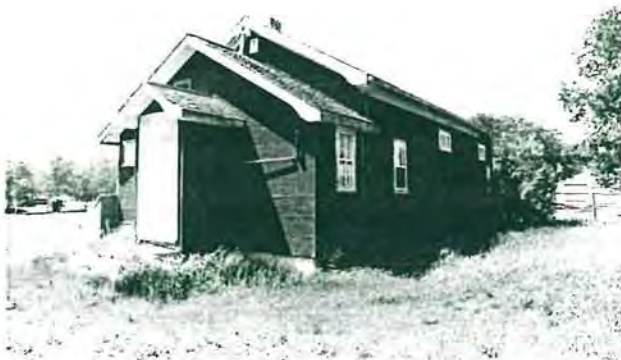
DELTA BEACH

LOCATION: SE 14-14-7W
 MUNICIPALITY: Portage la Prairie
 DATE BUILT: ca. 1910
 ARCHITECT:
 BUILDER:
 CONSTRUCTION: wood frame/siding
 PRESENT USE: community hall
 COMMENTS:

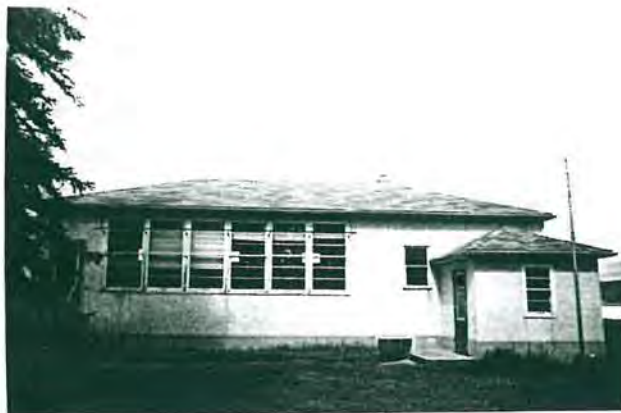
DEMPSEY

LOCATION: SW 35-11-14W
 MUNICIPALITY: North Cypress
 DATE BUILT: 1955
 ARCHITECT:
 BUILDER:
 CONSTRUCTION: wood frame/stucco
 PRESENT USE: community hall
 COMMENTS: still on its original site
 BIBLIOGRAPHY: 30, p. 110

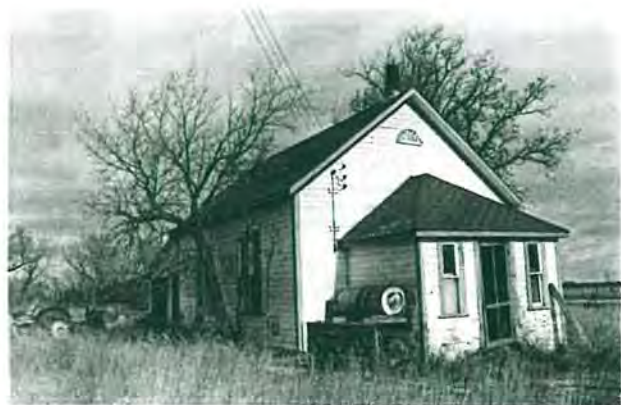
DERRY

LOCATION: SE 13-11-17W
 MUNICIPALITY: Elton
 DATE BUILT: 1900
 ARCHITECT:
 BUILDER:
 CONSTRUCTION: wood frame/siding
 PRESENT USE: storage
 COMMENTS: still on its original site
 BIBLIOGRAPHY: 27, p. 182

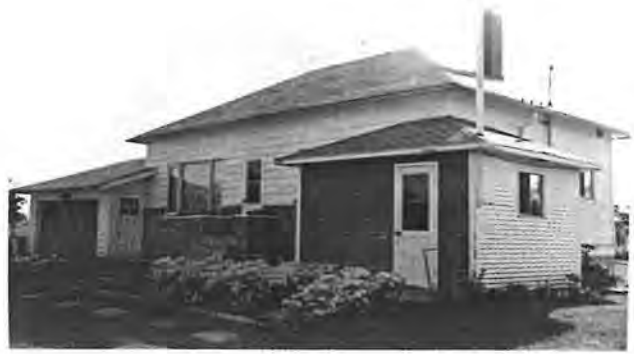
DICKSON

LOCATION: SW 21-25-18W
MUNICIPALITY: Dauphin
DATE BUILT: ca. 1920
ARCHITECT:
BUILDER:
CONSTRUCTION: wood frame/shingles
PRESENT USE: shop
COMMENTS: still on its original site

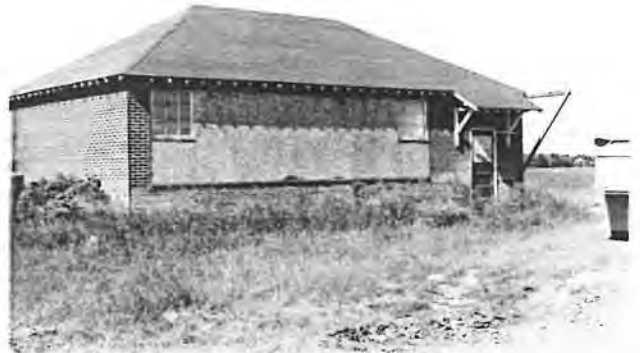
DOBBYN

LOCATION: SE 3-4-26W
MUNICIPALITY: Arthur
DATE BUILT: 1899
ARCHITECT:
BUILDER:
CONSTRUCTION: wood frame/siding
PRESENT USE: vacant
COMMENTS:

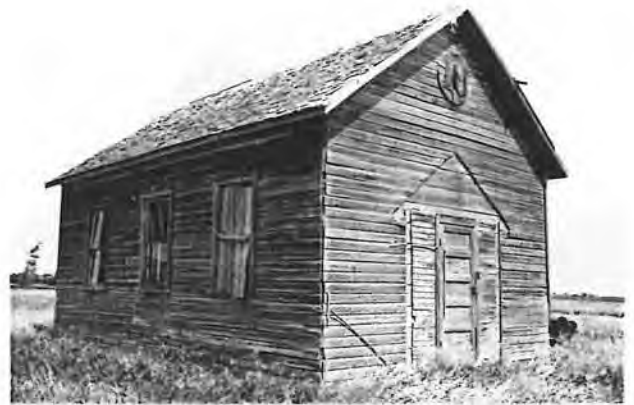
DON

LOCATION: SE 5-30-17W
MUNICIPALITY: Mossey River
DATE BUILT: 1916
ARCHITECT:
BUILDER:
CONSTRUCTION: wood frame/siding
PRESENT USE: vacant
COMMENTS:

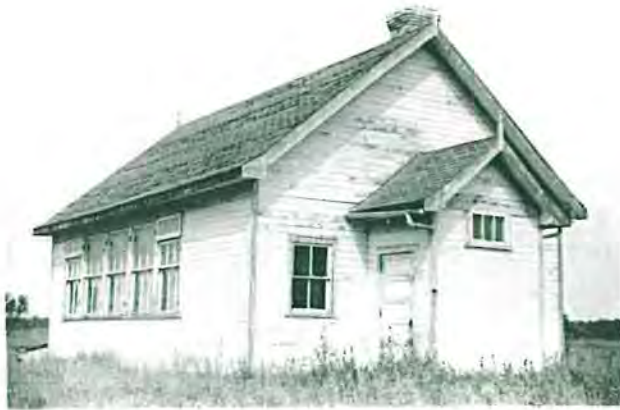
DRIFTING RIVER

LOCATION: NE 31-26-21W
 MUNICIPALITY: Gilbert Plains
 DATE BUILT: ca. 1920
 ARCHITECT:
 BUILDER:
 CONSTRUCTION: wood frame/siding
 PRESENT USE: vacant
 COMMENTS: still on its original site

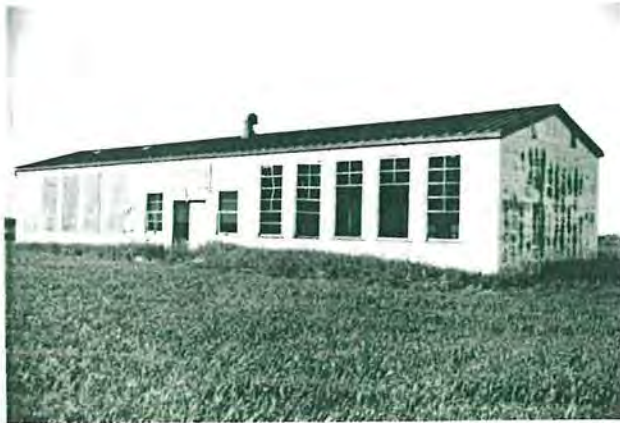
DUCK MOUNTAIN

LOCATION: SW 32-25-24W
 MUNICIPALITY: Grandview
 DATE BUILT: 1903
 ARCHITECT:
 BUILDER:
 CONSTRUCTION: wood frame/siding
 PRESENT USE: vacant
 COMMENTS:

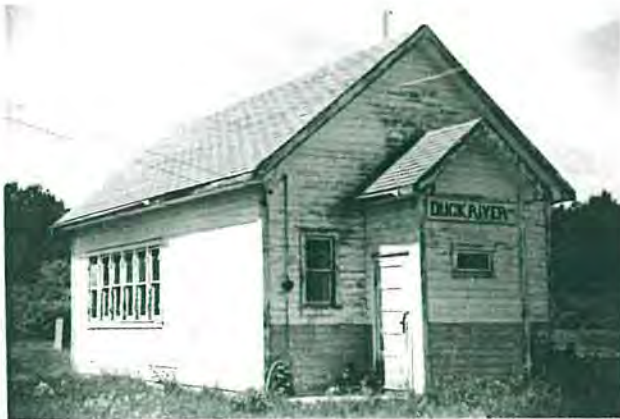
DUCK RIVER

LOCATION: NE 32-33-20W
 MUNICIPALITY: Mountain
 DATE BUILT: ca. 1915
 ARCHITECT:
 BUILDER:
 CONSTRUCTION: wood frame/siding
 PRESENT USE: vacant
 COMMENTS: still on its original site

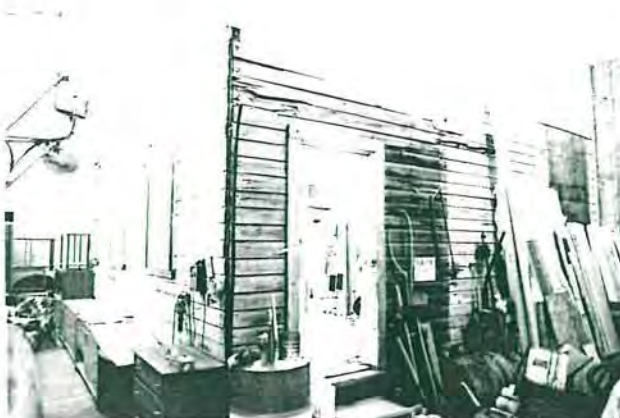
DUMFRIES

LOCATION: NE 14-14-15W
 MUNICIPALITY: Langford
 DATE BUILT: 1903
 ARCHITECT:
 BUILDER:
 CONSTRUCTION: wood frame/siding
 PRESENT USE: shop
 COMMENTS: the school remnant is now contained within a garage
 BIBLIOGRAPHY: 101, pp. 38-39

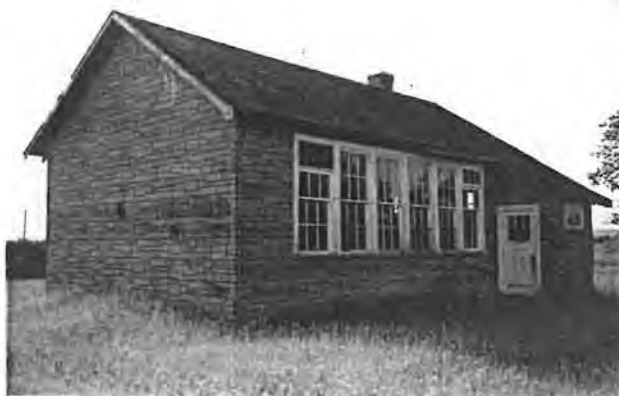
EARL GREY

LOCATION: SW 36-13-3E
MUNICIPALITY: At. Andrews
DATE BUILT: ca. 1940
ARCHITECT:
BUILDER:
CONSTRUCTION: wood frame/shingles
PRESENT USE: residence
COMMENTS: still on its original site

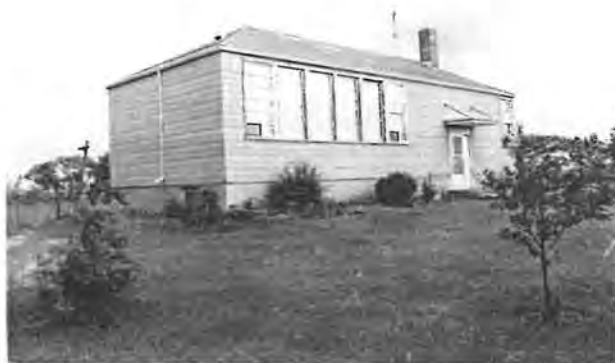
EAST LYNNE

LOCATION: NE 5-4-19W
MUNICIPALITY: Morton
DATE BUILT: 1902
ARCHITECT:
BUILDER: G. Hopkins
CONSTRUCTION: wood frame/siding
PRESENT USE: residence
COMMENTS:

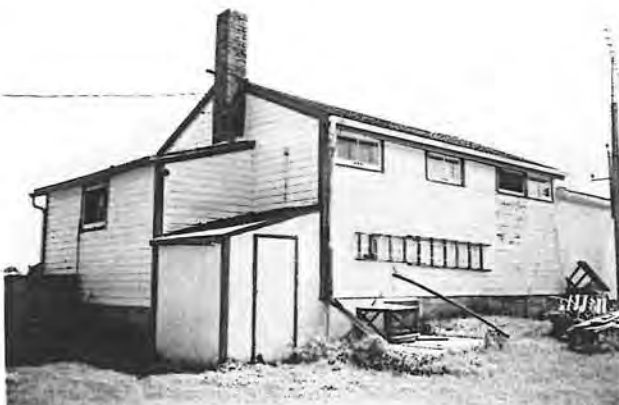
EAST MOUNTAIN

LOCATION: SW 6-2-14W
MUNICIPALITY: Roblin
DATE BUILT: ca. 1898
ARCHITECT:
BUILDER:
CONSTRUCTION: wood frame/siding
PRESENT USE: Royal Canadian Legion
COMMENTS:

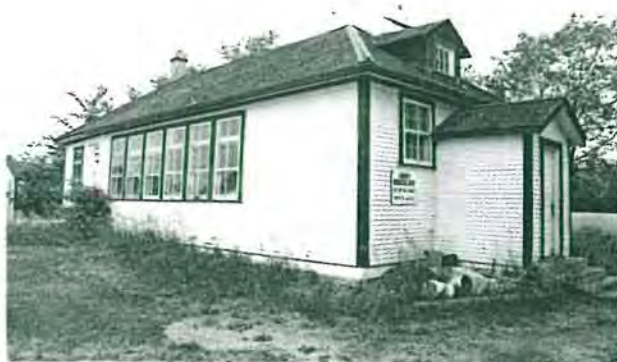
EAST ROSSER

LOCATION: SW 10-12-3W
 MUNICIPALITY: Rosser
 DATE BUILT: ca. 1915
 ARCHITECT:
 BUILDER:
 CONSTRUCTION: wood frame/siding
 PRESENT USE: business
 COMMENTS:

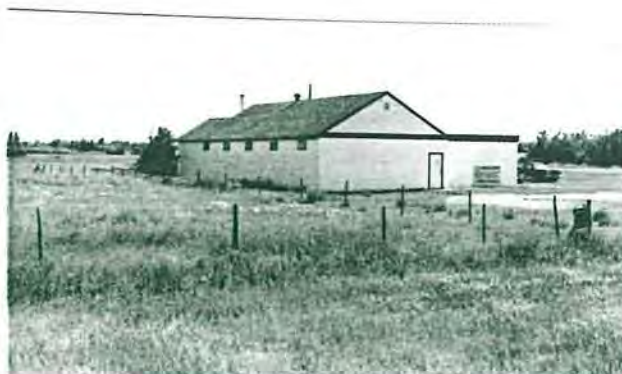
ECLIPSE

LOCATION: NE 6-25-18W
 MUNICIPALITY: Dauphin
 DATE BUILT: 1919
 ARCHITECT:
 BUILDER:
 CONSTRUCTION: wood frame/siding
 PRESENT USE: storage
 COMMENTS:

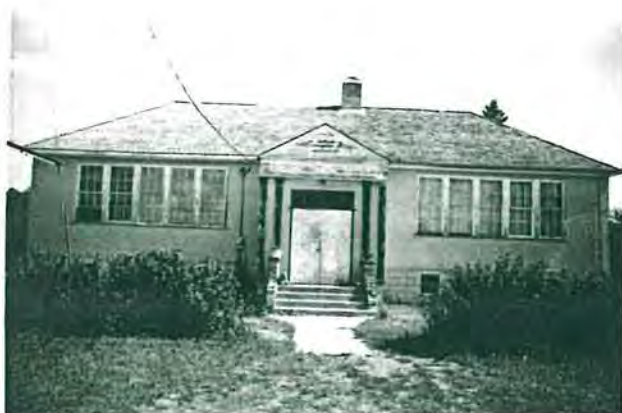
EDRANS UNION

LOCATION: SE 35-12-13W
 MUNICIPALITY: North Cypress
 DATE BUILT: 1944
 ARCHITECT:
 BUILDER:
 CONSTRUCTION: wood frame/stucco
 PRESENT USE: church
 COMMENTS: the building features a classically detailed porch
 BIBLIOGRAPHY: 30, p. 79

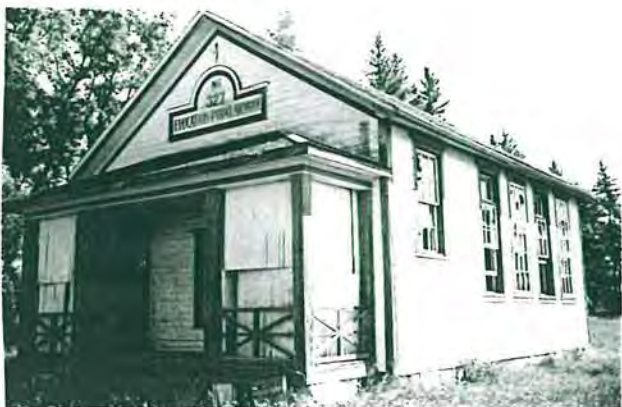
EDUCATION POINT

LOCATION: SW 14-11-23W
 MUNICIPALITY: Woodworth
 DATE BUILT: 1914
 ARCHITECT:
 BUILDER:
 CONSTRUCTION: wood frame/siding
 PRESENT USE: vacant
 COMMENTS: an unusual example, with its open porch; original location
 BIBLIOGRAPHY: 92, pp. 254-55

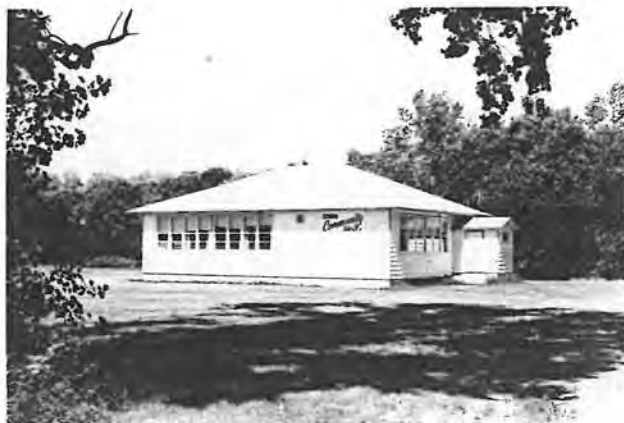
ELDON

LOCATION: SW 11-26-22W
MUNICIPALITY: Gilbert Plains
DATE BUILT: ca. 1900
ARCHITECT:
BUILDER:
CONSTRUCTION: brick
PRESENT USE: vacant
COMMENTS:

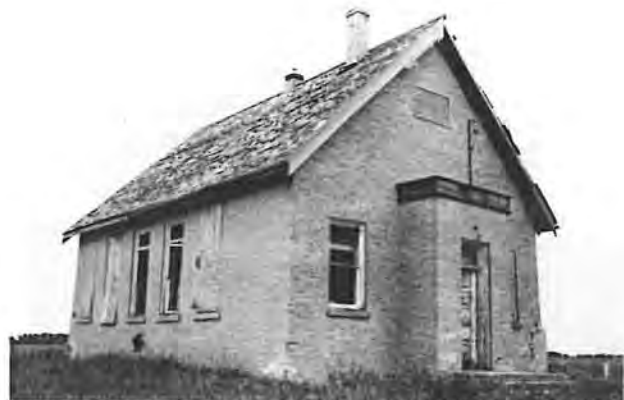
ELK RANCH

LOCATION: NE 10-17-16E
MUNICIPALITY: Rosedale
DATE BUILT: ca. 1910
ARCHITECT:
BUILDER:
CONSTRUCTION: wood frame/siding
PRESENT USE: garage
COMMENTS:

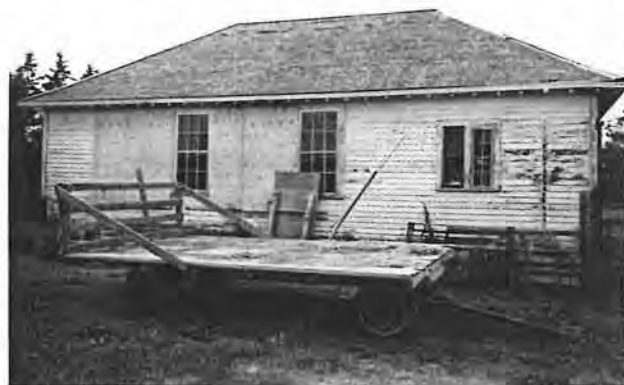
ELMWOOD

LOCATION: SW 15-10-9W
MUNICIPALITY: North Norfolk
DATE BUILT: 1958
ARCHITECT:
BUILDER:
CONSTRUCTION: wood frame/stucco
PRESENT USE: residence
COMMENTS:

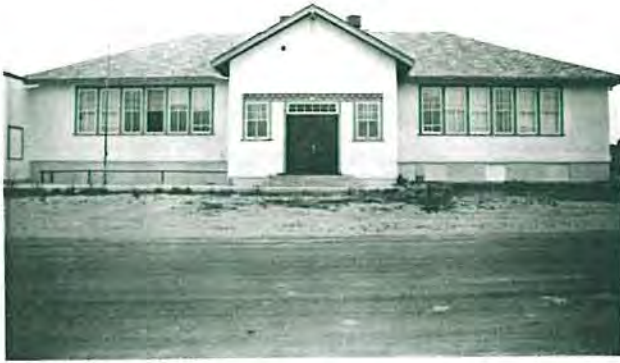
ELPHINSTONE

LOCATION: NW 9-18-21W
MUNICIPALITY: Strathclair
DATE BUILT: 1928
ARCHITECT:
BUILDER:
CONSTRUCTION: wood frame/stucco
PRESENT USE: school
COMMENTS:

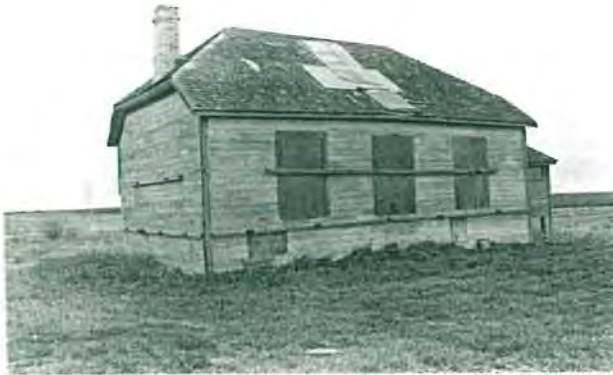
ELTON

LOCATION: SE 27-11-17W
MUNICIPALITY: Elton
DATE BUILT: 1900
ARCHITECT:
BUILDER:
CONSTRUCTION: wood frame/siding
PRESENT USE: granary
COMMENTS:

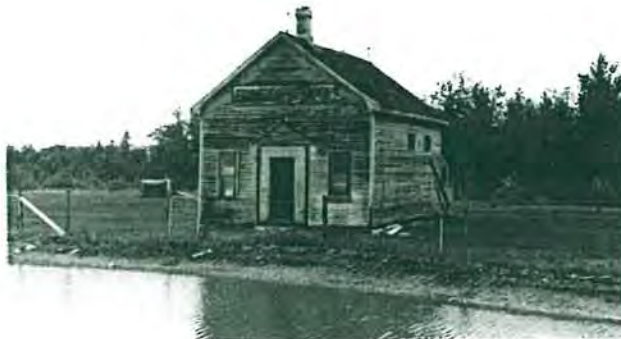
ERINSIDE

LOCATION: SW 22-16-1E
MUNICIPALITY: Rockwood
DATE BUILT: ca. 1905
ARCHITECT:
BUILDER:
CONSTRUCTION: wood frame/siding
PRESENT USE: vacant
COMMENTS:

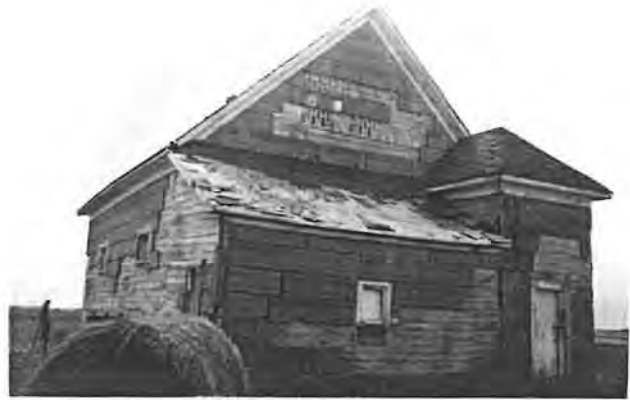
EUCLID

LOCATION: NW 6-13-6W
MUNICIPALITY: Portage la Prairie
DATE BUILT: ca. 1940
ARCHITECT:
BUILDER:
CONSTRUCTION: wood frame/shingles
PRESENT USE: residence
COMMENTS: still on its original site

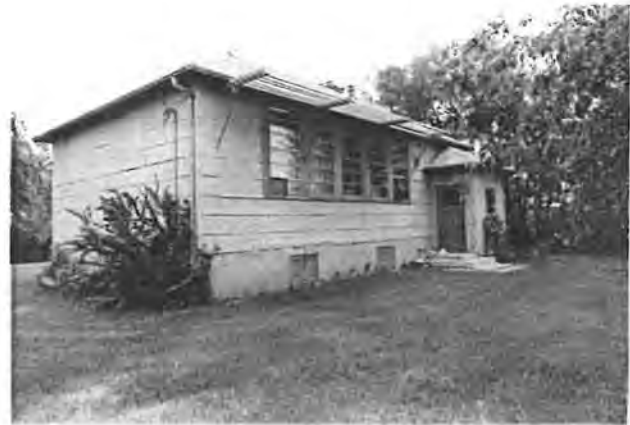
EUNOLA

LOCATION: SE 11-4-29W
MUNICIPALITY: Edward
DATE BUILT: 1937
ARCHITECT:
BUILDER:
CONSTRUCTION: wood frame/siding
PRESENT USE: vacant
COMMENTS:

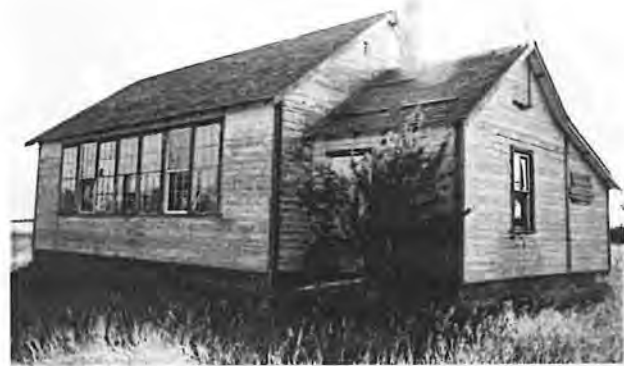
EWART

LOCATION: NE 9-8-28W
MUNICIPALITY: Pipestone
DATE BUILT: 1906
ARCHITECT:
BUILDER: T.S. Rintaul
CONSTRUCTION: wood frame/siding
PRESENT USE: vacant
COMMENTS:

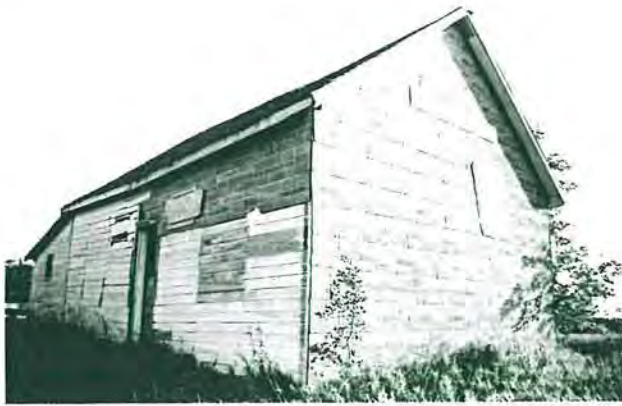
FAIRDALE

LOCATION: NW 21-2-16W
 MUNICIPALITY: Turtle Mountain
 DATE BUILT: 1883
 ARCHITECT:
 BUILDER:
 CONSTRUCTION: wood frame/siding
 PRESENT USE: granary
 COMMENTS:

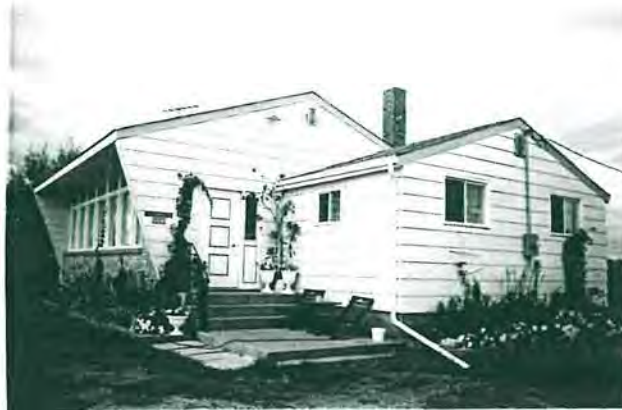
FAIRVIEW

LOCATION: NE 12-11-15W
 MUNICIPALITY: North Cypress
 DATE BUILT: 1950
 ARCHITECT:
 BUILDER: E. Court
 CONSTRUCTION: wood frame/siding
 PRESENT USE: residence
 COMMENTS:

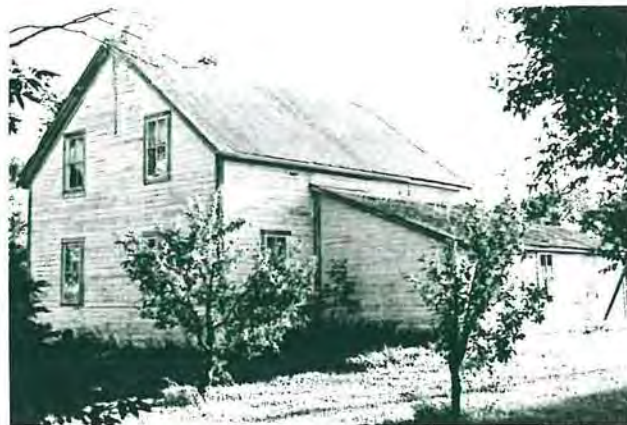
FANNYSTELLE

LOCATION: SE 36-8-3W
 MUNICIPALITY: Grey
 DATE BUILT: 1893
 ARCHITECT:
 BUILDER:
 CONSTRUCTION: wood frame/siding
 PRESENT USE: storage
 COMMENTS:

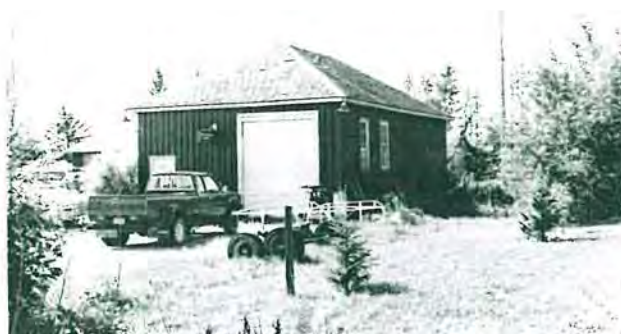
McKAY

LOCATION: SE 29-38-25W
 MUNICIPALITY: Minitonas
 DATE BUILT: 1918
 ARCHITECT:
 BUILDER: Gibson McLaughlin
 CONSTRUCTION: wood frame/siding
 PRESENT USE: storage
 COMMENTS: still on its original site
 BIBLIOGRAPHY: 178, p. 148

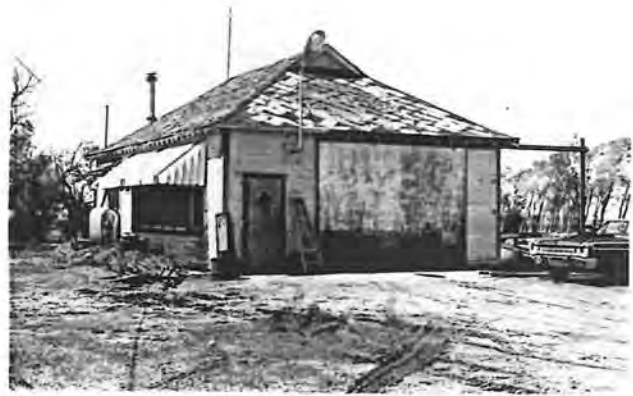
LOCATION: SE 20-13-1W
MUNICIPALITY: Woodlands
DATE BUILT: ca. 1915
ARCHITECT:
BUILDER:
CONSTRUCTION: wood frame/siding
PRESENT USE: shop
COMMENTS:

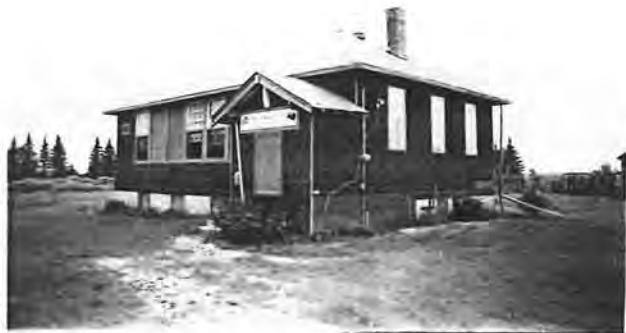
MEADOWVALE

LOCATION: NE 7-10-6E
MUNICIPALITY: Springfield
DATE BUILT: 1938
ARCHITECT:
BUILDER:
CONSTRUCTION: wood frame/shingles
PRESENT USE: residence
COMMENTS:

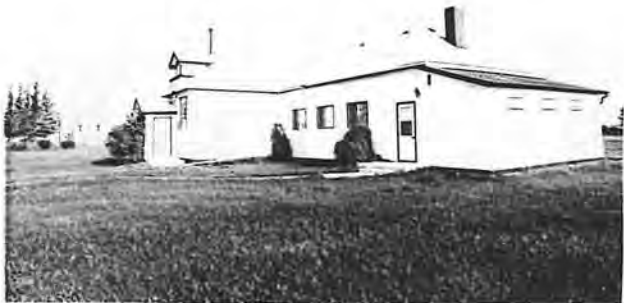
MELEB

LOCATION: Meleb
MUNICIPALITY: Armstrong
DATE BUILT: ca. 1910
ARCHITECT:
BUILDER:
CONSTRUCTION: wood frame/siding
PRESENT USE: storage
COMMENTS: still on its original site
BIBLIOGRAPHY:

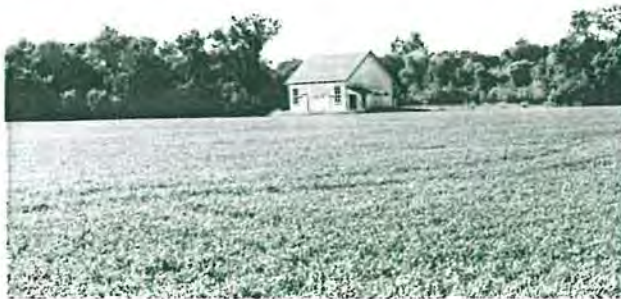
MELROSE

LOCATION: NE 27-12-5E
 MUNICIPALITY: Springfield
 DATE BUILT: 1928
 ARCHITECT:
 BUILDER:
 CONSTRUCTION: wood frame/stucco
 PRESENT USE: vacant
 COMMENTS:

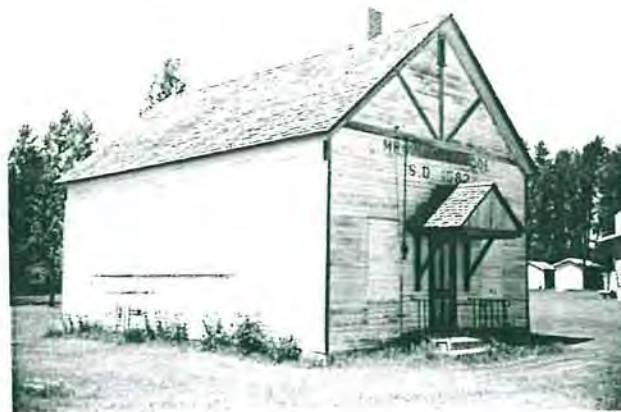
MELTON

LOCATION: NE 36-25-19W
 MUNICIPALITY: Dauphin
 DATE BUILT: 1901
 ARCHITECT:
 BUILDER:
 CONSTRUCTION: wood frame/siding
 PRESENT USE: vacant
 COMMENTS:

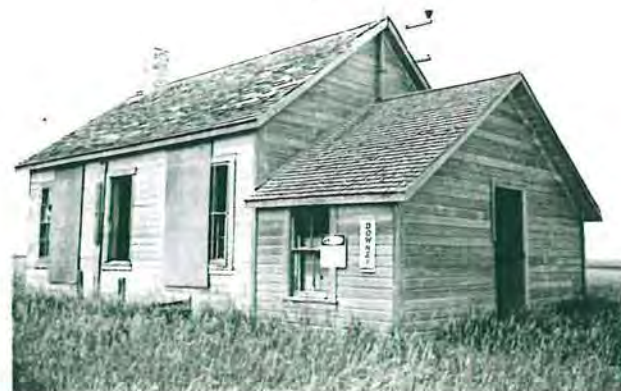
MENISINO

LOCATION: NE 35-1-10E
 MUNICIPALITY: Piney
 DATE BUILT: ca. 1900
 ARCHITECT:
 BUILDER:
 CONSTRUCTION: wood frame/siding
 PRESENT USE: vacant
 COMMENTS:

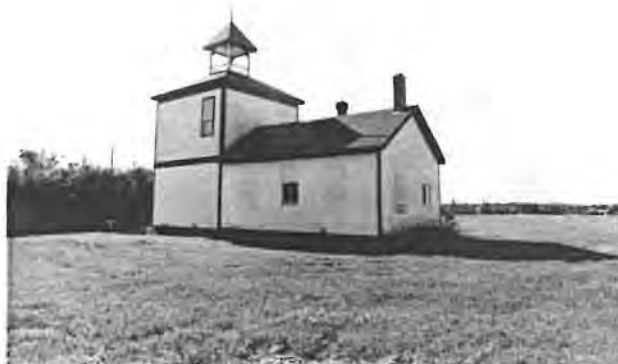
LOCATION: SW 33-27-27W
MUNICIPALITY: Hillsburg
DATE BUILT: 1909
ARCHITECT:
BUILDER:
CONSTRUCTION: wood frame/siding
PRESENT USE: community centre
COMMENTS: a novel design

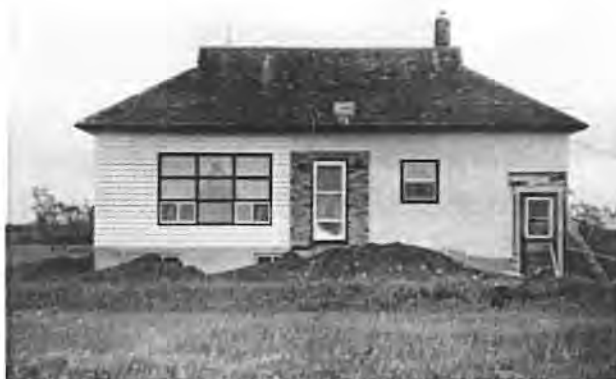
MILLBROOK

LOCATION: NW 22-10-6E
MUNICIPALITY: Springfield
DATE BUILT: ca. 1925
ARCHITECT:
BUILDER:
CONSTRUCTION: wood frame/siding
PRESENT USE: residence
COMMENTS:

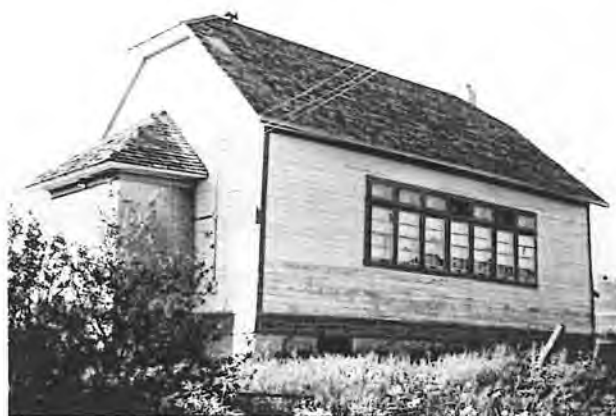
MILLWOOD

LOCATION: NW 2-20-29W
MUNICIPALITY: Russell
DATE BUILT: ca. 1915
ARCHITECT:
BUILDER:
CONSTRUCTION: wood frame/siding
PRESENT USE: vacant
COMMENTS: still on its original site
BIBLIOGRAPHY:

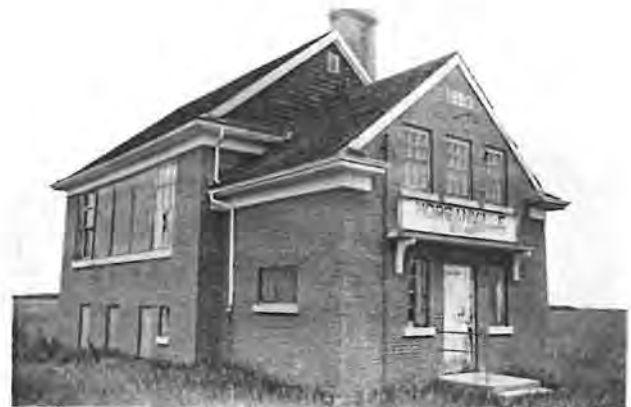
MORRANVILLE (2)

LOCATION: NW 2-26-24W
MUNICIPALITY: Grandview
DATE BUILT: 1920
ARCHITECT: Plan B-131-K-L3/
Department of Education
BUILDER:
CONSTRUCTION: brick
PRESENT USE: vacant
COMMENTS: a very rare example of
this particular standardized design
BIBLIOGRAPHY: 142, pp. 13 & 17

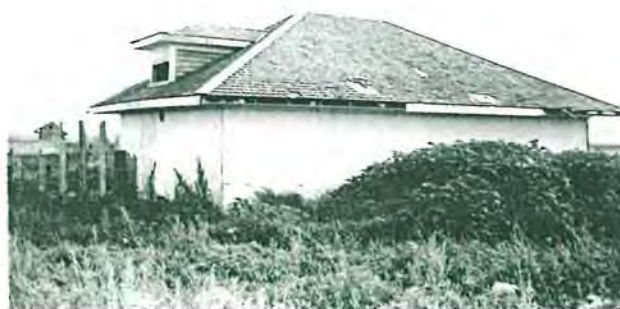
MOSSEY RIVER

LOCATION: SE 26-29-19W
 MUNICIPALITY: Mossey River
 DATE BUILT: ca. 1920
 ARCHITECT:
 BUILDER:
 CONSTRUCTION: brick
 PRESENT USE: vacant
 COMMENTS: an example with dual
 doors for girls and boys
 BIBLIOGRAPHY:

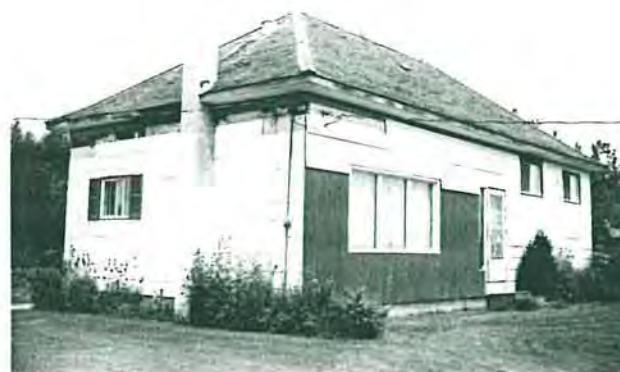
MOSSGIEL

LOCATION: NW 35-11-28W
 MUNICIPALITY: Wallace
 DATE BUILT: 1916
 ARCHITECT:
 BUILDER: A.E Parsons
 CONSTRUCTION: wood frame
 PRESENT USE: vacant
 COMMENTS: only the roof
 remains
 BIBLIOGRAPHY: 53, pp. 86-87

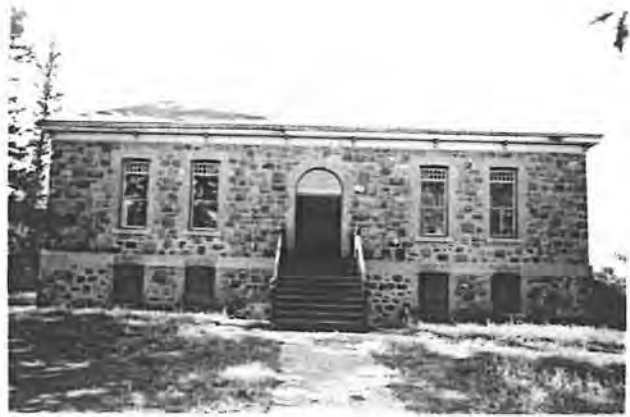
NAPINKA

LOCATION: NE 19-4-25W
MUNICIPALITY: Brenda
DATE BUILT: 1896
ARCHITECT:
BUILDER: Phinney, Foster & Gibson
CONSTRUCTION: stone
PRESENT USE: drop-in centre
COMMENTS: a rare remaining example
of an early two-room design
BIBLIOGRAPHY: 118, pp. 250-51

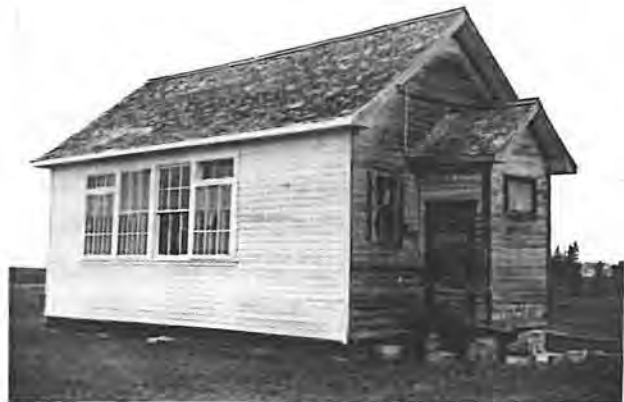
NEDROB

LOCATION: SE 32-17-18W
MUNICIPALITY: Clanwilliam
DATE BUILT: 1919
ARCHITECT:
BUILDER:
CONSTRUCTION: wood frame/siding
PRESENT USE: museum piece
COMMENTS: a good example of a
standardized type built after 1918
BIBLIOGRAPHY: 34, pp. 158-60

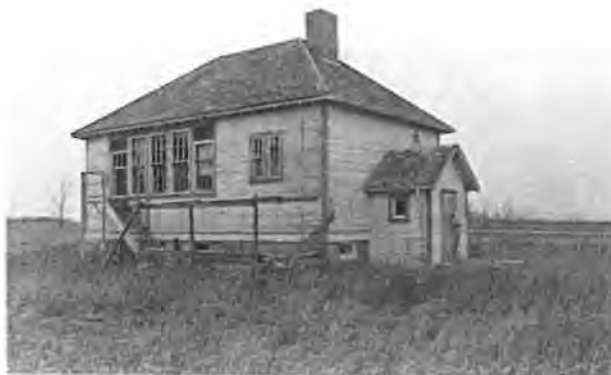
NORMAN

LOCATION: SE 27-12-17W
MUNICIPALITY: Elton
DATE BUILT: 1926
ARCHITECT:
BUILDER:
CONSTRUCTION: wood frame/siding
PRESENT USE: vacant
COMMENTS: still on its original site
BIBLIOGRAPHY: 27, p. 185
