A STUDY OF PUBLIC SCHOOL BUILDINGS IN MANITOBA

DAVID BUTTERFIELD

1994

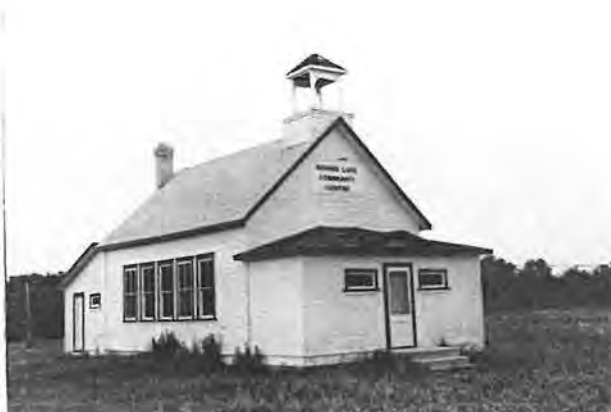
NORRIS LAKE

LOCATION: SE 11-17-1E
MUNICIPALITY: Rockwood
DATE BUILT: 1904
ARCHITECT:
BUILDER:
CONSTRUCTION: wood frame/siding
PRESENT USE: vacant
COMMENTS: still on its original site
BIBLIOGRAPHY: 157, p. 118

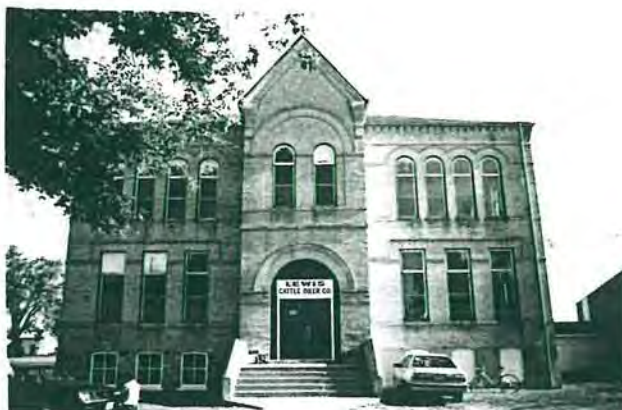
OAKNER

LOCATION: NE 8-13-24W
 MUNICIPALITY: Hamiota
 DATE BUILT: 1919-20
 ARCHITECT: A.E Tuttle
 BUILDER: Sigurdson Bros.
 CONSTRUCTION: brick
 PRESENT USE: vacant
 COMMENTS: an ambitious
 and handsome design
 BIBLIOGRAPHY: 78, p. 103

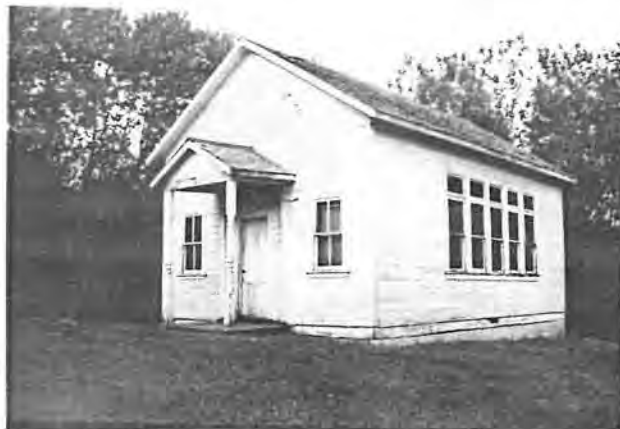
OLHA

LOCATION: 33-19-22W
MUNICIPALITY: Park
DATE BUILT: 1902
ARCHITECT:
BUILDER:
CONSTRUCTION: wood frame/siding
PRESENT USE: museum piece
COMMENTS: appears to be derived from a standardized Hooper #1
BIBLIOGRAPHY:

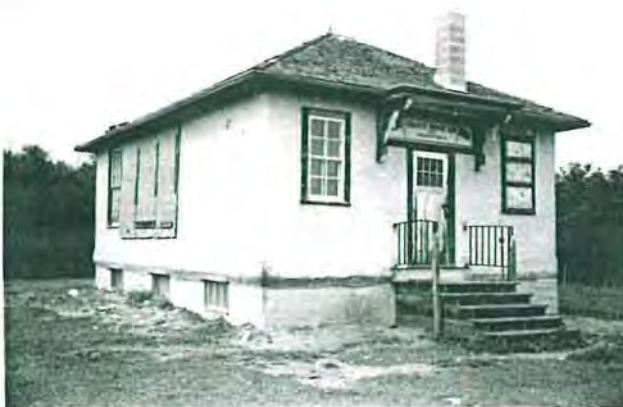
OPAWAKA

LOCATION: NE 16-4-7W
 MUNICIPALITY: Stanley
 DATE BUILT: 1919
 ARCHITECT:
 BUILDER:
 CONSTRUCTION: wood frame/siding
 PRESENT USE: community hall
 COMMENTS: a novel variation on
 a common design; original site
 BIBLIOGRAPHY: 23, p. 94

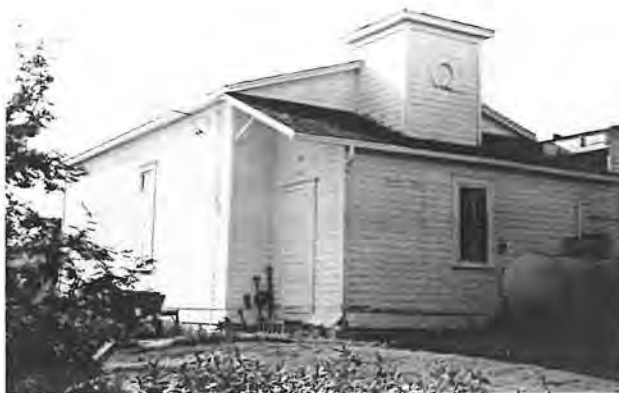
OSTRANDER

LOCATION: SW 5-6-4W
MUNICIPALITY: Dufferin
DATE BUILT: 1898
ARCHITECT:
BUILDER:
CONSTRUCTION: wood frame/siding
PRESENT USE: garage
COMMENTS: the only known example of
the first locally standardized design
BIBLIOGRAPHY: 84, pp. 165-67

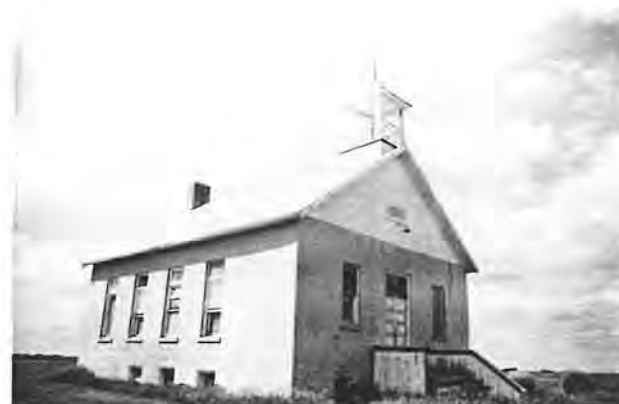
OTTER

LOCATION: NE 10-3-24W
MUNICIPALITY: Brenda
DATE BUILT: 1908
ARCHITECT: Samuel Hooper
BUILDER: Mr. Bell
CONSTRUCTION: concrete block/stucco
PRESENT USE: granary
COMMENTS: a modified version of a
standardized Hooper #2
BIBLIOGRAPHY: 22, p. 145

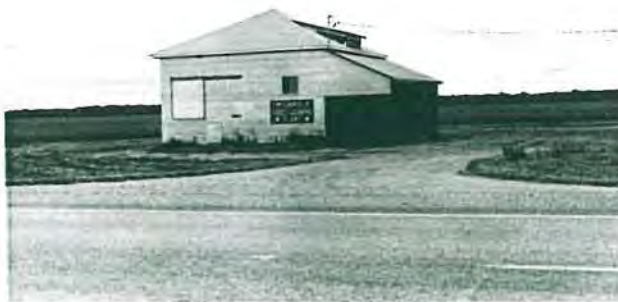
OXFORD

LOCATION: NE 19-16-27W
 MUNICIPALITY: Birtle
 DATE BUILT: 1883
 ARCHITECT:
 BUILDER:
 CONSTRUCTION: log
 PRESENT USE: residence
 COMMENTS: a rare log example

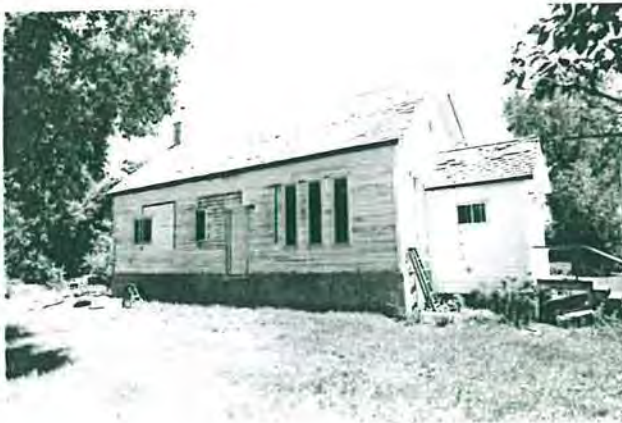
POMEROY

LOCATION: NW 1-3-5W
MUNICIPALITY: Stanley
DATE BUILT: 1909
ARCHITECT: Samuel Hooper
BUILDER:
CONSTRUCTION: wood frame/siding
PRESENT USE: Pembina Treshermen's Museum
COMMENTS: an excellent surviving example of a standardized Hooper #2
BIBLIOGRAPHY: 128, p. 14
76, p. 134

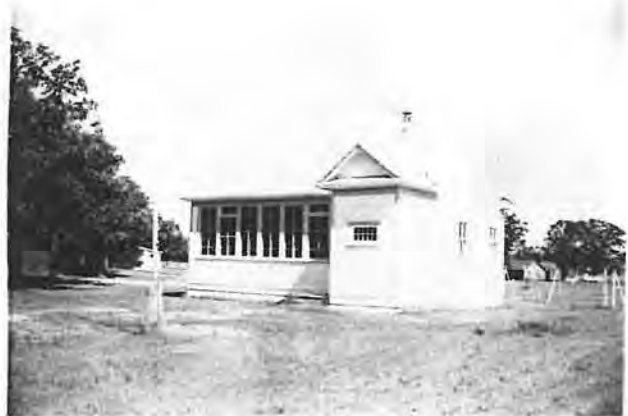
PURPLE BANK

LOCATION: NE 34-1-6E
MUNICIPALITY: Stuartburn
DATE BUILT: 1905-06
ARCHITECT:
BUILDER:
CONSTRUCTION: wood frame/siding
PRESENT USE: museum
COMMENTS: a one-room school designed for enlargement; still on its original site
BIBLIOGRAPHY: 95, p. 32
89, p. 81

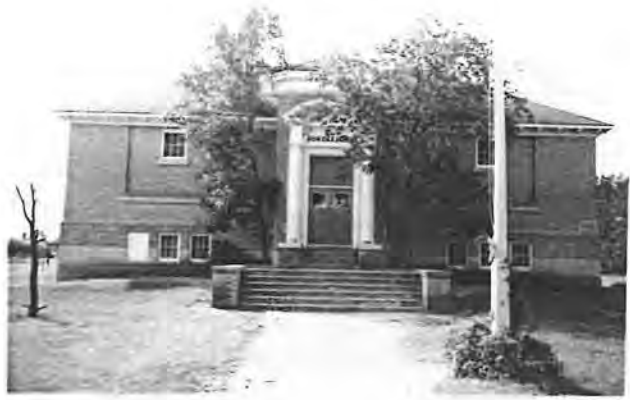
ROSEISLE

LOCATION: Roseisle
MUNICIPALITY: Dufferin
DATE BUILT: 1921
ARCHITECT: E.D. Tuttle (Winnipeg)
BUILDER:
CONSTRUCTION: brick
PRESENT USE: Roseisle Elementary School
COMMENTS: a fine porch of classical inspiration
BIBLIOGRAPHY: 184, pp. 178-80

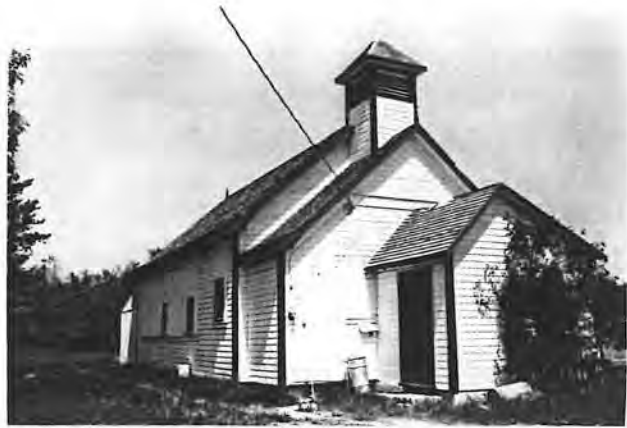
ST. OUEN'S

LOCATION: NW 33-12-8E
MUNICIPALITY: Brokenhead
DATE BUILT: 1897
ARCHITECT:
BUILDER:
CONSTRUCTION: wood frame/siding
PRESENT USE: maintenance shop
COMMENTS: still on its original site
BIBLIOGRAPHY: 42, pp. 245-47

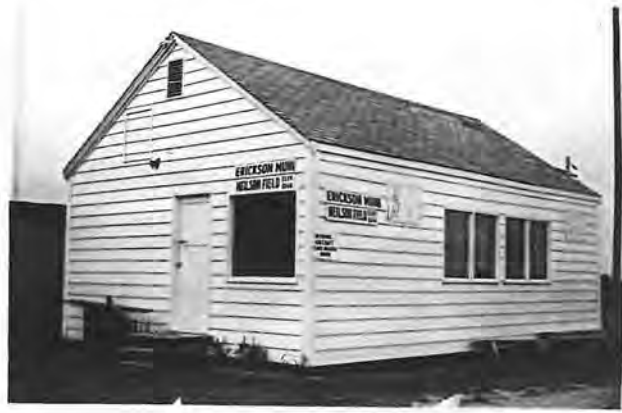
SCARTH

LOCATION: SE 9-9-26W
MUNICIPALITY: Pipestone
DATE BUILT: ca. 1911
ARCHITECT:
BUILDER:
CONSTRUCTION: wood frame/siding
PRESENT USE: Scarth Community Centre
COMMENTS:

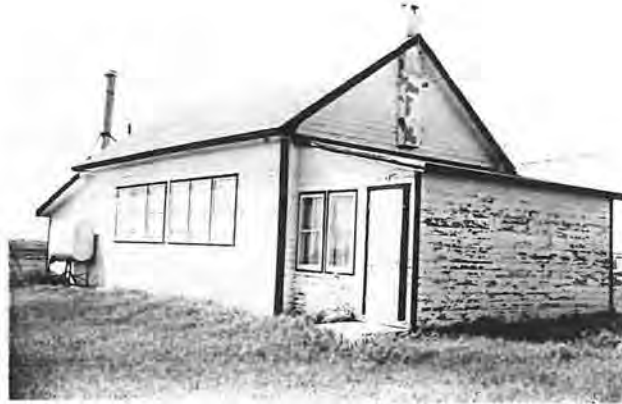
SCHOWENWIESE

LOCATION: SE 17-1-3W
MUNICIPALITY: Rhineland
DATE BUILT: 1925
ARCHITECT:
BUILDER:
CONSTRUCTION: wood frame/siding
PRESENT USE: community centre
COMMENTS:

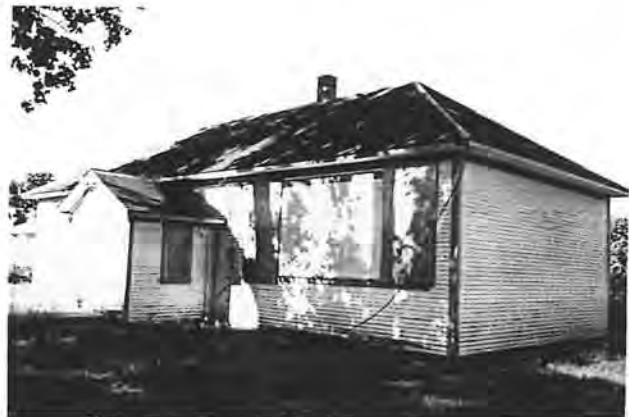
SEBRIGHT

LOCATION: SE 1-13-7E
MUNICIPALITY: Brokenhead
DATE BUILT: 1902
ARCHITECT:
BUILDER:
CONSTRUCTION: wood frame/siding
PRESENT USE: museum piece
COMMENTS:

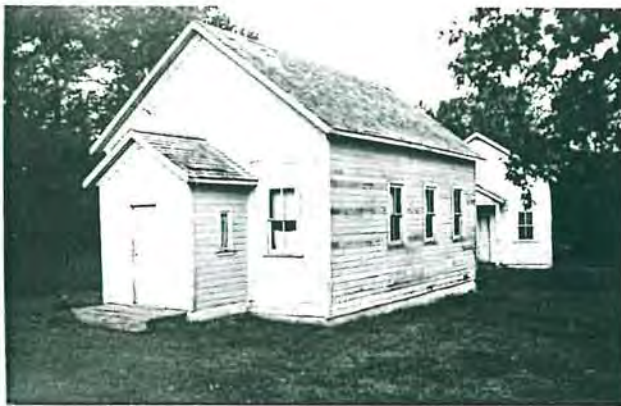
SEECH

LOCATION: 33-19-22W
 MUNICIPALITY: Park
 DATE BUILT: 1908
 ARCHITECT:
 BUILDER:
 CONSTRUCTION: wood frame/siding
 PRESENT USE: museum piece
 COMMENTS:

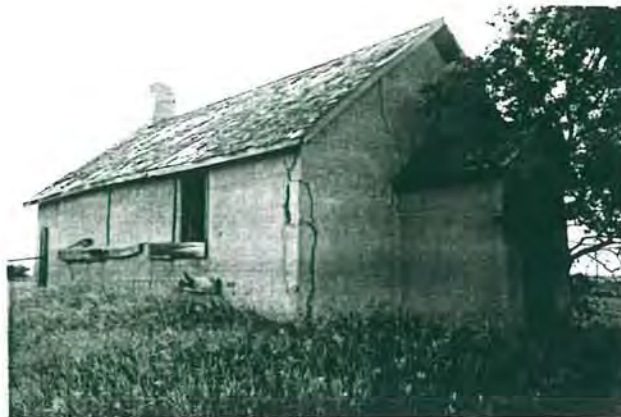
SENECA

LOCATION: NW 23-16-15W
 MUNICIPALITY: Rosedale
 DATE BUILT: 1898
 ARCHITECT:
 BUILDER:
 CONSTRUCTION: wood frame/stucco
 PRESENT USE: vacant
 COMMENTS:

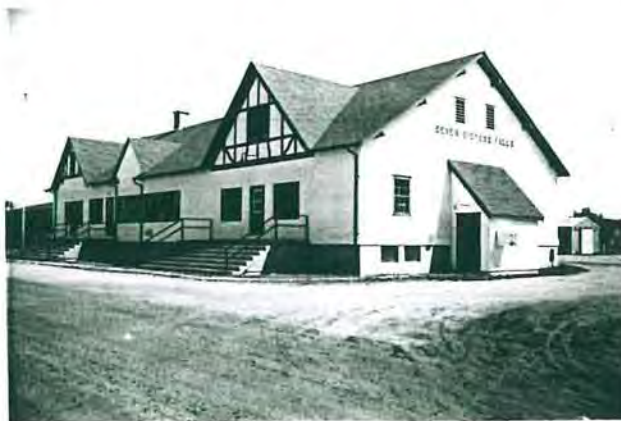
SEVEN SISTERS

LOCATION: NW 27-13-11E
 MUNICIPALITY: Whitemouth
 DATE BUILT: 1930
 ARCHITECT:
 BUILDER:
 CONSTRUCTION: wood frame/stucco
 PRESENT USE: Manitoba Hydro
 COMMENTS:

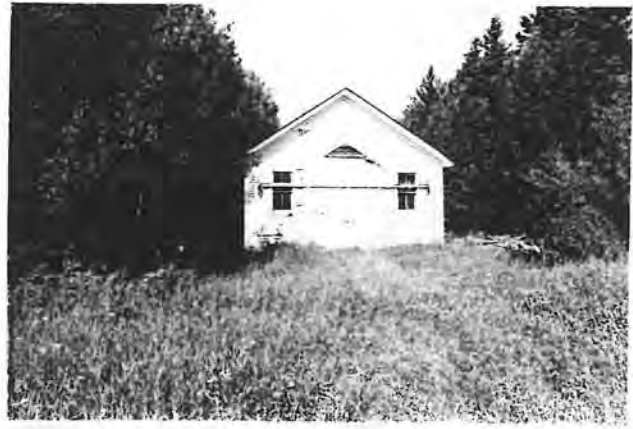
SHOAL LAKE

LOCATION: SW 9-17-23W
MUNICIPALITY: Shoal Lake
DATE BUILT: 1926
ARCHITECT:
BUILDER:
CONSTRUCTION: brick
PRESENT USE: school
COMMENTS:

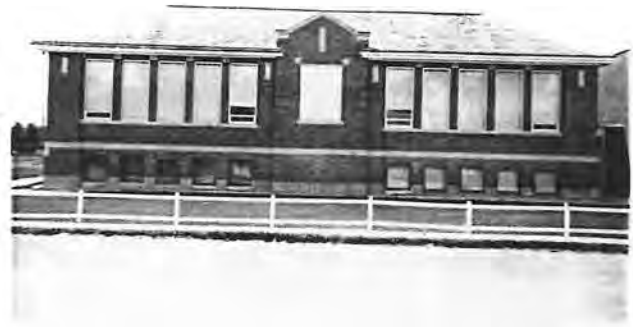
SHORTDALE

LOCATION: NE 18-35-24W
MUNICIPALITY: Grandview Hillsburg
DATE BUILT: 1922
ARCHITECT:
BUILDER:
CONSTRUCTION: wood frame/siding
PRESENT USE: vacant
COMMENTS:

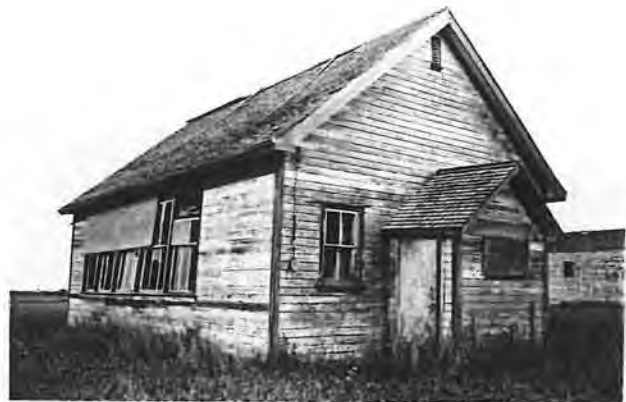
SIDNEY

LOCATION: NW 5-11-12W
MUNICIPALITY: North Norfolk
DATE BUILT: 1906
ARCHITECT:
BUILDER:
CONSTRUCTION: wood frame/siding
PRESENT USE: community centre
COMMENTS: an unusual school design;
original site
BIBLIOGRAPHY: 30, p. 188

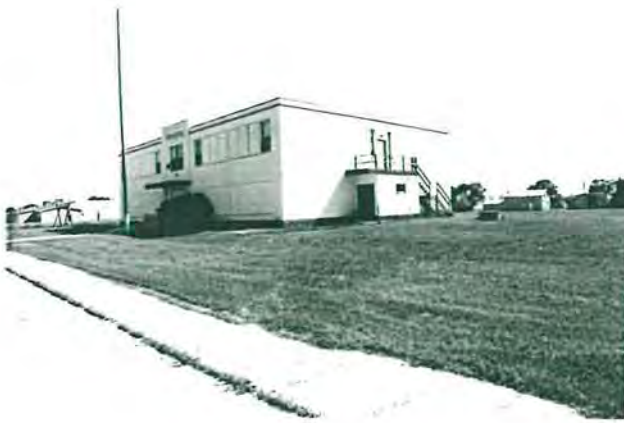
SIFTON

LOCATION: Sifton
MUNICIPALITY: Dauphin
DATE BUILT: ca. 1950
ARCHITECT:
BUILDER:
CONSTRUCTION: wood frame/stucco
PRESENT USE: school
COMMENTS:

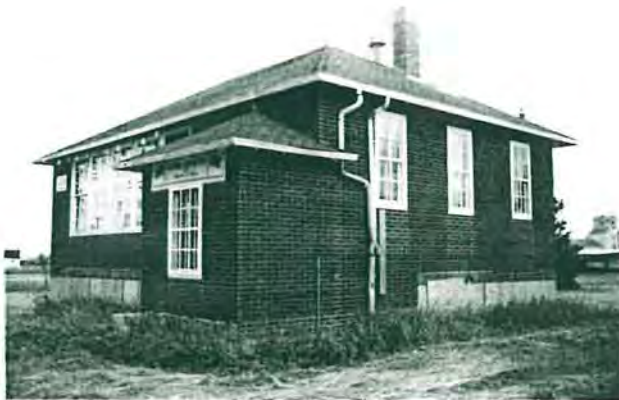
SILVER CREEK

LOCATION: NE 33-20-27W
MUNICIPALITY: Silver Creek
DATE BUILT: 1939
ARCHITECT:
BUILDER:
CONSTRUCTION: wood frame/shingles
PRESENT USE: vacant
COMMENTS: still on its original site
BIBLIOGRAPHY: 173, pp. 63-64

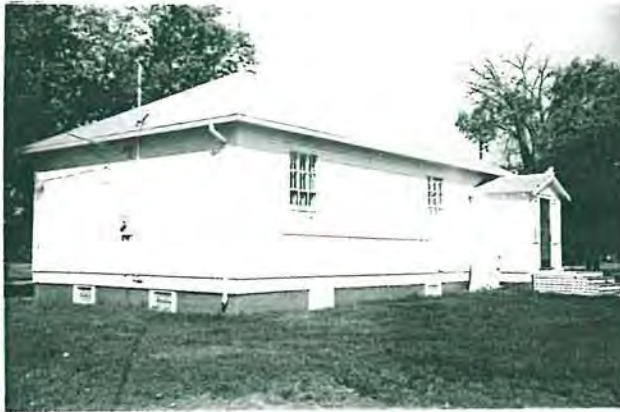
SOMMERFELD

LOCATION: NW 30-1-1E
 MUNICIPALITY: Rhineland
 DATE BUILT: 1921
 ARCHITECT:
 BUILDER:
 CONSTRUCTION: wood frame/siding
 PRESENT USE: Sommerfeld Community Centre
 COMMENTS:

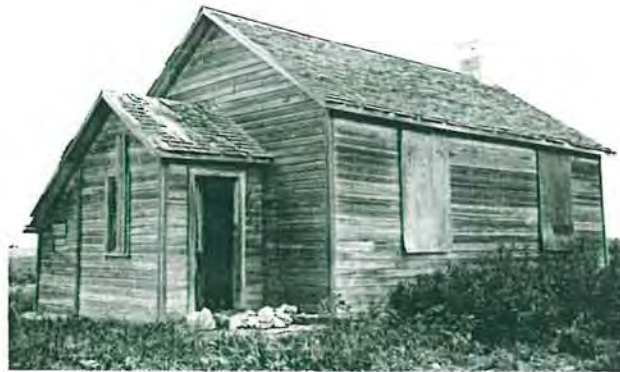
SOURISFORD

LOCATION: NW 29-2-27W
 MUNICIPALITY: Arthur
 DATE BUILT: 1899
 ARCHITECT:
 BUILDER: R.J. Humphrey
 CONSTRUCTION: wood frame/siding
 PRESENT USE: vacant
 COMMENTS:

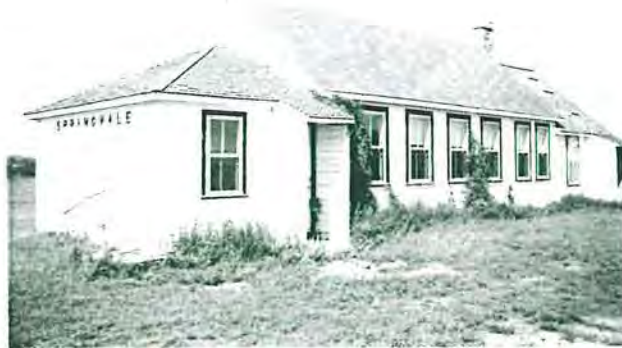
SPRINGVALE

LOCATION: NE 14-10-28W
 MUNICIPALITY: Wallace
 DATE BUILT: 1902/1921
 ARCHITECT:
 BUILDER: volunteers
 CONSTRUCTION: wood frame/siding
 PRESENT USE: vacant
 COMMENTS: addition made in 1921

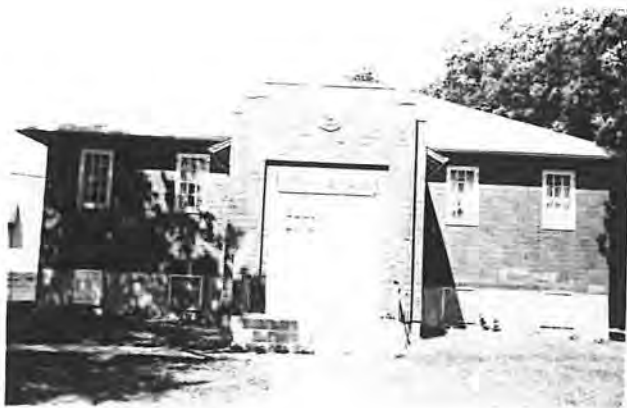
STAR MOUND

LOCATION: SE 27-1-10W
MUNICIPALITY: Pembina
DATE BUILT: 1886
ARCHITECT:
BUILDER:
CONSTRUCTION: wood frame/siding
PRESENT USE: Star Mound Museum
COMMENTS: still on its original site
BIBLIOGRAPHY: 112, p. 91

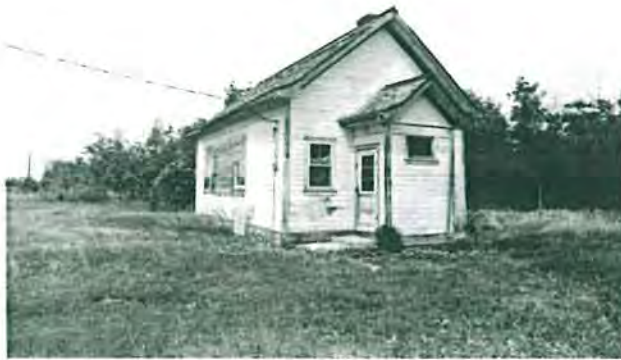
STODGELL

LOCATION: SW 10-15-2W
 MUNICIPALITY: Woodlands
 DATE BUILT: 1920
 ARCHITECT:
 BUILDER:
 CONSTRUCTION: wood frame/siding
 PRESENT USE: vacant
 COMMENTS: also called Wynona;
 original site
 BIBLIOGRAPHY: 102

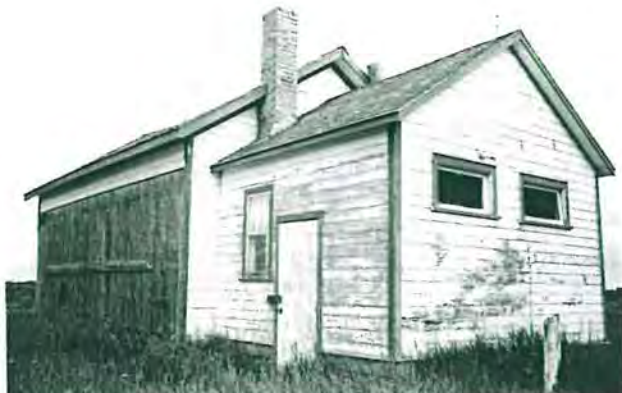
STRATFORD

LOCATION: NW 9-20-27W
 MUNICIPALITY: Silver Creek
 DATE BUILT: 1894
 ARCHITECT:
 BUILDER:
 CONSTRUCTION: wood frame/siding
 PRESENT USE: granary
 COMMENTS:

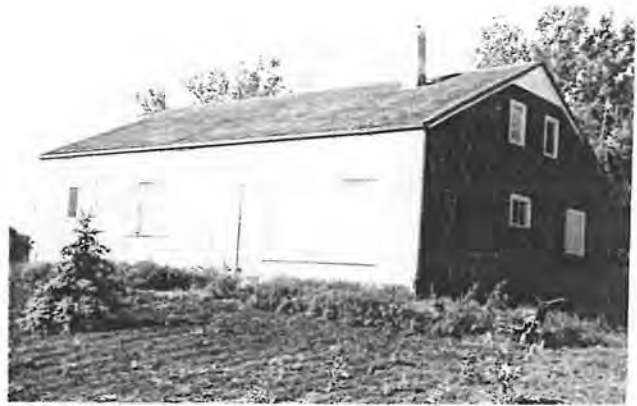
TALES

LOCATION: SE 20-18-18W
MUNICIPALITY: Clanwilliam
DATE BUILT: 1911
ARCHITECT:
BUILDER: A. Rognan
CONSTRUCTION: wood frame/siding
PRESENT USE: granary
COMMENTS: a modified version of a
standardized Hooper #1
BIBLIOGRAPHY: 34, pp. 128-31

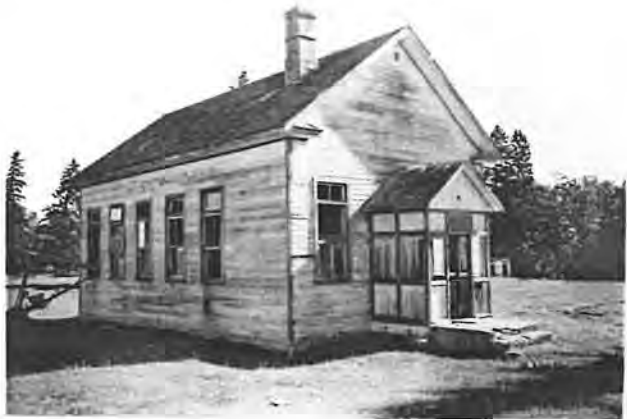
TAMARISK

LOCATION: SW 29-24-23W
MUNICIPALITY: Grandview
DATE BUILT: 1909
ARCHITECT: Samuel Hooper
BUILDER:
CONSTRUCTION: wood frame/siding
PRESENT USE: vacant
COMMENTS: an excellent example of
a standardized Hooper #2, with an
addition; original site
BIBLIOGRAPHY: 142, p. 15

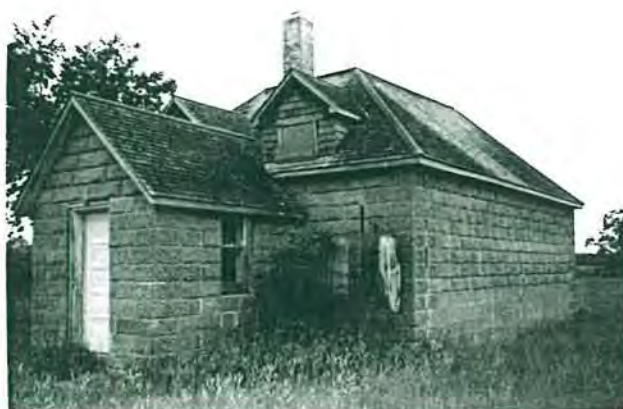
TENBY

LOCATION: NE 36-17-13W
 MUNICIPALITY: Lansdowne
 DATE BUILT: 1895
 ARCHITECT:
 BUILDER:
 CONSTRUCTION: concrete block
 PRESENT USE: storage
 COMMENTS: a fine design in an unusual material
 BIBLIOGRAPHY:

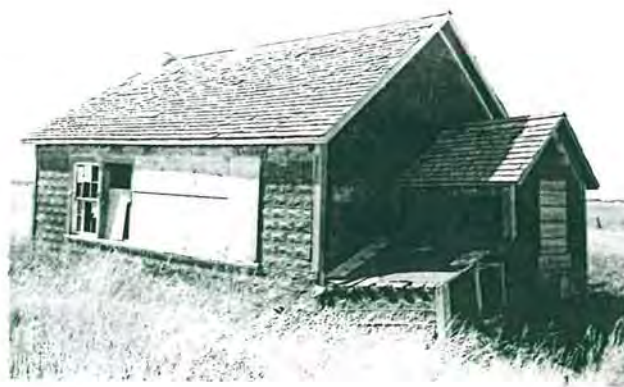
TREMBLAY

LOCATION: NE 26-4-25W
 MUNICIPALITY: Brenda
 DATE BUILT: 1890
 ARCHITECT:
 BUILDER:
 CONSTRUCTION: wood frame/metal
 PRESENT USE: vacant
 COMMENTS: a rare example
 featuring pressed metal siding
 BIBLIOGRAPHY: 82, p. 104
 22, p. 127

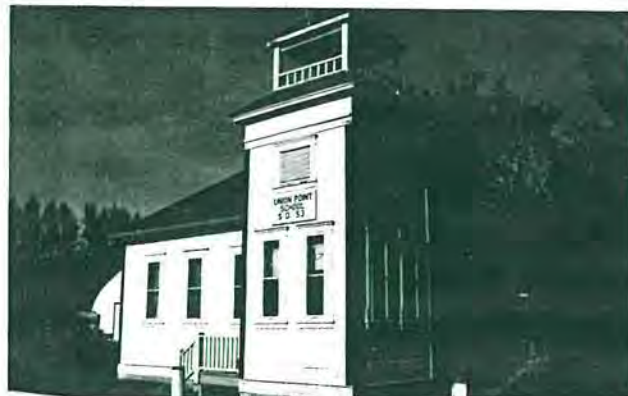
UNION POINT

LOCATION: St. Joseph
MUNICIPALITY: Montcalm
DATE BUILT: ca. 1905
ARCHITECT: Samuel Hooper
BUILDER: Turner Bros.
CONSTRUCTION: wood frame/siding
PRESENT USE: museum piece
COMMENTS: a rare example of a
standardized Hooper #3
BIBLIOGRAPHY:

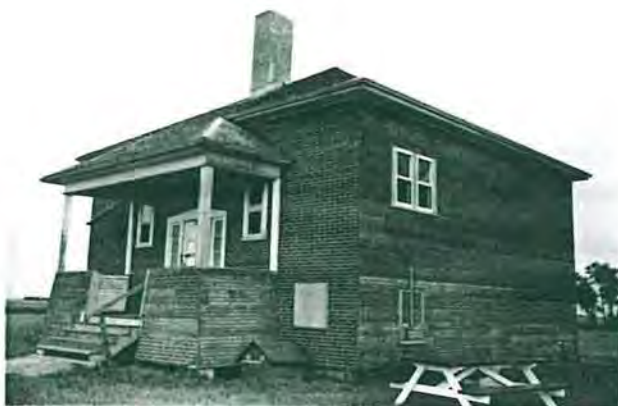
VERONA

LOCATION: NW 15-2-26W
MUNICIPALITY: Arthur
DATE BUILT: ca. 1915
ARCHITECT:
BUILDER: Temple Bros.
CONSTRUCTION: wood frame/shingles
PRESENT USE: vacant
COMMENTS: still on its original site
BIBLIOGRAPHY: 118, pp. 259-62

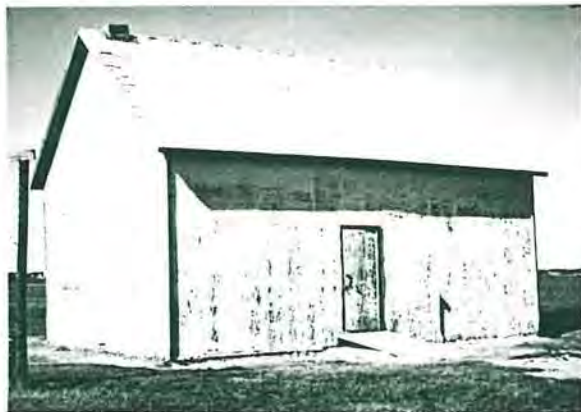
CANAL

LOCATION: McCreary
MUNICIPALITY: McCreary
DATE BUILT: ca. 1915
ARCHITECT:
BUILDER:
CONSTRUCTION: wood frame/siding
PRESENT USE: storage
COMMENTS:

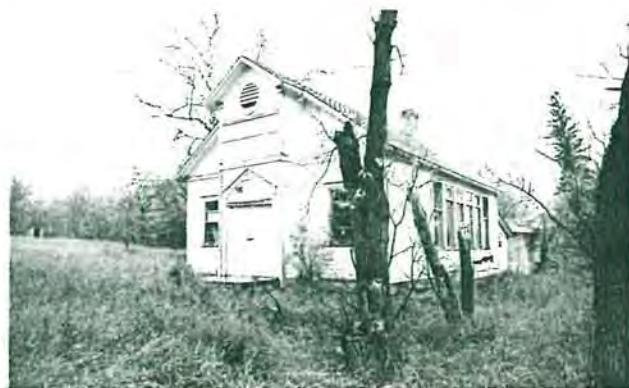
CLOVER HILL

LOCATION: Sinclair
MUNICIPALITY: Pipestone
DATE BUILT: ca. 1910
ARCHITECT:
BUILDER:
CONSTRUCTION: wood frame/siding
PRESENT USE: vacant
COMMENTS:

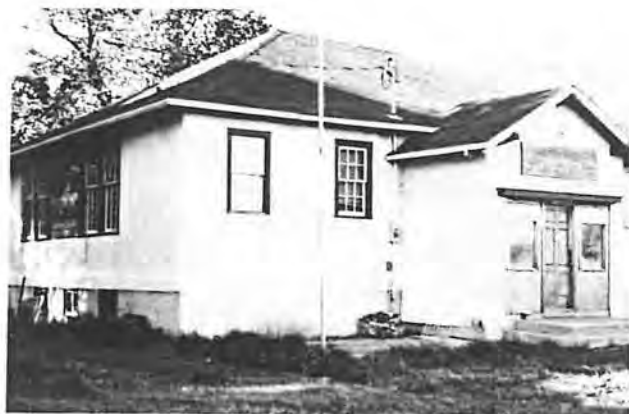
DUFFERIN

LOCATION: Carman
MUNICIPALITY: Dufferin
DATE BUILT: ca. 1920
ARCHITECT:
BUILDER:
CONSTRUCTION: wood frame/siding
PRESENT USE: Christian School
COMMENTS:

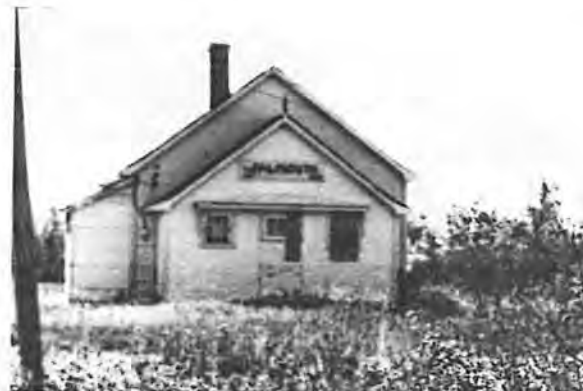
FALMOUTH

LOCATION: 19-19-2W
MUNICIPALITY: Armstrong
DATE BUILT: ca. 1910
ARCHITECT:
BUILDER:
CONSTRUCTION: wood frame/siding
PRESENT USE: vacant
COMMENTS:

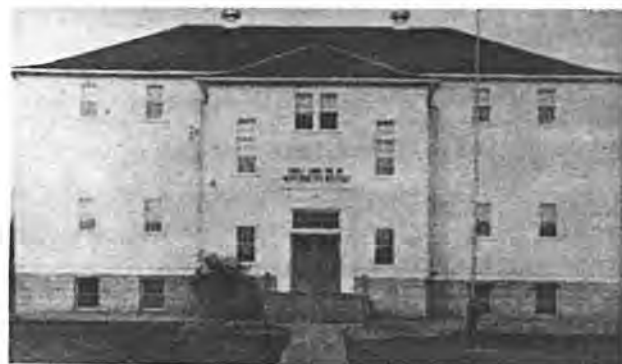
LETELLIER

LOCATION: Lettelier
MUNICIPALITY: Montcalm
DATE BUILT: ca. 1930
ARCHITECT:
BUILDER:
CONSTRUCTION: wood frame/siding
PRESENT USE:
COMMENTS:

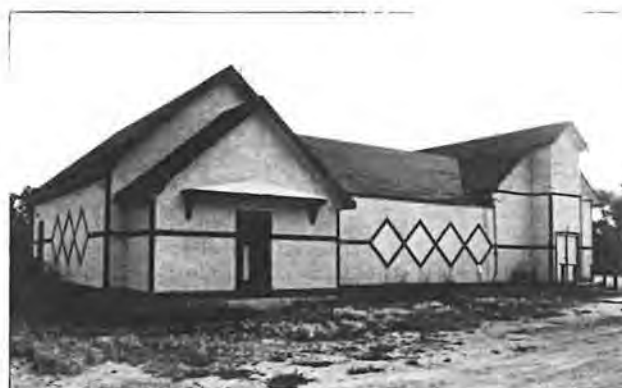
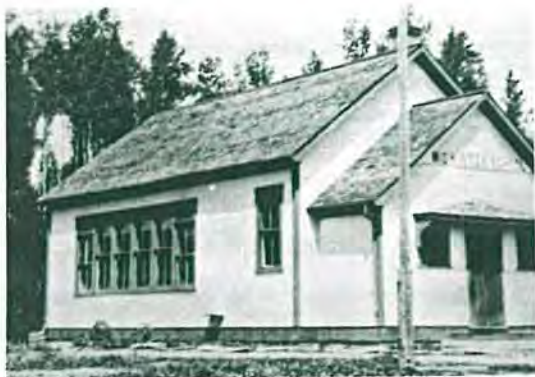
LOCKPORT

LOCATION: Lyall Dr.
MUNICIPALITY: St. Andrews
DATE BUILT: ca. 1912 and 1920
ARCHITECT: Samuel Hooper
BUILDER:
CONSTRUCTION: wood frame /siding
PRESENT USE:
COMMENTS: a Hooper No. 2 joined with
a 1918 standardized design
BIBLIOGRAPHY:

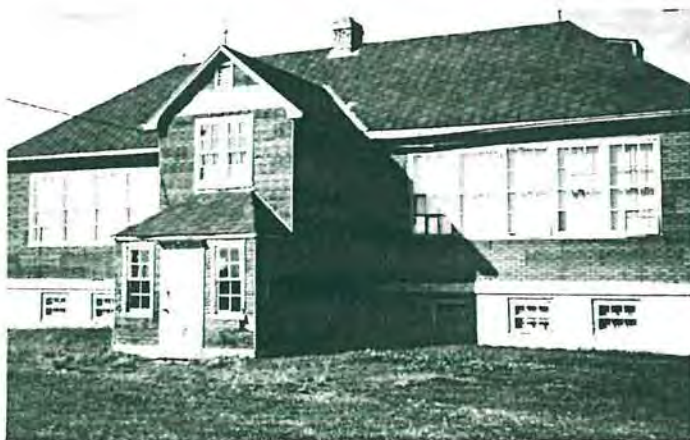
MIDWINTER

LOCATION: SE 4-8-14E
 MUNICIPALITY: Reynolds
 DATE BUILT: ca. 1920
 ARCHITECT:
 BUILDER:
 CONSTRUCTION: wood frame/siding
 PRESENT USE:
 COMMENTS:

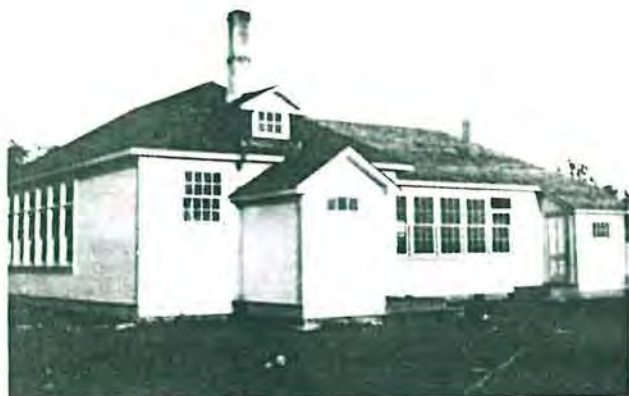
MOLINE

LOCATION: SE 18-14-20W
 MUNICIPALITY: Saskatchewan
 DATE BUILT: ca. 1925
 ARCHITECT:
 BUILDER:
 CONSTRUCTION: wood frame/siding
 PRESENT USE: hall
 COMMENTS: an exceptional two-room design
 BIBLIOGRAPHY:

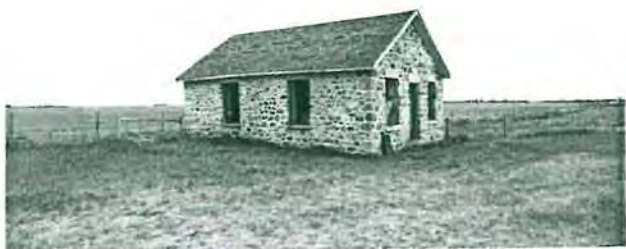
OAK POINT

LOCATION: 26-17-3W
 MUNICIPALITY: St. Laurent
 DATE BUILT: ca. 1900
 ARCHITECT:
 BUILDER:
 CONSTRUCTION: wood frame/siding
 PRESENT USE:
 COMMENTS:

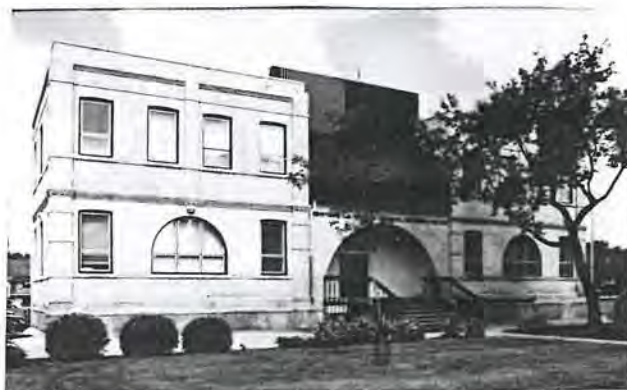
PORTAGE LA PRAIRIE NORTH WARD

LOCATION: *535-3rd St NW*
MUNICIPALITY: Portage la Prairie
DATE BUILT: 1910
ARCHITECT:
BUILDER:
CONSTRUCTION: brick
PRESENT USE: school division offices
COMMENTS: the only known example of an urban ward school left in the province
BIBLIOGRAPHY:

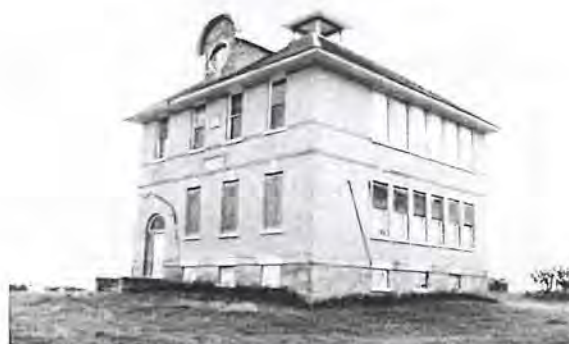
ROSS

LOCATION: SE 33-12-26W
MUNICIPALITY: Wallace
DATE BUILT: 1915
ARCHITECT:
BUILDER:
CONSTRUCTION: brick
PRESENT USE: hall
COMMENTS: the basic square design is here enriched with a dormer
BIBLIOGRAPHY:

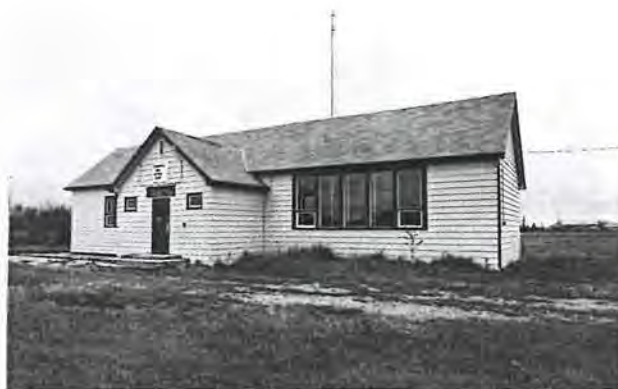
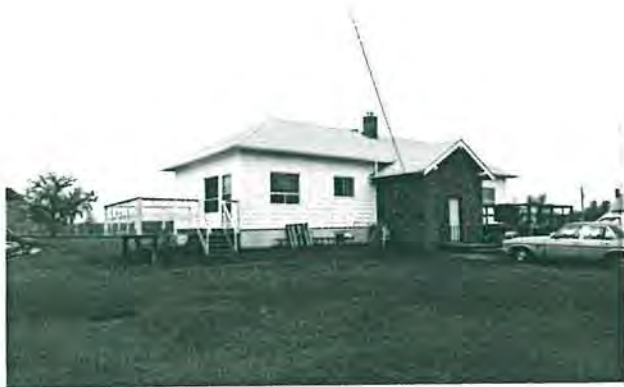
ST. AMBROISE

LOCATION: St. Ambroise
MUNICIPALITY: Portage la Prairie
DATE BUILT: ca. 1930
ARCHITECT:
BUILDER:
CONSTRUCTION: wood frame/stucco
PRESENT USE: hall
COMMENTS:

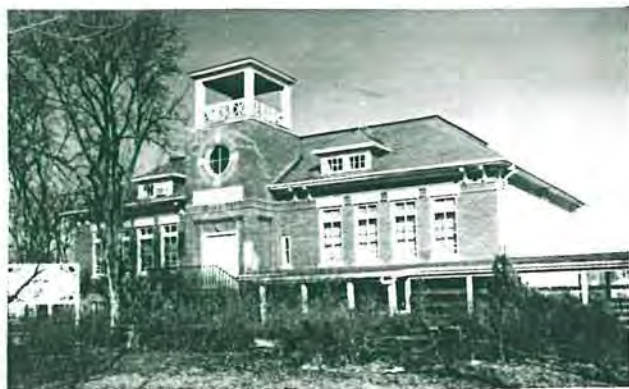
ST. FRANCOIS XAVIER

LOCATION: St. Francois Xavier
 MUNICIPALITY: St. Francois Xavier
 DATE BUILT: ca. 1920
 ARCHITECT:
 BUILDER:
 CONSTRUCTION: wood frame/siding
 PRESENT USE: residence
 COMMENTS:

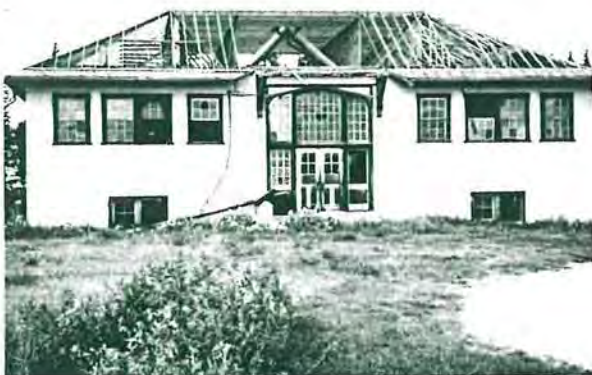
STE. ROSE

LOCATION: Ste. Rose du Lac
 MUNICIPALITY: Ste. Rose
 DATE BUILT: ca. 1925
 ARCHITECT:
 BUILDER:
 CONSTRUCTION: brick
 PRESENT USE: school
 COMMENTS: an exceptional two-room design
 BIBLIOGRAPHY:

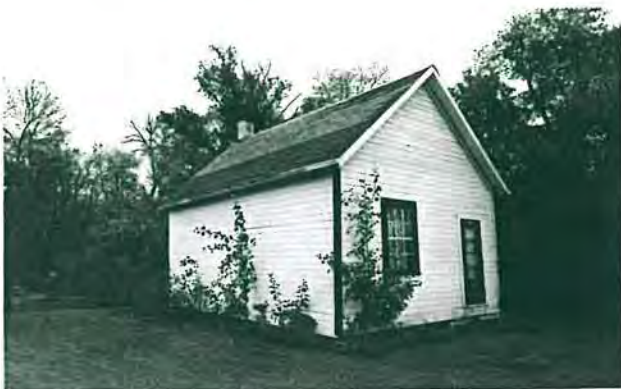
TUMMELL

LOCATION: SW 7-25-28W
 MUNICIPALITY: Shell River
 DATE BUILT: ca. 1925
 ARCHITECT:
 BUILDER:
 CONSTRUCTION: wood frame/siding
 PRESENT USE:
 COMMENTS: demolished

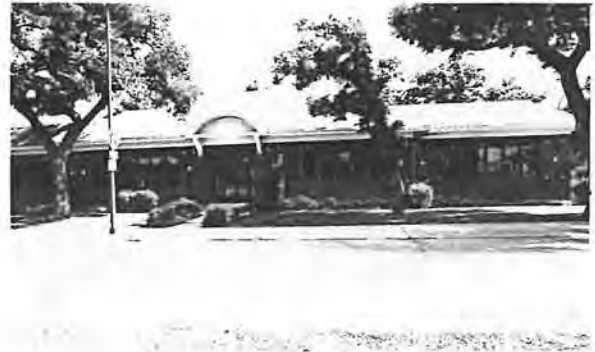
ANNA GIBSON

LOCATION: Henderson Highway
MUNICIPALITY: Winnipeg
DATE BUILT: ca. 1925
ARCHITECT:
BUILDER:
CONSTRUCTION: brick
PRESENT USE: Mennonite school
COMMENTS:

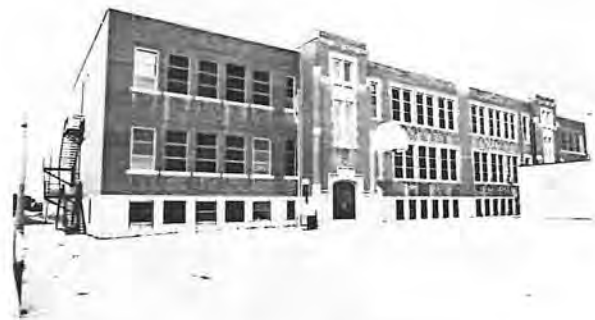
CENTENNIAL

LOCATION: 240 Royal Ave.
MUNICIPALITY: Winnipeg
DATE BUILT: ca. 1925
ARCHITECT:
BUILDER:
CONSTRUCTION: brick
PRESENT USE: school
COMMENTS:

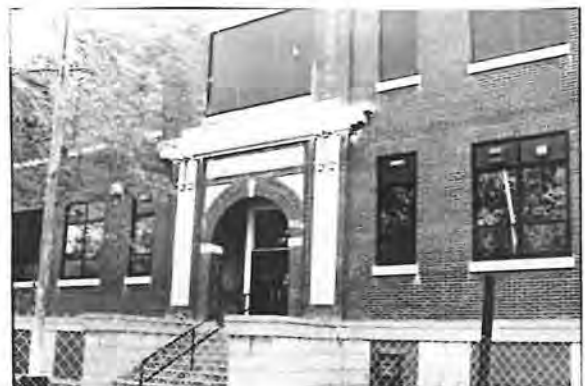
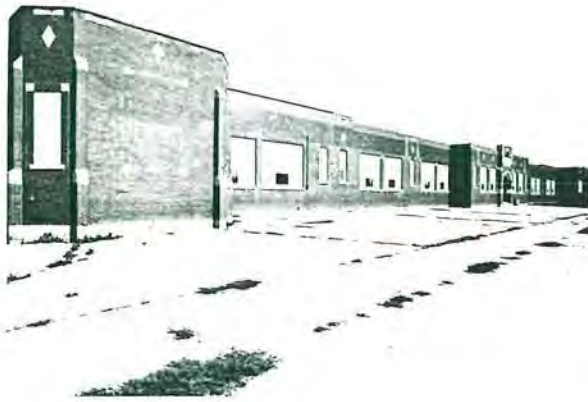
CENTRAL

LOCATION:
MUNICIPALITY: Winnipeg
DATE BUILT: ca. 1915
ARCHITECT:
BUILDER:
CONSTRUCTION: brick
PRESENT USE:
COMMENTS: demolished

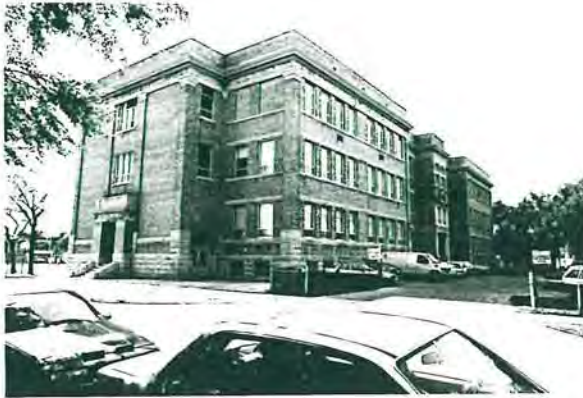
PRINCE EDWARD

LOCATION: 649 Brazier
 MUNICIPALITY: Winnipeg
 DATE BUILT: ca. 1925
 ARCHITECT:
 BUILDER:
 CONSTRUCTION: brick
 PRESENT USE: school
 COMMENTS:

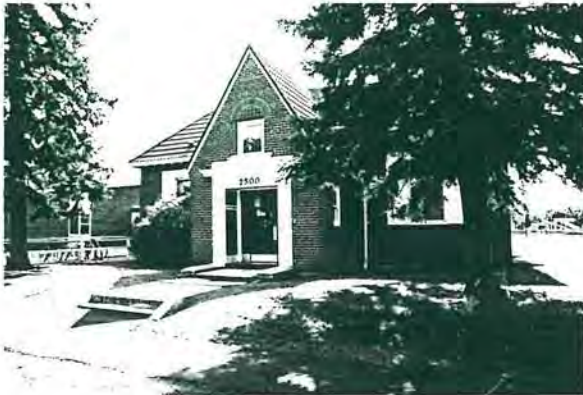
PROVENCHER

LOCATION: Ave. de la Cathedrale
 MUNICIPALITY: Winnipeg
 DATE BUILT: 1910
 ARCHITECT:
 BUILDER:
 CONSTRUCTION: brick
 PRESENT USE: school
 COMMENTS:
