# RAILWAY STATIONS OF MANITOBA: A BUILDING INVENTORY

Patricia Trainor  
Farhad Rahbary  
David Butterfield

1987

This report on Manitoba's railway buildings is divided into two sections. The first provides a brief historic background of rail line and specific station design developments in the province. The second, comprehensive, section is a catalogue of extant railway buildings in Manitoba. The first section is organized according to station types, while the information in the second part is grouped according to ownership. For easier reference, this second section will also be subdivided according to specific station types. Photographs of the stations in the catalogue section are accompanied by basic data sheets. Information given for each station includes: date built; past and present locations; present owner and use, as well as facts relative to renovations and noteworthy features.

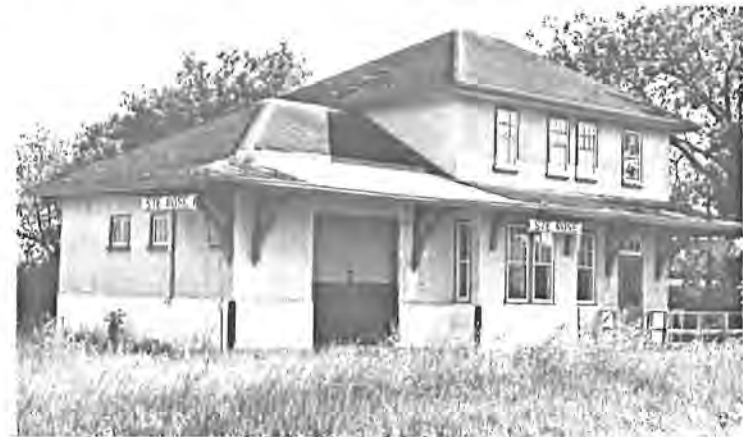
One final revision of the official 3rd class design resulted in a slightly different design. Almost identical in planning and size to its immediate predecessor, these stations, common after 1915, incorporated a few external revisions in their designs (Figure 9). Slight fenestration changes, the addition of a second chimney and the elimination of the large dormers constituted the most noticeable of these changes.

Figure 9. The old Ste. Rose station. This kind of building accommodated living, kitchen and dining at the back of the ground floor.

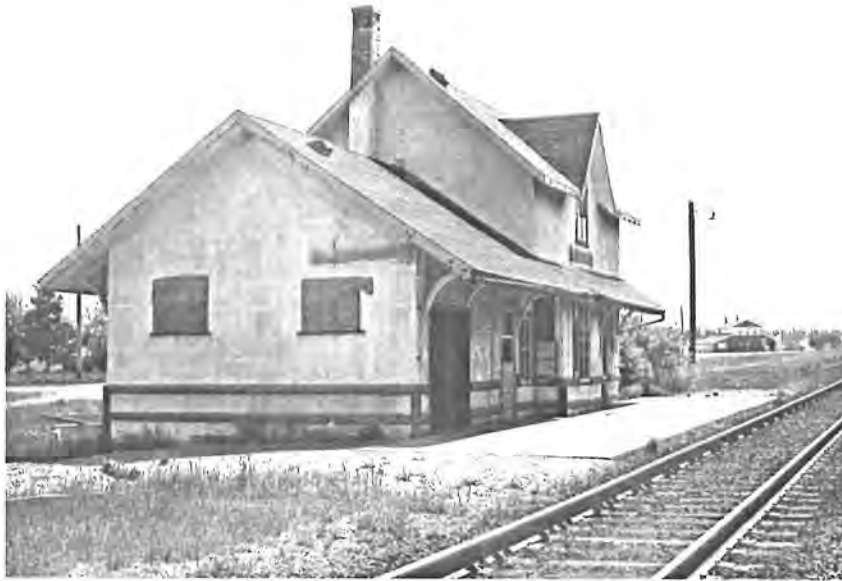
Also similar to the later, official 3rd class station, are those which Bohi calls "Type B" (Figure 11). The outward, physical differences that distinguish these stations from Type A or official 3rd class are further complicated by the difference in purpose and therefore in plan. Type B stations, typically built in remote areas at the turn of the century, included room for section workers but not for an agent's family. The agent's bedroom was completely separate from those of the workers.

Figure 11. The Woodridge station is one of Bohi's Type B.

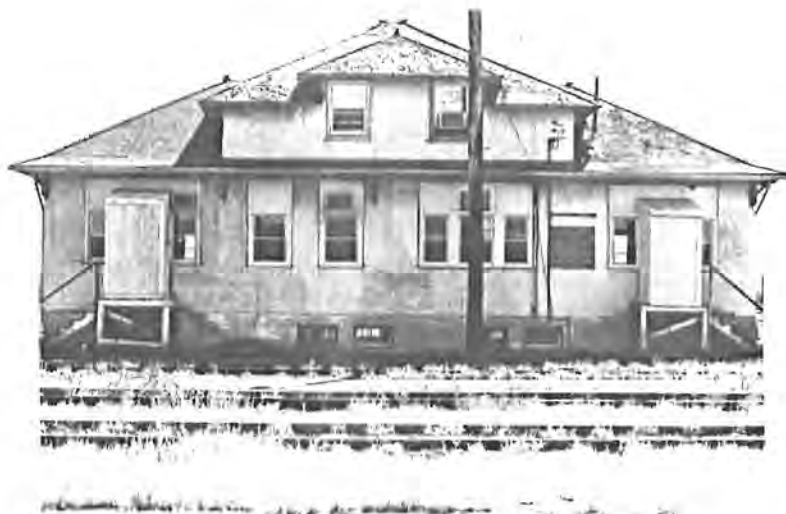
The National Transcontinental also had its own distinctive 3rd class stations, although only two of the original number are still standing in Manitoba today. The station in Transcona, constructed around 1910, is the more substantial of the two (Figure 15). The characteristic second storey is present, although in this case it is not clear whether it served as living quarters. The strong symmetrical roof is animated by projecting hipped gable dormers. The other National Transcontinental Station at Anola features similar massing, with a less picturesque roof.

Figure 15. The National Transcontinental's Transcona station.

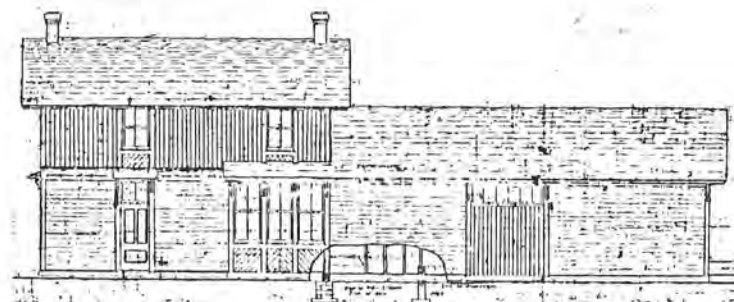
The majority of all CPR stations in Manitoba can, with a few reservations, be compared to Canadian Northern's various 3rd class types. Indeed, one of the chief characteristics of the 3rd class designation, the inclusion of living quarters, was initiated by the CPR. The very first standard plan, used mostly along the CPR mainline, provided space in the second storey for the station agent and his family (Figure 16). A long freight and baggage shed extending from the main building created, with the reiteration of gabled roofs, a rather long, uninteresting roof line. Architectural ornamentation was also minimal and consideration about dramatic massing was reserved, apparently in favour of simplicity and low costs. The distinctive bracketed overhang of other stations was also ignored. While there were a number of these earliest CP designs, today only the much renovated Poplar Point station remains.

Figure 16. CPR's earliest standard station design.<sup>15</sup> The station was rather plain, lacking as it did the bracketed overhang and an interesting roof line, distinctive features of later, typical stations.

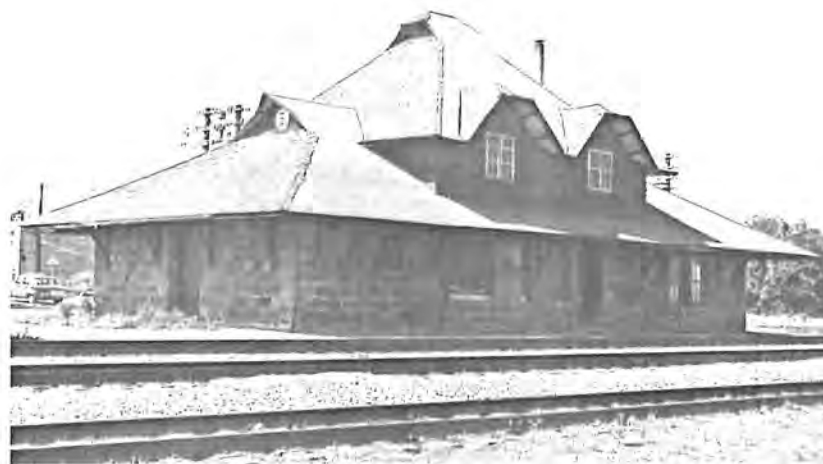
Another fairly popular CPR station design in Manitoba was used for the depot at Virden, among others (Figure 17). The design was drawn up by Ralph B. Pratt in 1899, before he left Canadian Pacific to work for Canadian Northern.<sup>16</sup> The standard plan, somewhat larger than Canadian Northern's own 3rd class stations, combined all ground level functions into a neat, full rectangle. The broad overhanging eaves that encircle the whole building slope up to form part of the exceptional roof form. This distinctive design was repeated, using frame construction, in Morden, Kenton, Hartney and Boissevain (the latter has since been demolished, Hartney has been moved and Kenton has been considerably altered). The use of stone in the Virden station makes it unique among these designs. Indeed, there is only one other station (the Greater Winnipeg Water District station in St. Boniface) of any design extant in the province, besides the three main stations in Winnipeg and Brandon, that is built of stone.

Figure 17. CPR station at Virden.

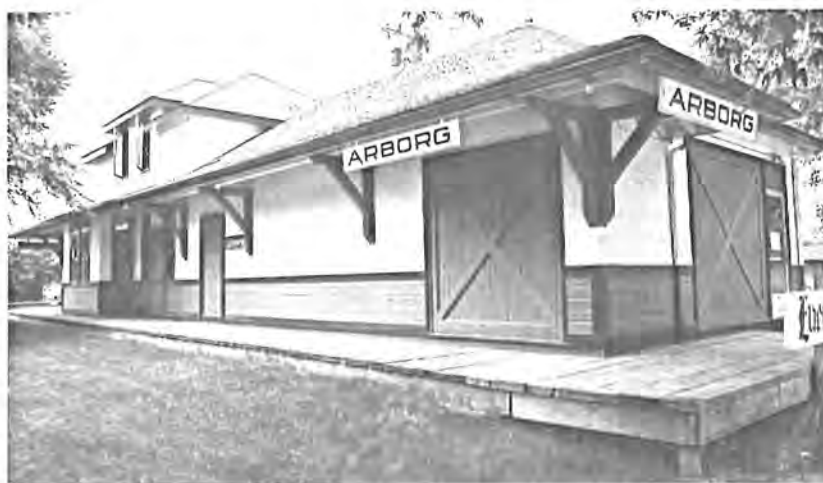
The CPR's #10 design was another early example of that company's 3rd class station. A good example at Arborg, built in 1906, is still standing (Figure 18). Very similar in its massing and planning to Canadian Northern's official 3rd class station, CP's #10 reiterated the hipped roof form on both roofs and on the dormers as well. This design was also used for the Molson and the Beausejour stations, although the Beausejour station, rebuilt in part with logs for its current use as a museum, no longer retains its former appearance.

Figure 18. The Arborg station, now used as a museum, is a #10 design.

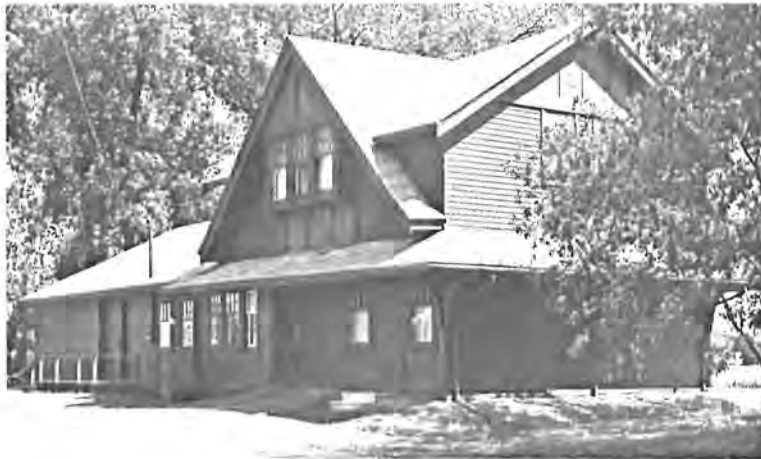
A series of CPR designs that proved very popular on the Prairies were the special "Western Lines" designs. The Western Lines "A" design, used during the first decade of this century, appears to be represented in Manitoba only by what little remains of the old Tilston station. However, the station at Mowbray, though undesignated in CPR records, looks very much like a W.L. "A" design (Figure 19). These buildings bear a striking resemblance to the first standard CPR station. The later station, however, was enlarged with a broad dormer and a rectangular bay window. A shingled awning, supported by small brackets provides protection only on the platform side.

Figure 19. The old Mowbray Station resembles CPR's W.L. "A" design.

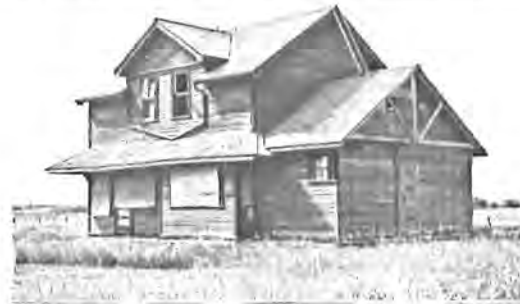
In the next decade a slightly different design, designated W.L. "A2" was developed. These buildings, which differ from their W.L. "A" predecessors only in some slight fenestration adjustments appear to be represented in Manitoba only by the abandoned station at Riverton (Figure 20).

Figure 20. Former Riverton Station.

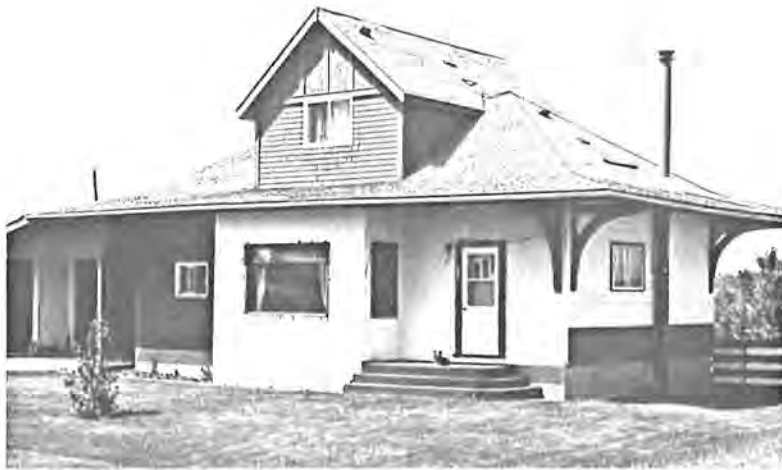
One final group of standard CPR stations that have proved amenable for conversion to residences are the small #14 (or 14A) used at Fraserwood and Pettapiece (Figure 22). These designs, rendered assymetrical by offset dormers feature large brackets that support a sweeping bellcast roof. The Pettapiece station, which has been enclosed on one side retains its original size; the Fraserwood station has been considerably enlarged and renovated for its present use as a residence.

Figure 22. The former Pettapiece station.

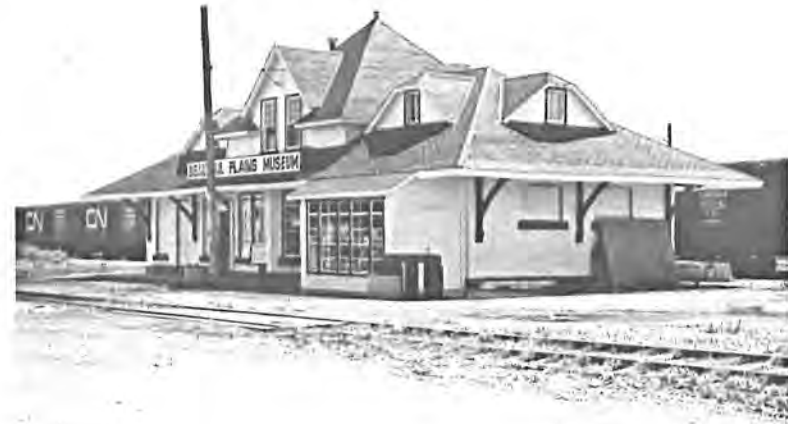
Like 3rd class stations in Manitoba, 2nd class stations include those officially designated as such in Canadian Northern's records (Figure 23) and those that, despite "Special" designation by the major companies, are of a somewhat humbler nature. The Canadian Northern station at Neepawa, built in 1902, is currently used as the Beautiful Plains Museum (Figure 24). Some minor renovations have obscured the original character of the building, but, in general, it is still a good example of the official 2nd class style. 2nd class stations were among the first of Canadian Northern depots to employ the roofline that was to become a trademark of that company. The complex, but symmetrical, roof is dominated by a high pyramidal section that is interrupted at both front and back by prominent gabled dormers. The Gladstone station features decorative woodwork in these dormers (Figure 25). Smaller hipped dormers break the medium hipped roof that covers the rest of the station.

Figure 24. The former Neepawa station is a fine example of an "official" 2nd class design.

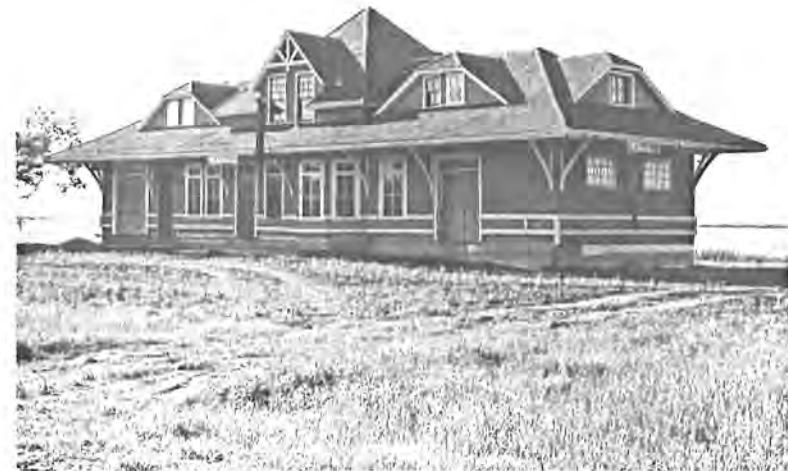
Figure 25. Canadian Northern's old Gladstone station.

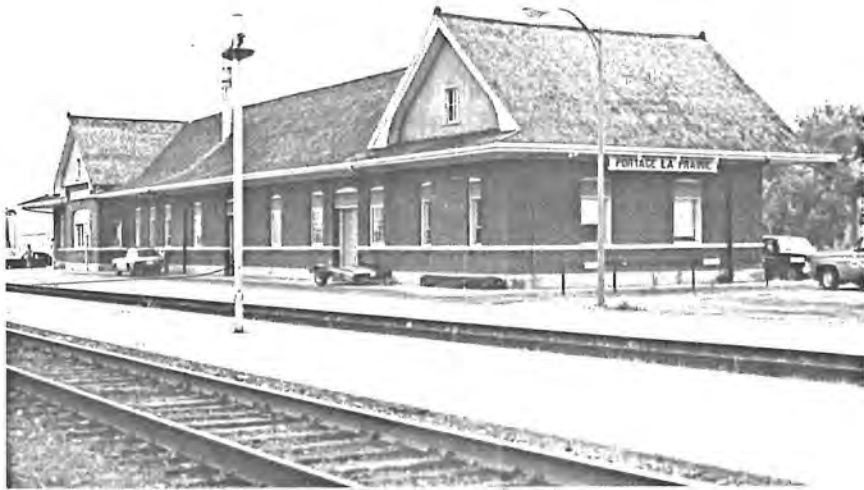
CN stations that have been accorded Special status but are nevertheless still 2nd class include two very good examples at Portage la Prairie and Rivers. The others of this category, including Emerson and Virden, have been less fortunate, having been unsympathetically renovated or abandoned. The Portage la Prairie station, built in 1908 has no provision for living quarters, but its size, construction and appointments link it to the official 2nd class designation (Figure 26). The Rivers station, built later, in 1917, is similar to the previous buildings, although with less architectural ornamentation than the official types, or even the Portage station (Figure 27).

Figure 26. The CN station in Portage la Prairie.

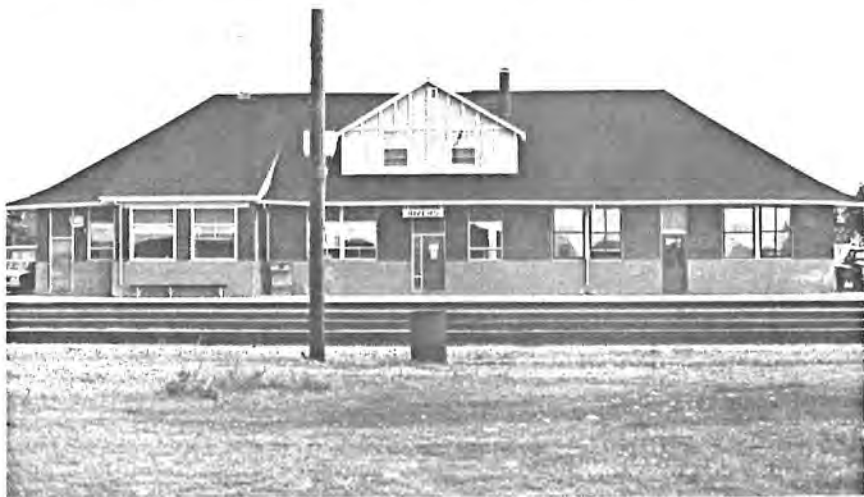
Figure 27. Rivers station.

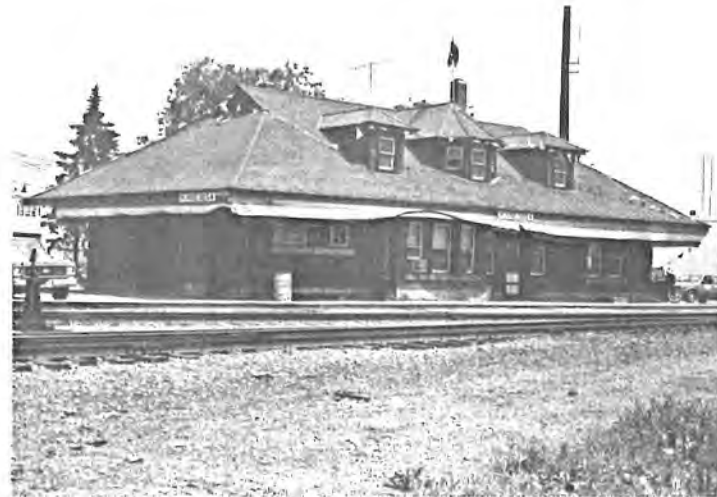
Figure 28. The CPR station in Minnedosa.

station is framed by a radiating voussoir arch constructed of large stones. Other CPR stations, like that at Killarney, are abandoned and, often, decaying (Figure 30).

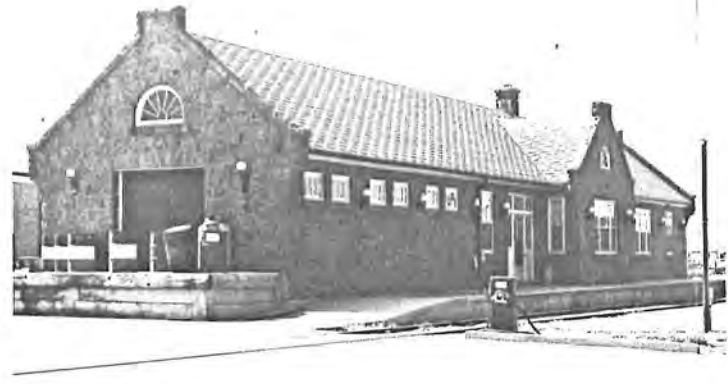
While the smaller railway companies in Manitoba constructed stations that were usually small and simple, some buildings do appear to be of a 2nd class nature. The Greater Winnipeg Water District Station in Saint-Boniface is the best of the few small company stations remaining (Figure 31). Built of stone, in 1929, this attractive building features excellent workmanship and some fine detailing, including arched windows and numerous ball lamps.

Figure 31. The Greater Winnipeg Water District station in Saint-Boniface.

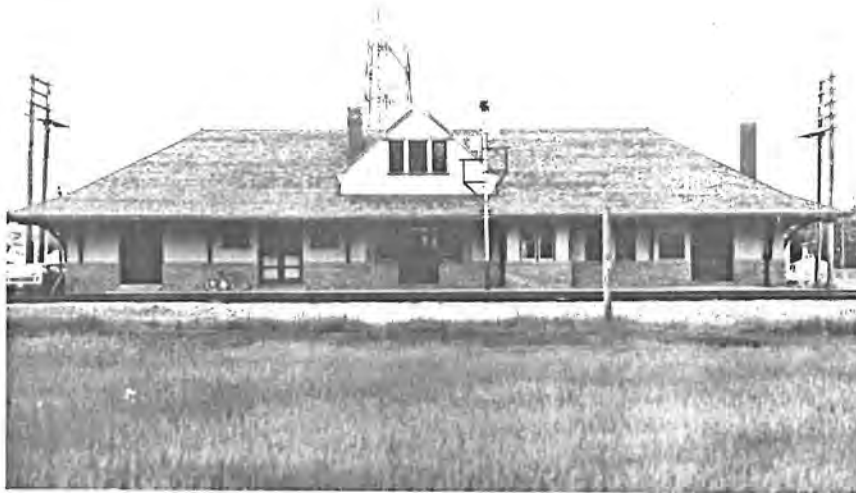
Those Special CPR stations of 2nd class nature are, like their CN counterparts, in varying states of upkeep. Of the four that may properly be considered 2nd class, the Minnedosa and Portage la Prairie stations, both still used, are the most outstanding. The Minnedosa station, constructed of brick, features a broad hipped gable roof that is interrupted by three dormers, the middle one with a faceted roof (Figure 28). The solid Portage la Prairie station boasts some interesting architectural features. The low, flared roof, supported with sweeping brackets, is accented at its midpoint by an interesting gable (Figure 29). The main entrance to the

Figure 29. Portage la Prairie CPR station.

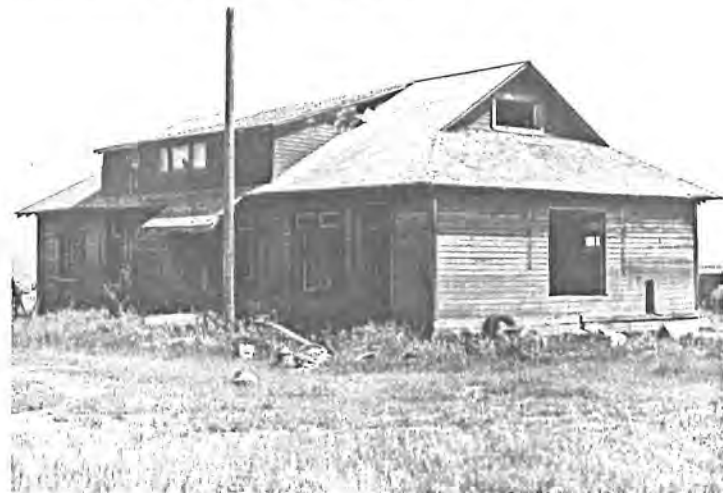
Figure 30. The old station at Killarney, like several others, is not in good condition.

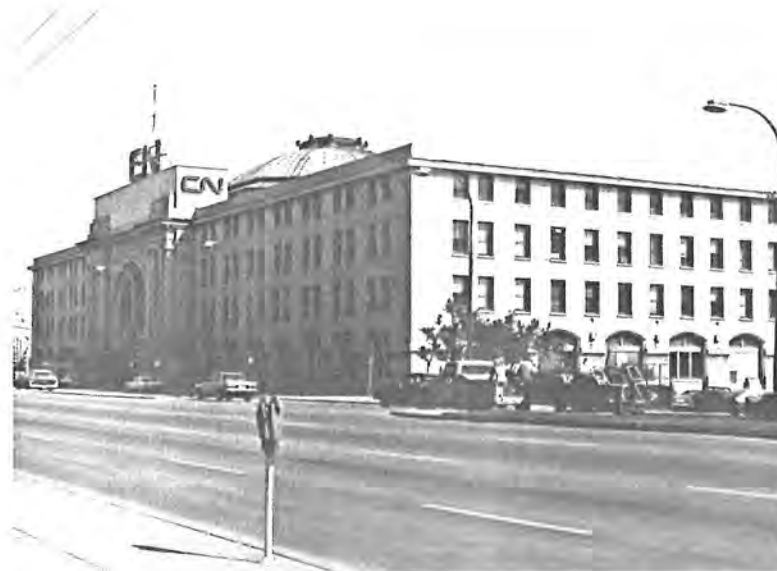
Among Canadian Northern's 1st class designs in Manitoba, Winnipeg's Main Street station, which is an identified Federal Historic Site, ranks as the finest (Figure 32). The only other truly 1st class Canadian Northern station in Manitoba is the 1912 structure at Dauphin. Three storeys high, the building is animated with picturesque roofs, dormers, turrets and decorative brick and stonework (Figure 33). Having been one of the most important division points along Canadian Northern during its years of operation, the large floor plan provides ample space for dispatchers and other service personnel.

Figure 32. CN's elaborate Union Station on Main Street.

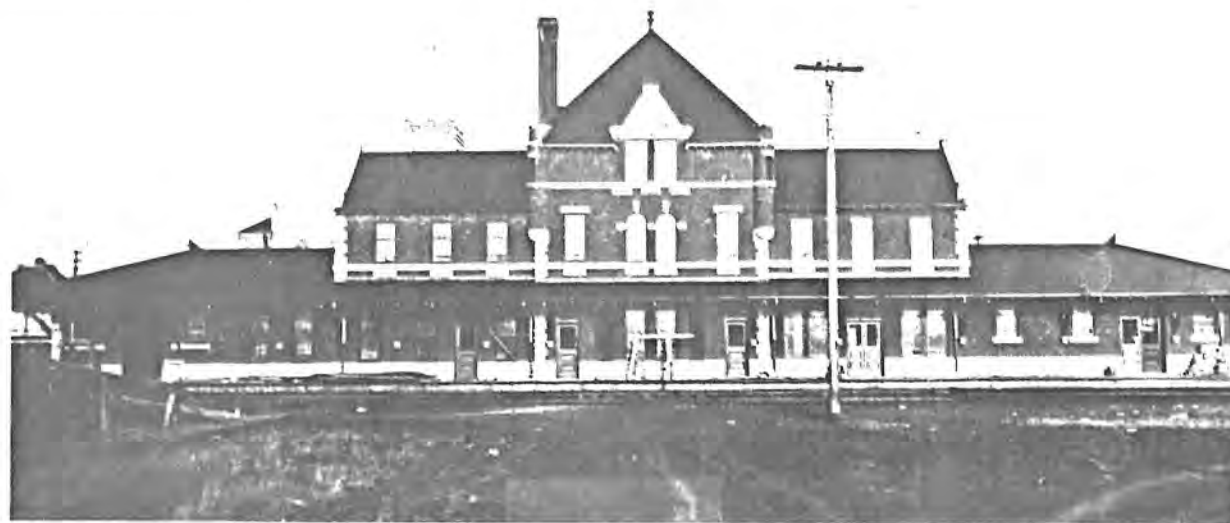
Figure 33. Dauphin station nearing completion, ca. 1912. (Provincial Archives Manitoba.)

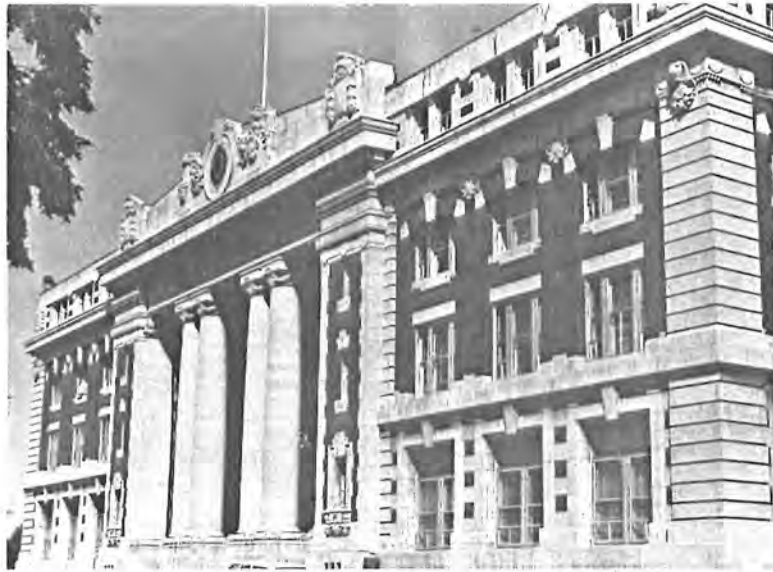
Figure 34. The Higgins Avenue station of the CPR.

Among CP's seven Special stations, Winnipeg, Brandon and Souris are the largest still standing in Manitoba (Figures 34, 35 and 36). The other four Special CP stations are, as already noted, more of a 2nd class nature. The three Special stations that are of a 1st class nature provide an indication of the diverse qualities that 1st class stations could achieve. The huge, grand station in Winnipeg is richly ornamented with large classically-inspired elements. While smaller and less ornate, Brandon's station is nevertheless an attractive building that, at the end of a street, commands attention. The old CPR station at Souris, now simply used for storage, is humbler than the other two. However, constructed of brick, with some decorative stonework, the Souris station retains a prominent position in its rural community.

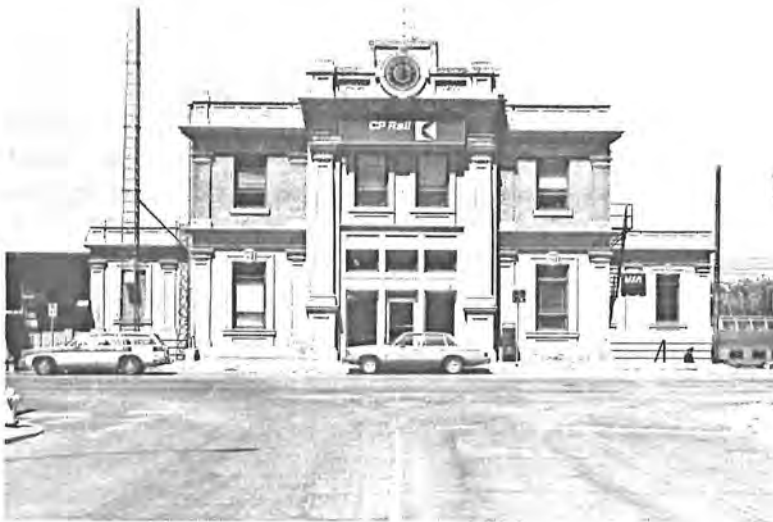
Figure 35. Brandon's CPR station.

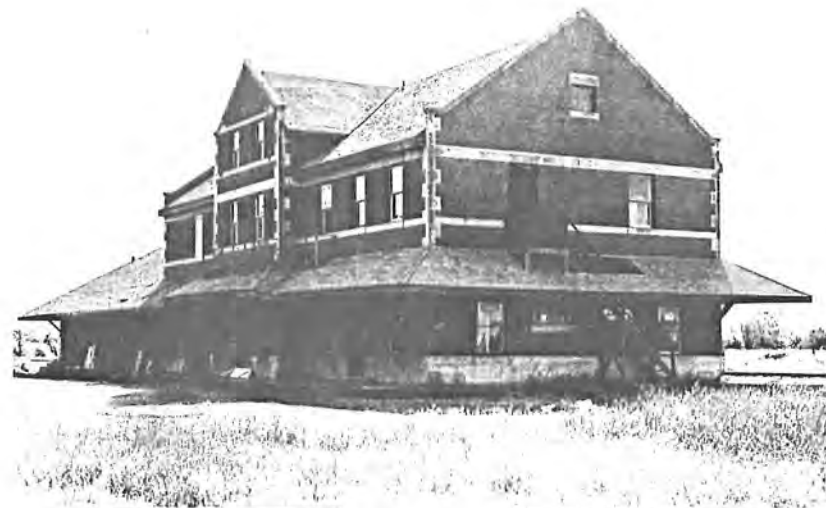
Figure 36. CPR's Souris station, now vacant.

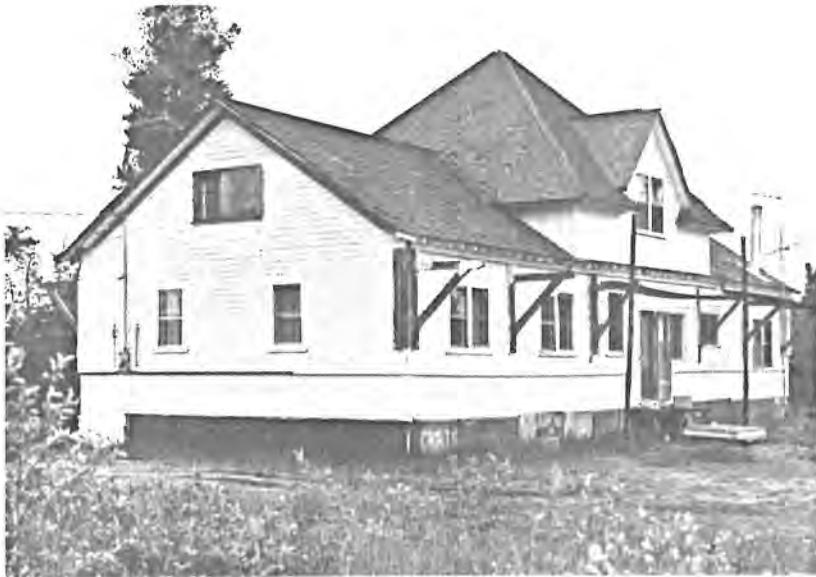
Both CN's and CP's Special status can often be misleading, as it includes all stations built for specific, local circumstances. As previously noted, several Special CP stations are actually of a 2nd class nature. CN's designation often overstates the design as well. The old Canadian Northern station at Victoria Beach is clearly not 1st class (Figure 37). Its Special designation owes more to its purpose than its form; Victoria Beach station, which actually resembles 3rd class, was designed to suit the community's special function as a summer resort.

Figure 37. Canadian Northern's "Special" Victoria Beach station.

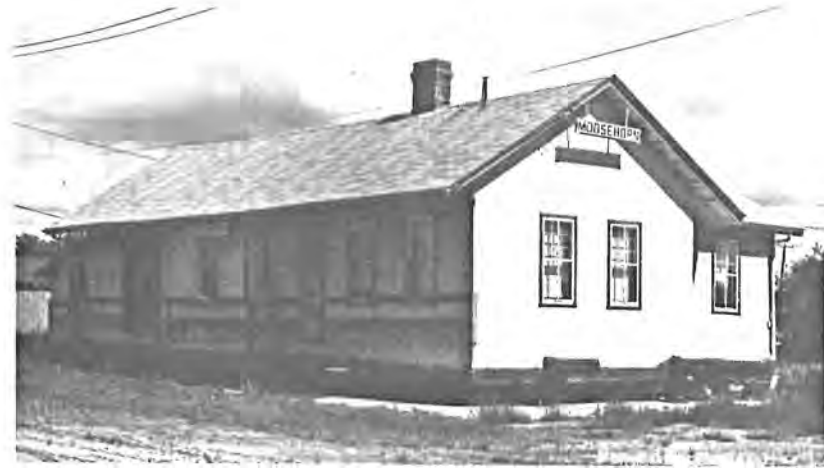
Some Special stations, in fact, seem more closely related to Canadian Northern's 4th class designation. The humble 4th class station was quite different from other depots in the system (Figure 38). Notably, it did not have a second storey and had no provision for living quarters. These simple structures were covered by a low gable roof, unbroken by dormers. A shingled awning was absent and, in this simplified state, the ubiquitous bay window assumed a more prominent role than in other designs. The former Canadian Northern station at Moosehorn, now used as a museum, is a good representative of the remaining nine 4th class station designs (Figure 39).

Figure 39. Moosehorn station.

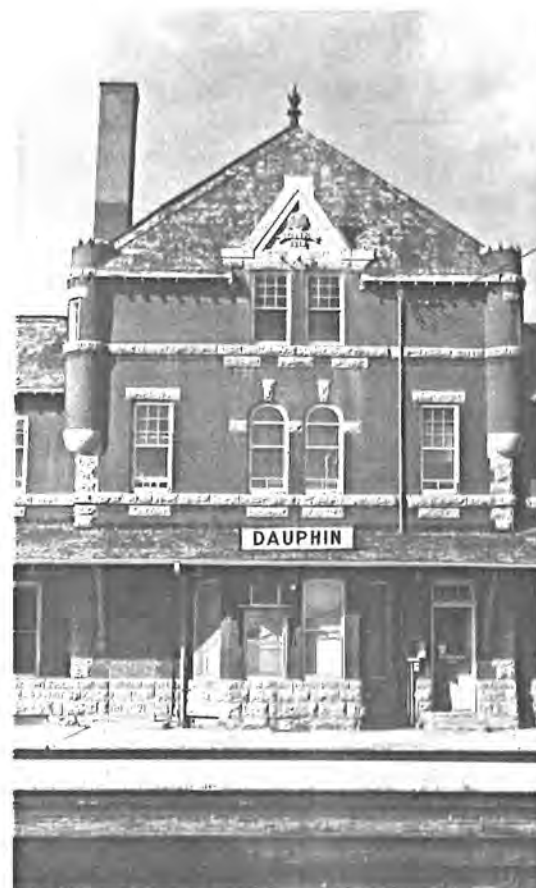
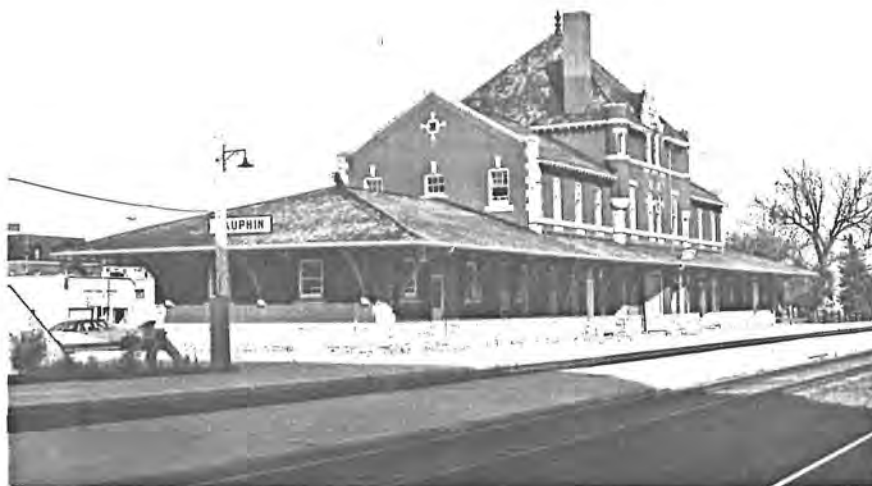
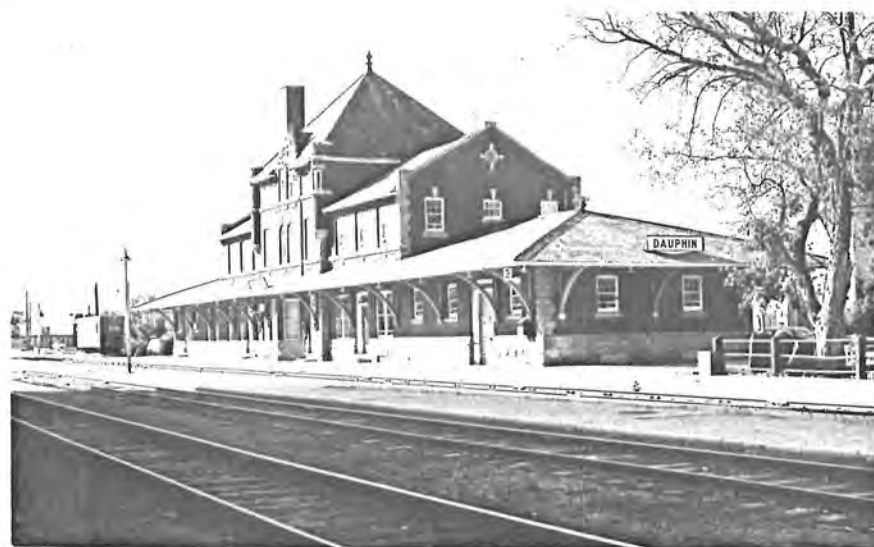
# DAUPHIN (cont'd)

-brick construction  
-station is unusually large, even for a special station (rural)

- segmental arch window openings (glazing and sashes are flat)
- semi-circular windows on second floor
- round openings with four tyndall keystones for second floor ventilation
- tyndallstone plinth, quoins, lugsills, set-out keystones, and stone belt
- some of the metal roof finials appear to be shaped like birds. Also, metal ridgepoles
- datestone is part of a carved decorative pediment with the CNR crest on it. There is one on each of town and track sides
- parapets
- pilastered decorative bartizans adorn top two floors

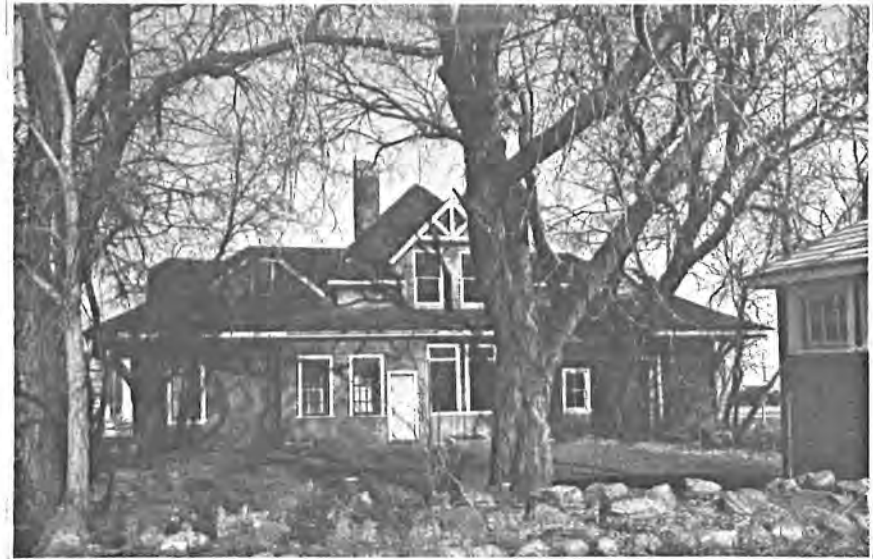
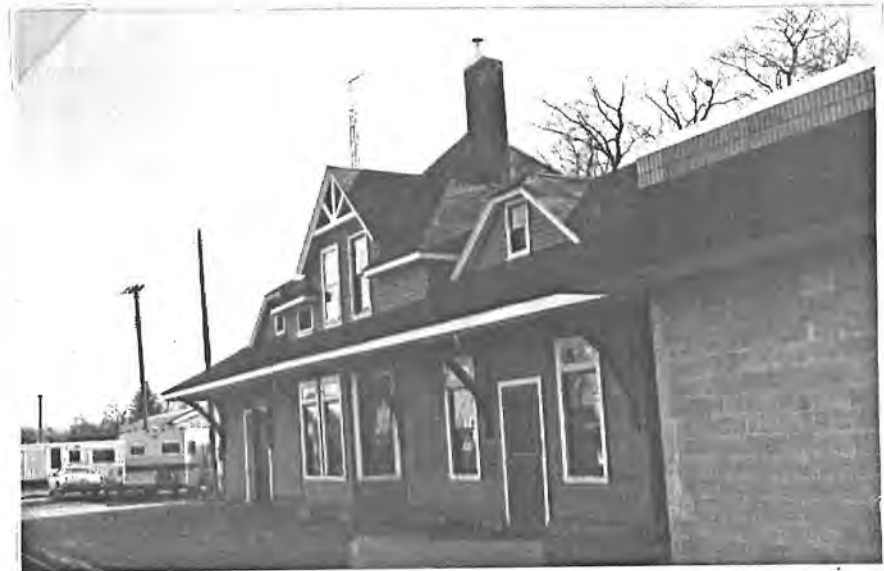
# CARMAN

General Condition of Building: Good

EXTERIOR: -the station colours have been retained after repainting (grey with red doors and white trim)

INTERIOR: -the agent's second floor quarters are unaltered and are now rented out  
-the main floor partitions remain, as does the ticket wicket

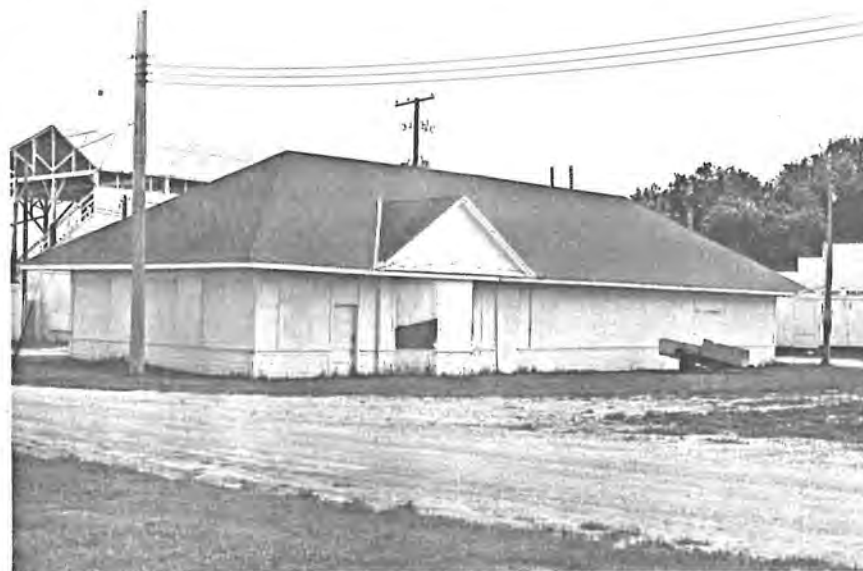
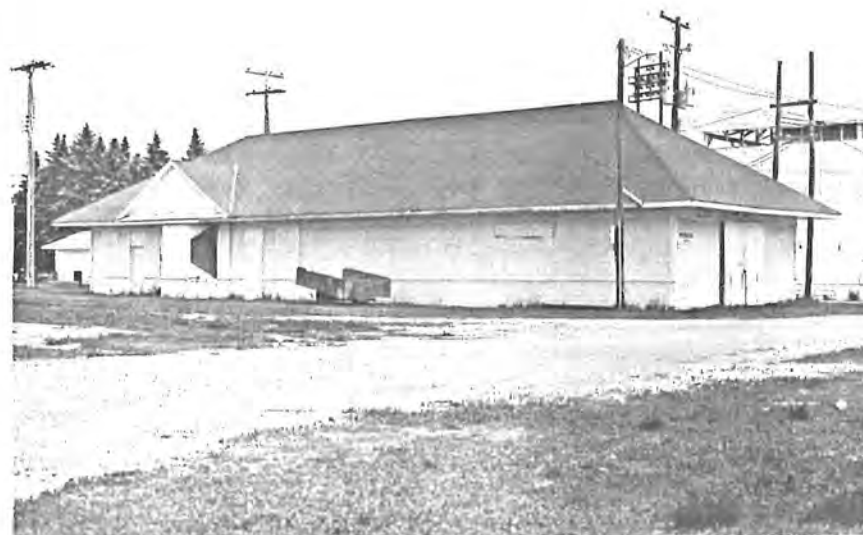
# CARMAN

General Condition of Building: Fair

EXTERIOR: -new asphalt shingles at some  
point  
-both track and town-side freight  
shed doors are now semi-  
permanently closed

INTERIOR: -baggage and office converted  
to a cafeteria-like kitchen  
(non-permanent)

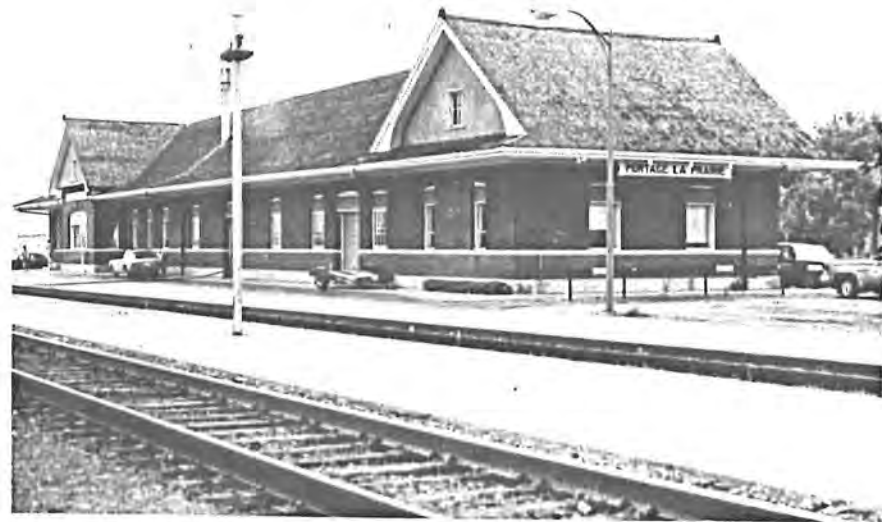
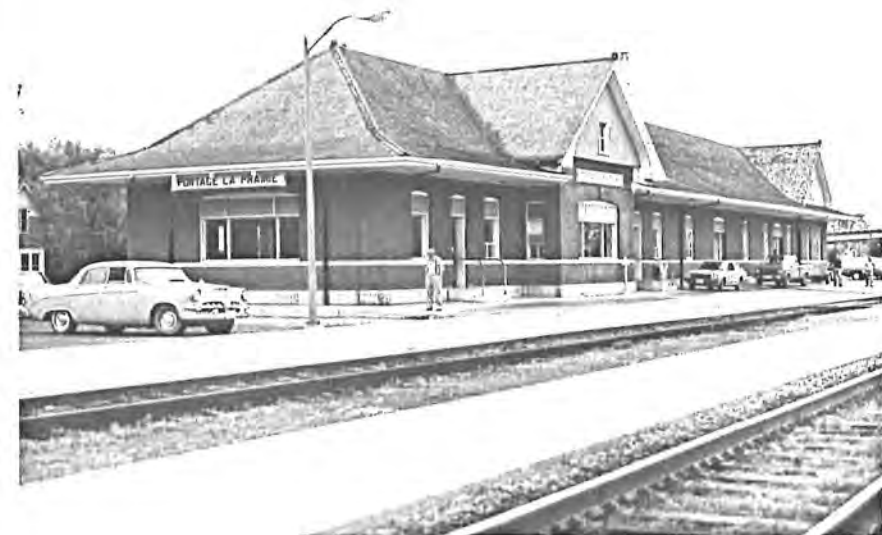
# PORTAGE LA PRAIRIE

General Condition of Building: Very Good

-simple bargeboard  
 -segmental arch window openings  
 -no brackets  
 -decorative stone belt

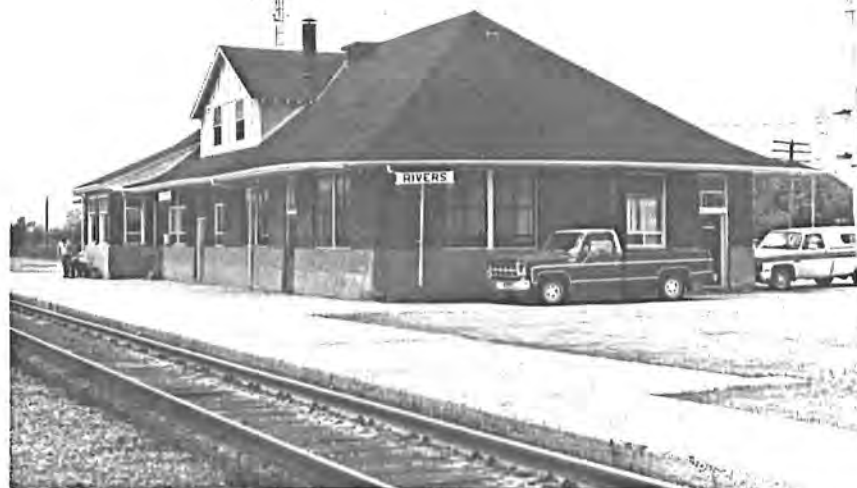
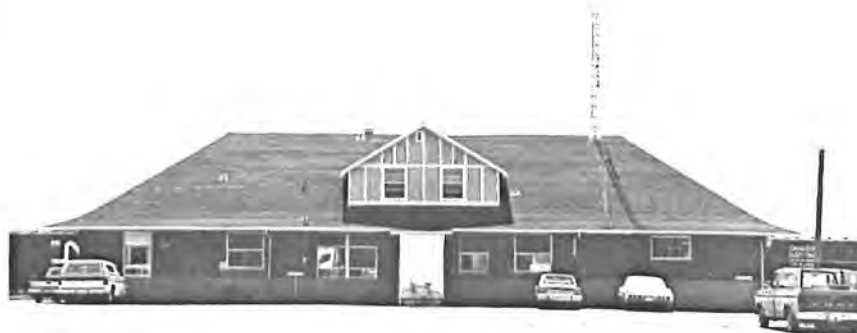
# RIVERS

General Condition of Building: Good

GENERAL: -this is the second major station at Rivers. The first burned down before this one was built

EXTERIOR: -mostly unchanged  
-many new windows, including replacements for former freight shed doors

-brick coursing is not quite uniform (i.e. following any

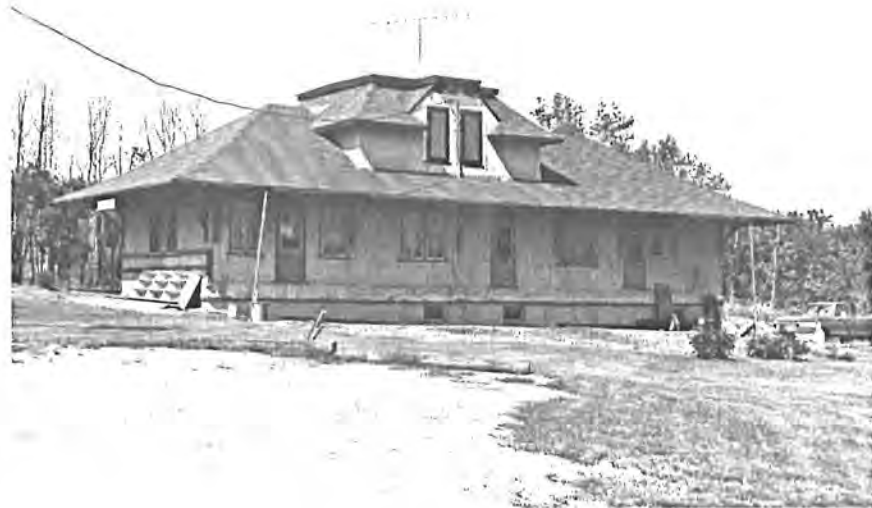
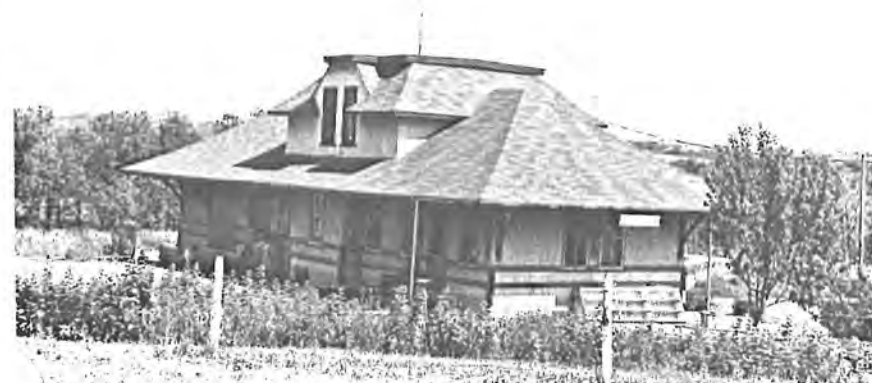
# VIRDEN

General Condition of Building: Good

- EXTERIOR:
- has been re-roofed
  - otherwise purposely unchanged

- INTERIOR:
- presently receiving extensive renovations: drywall and

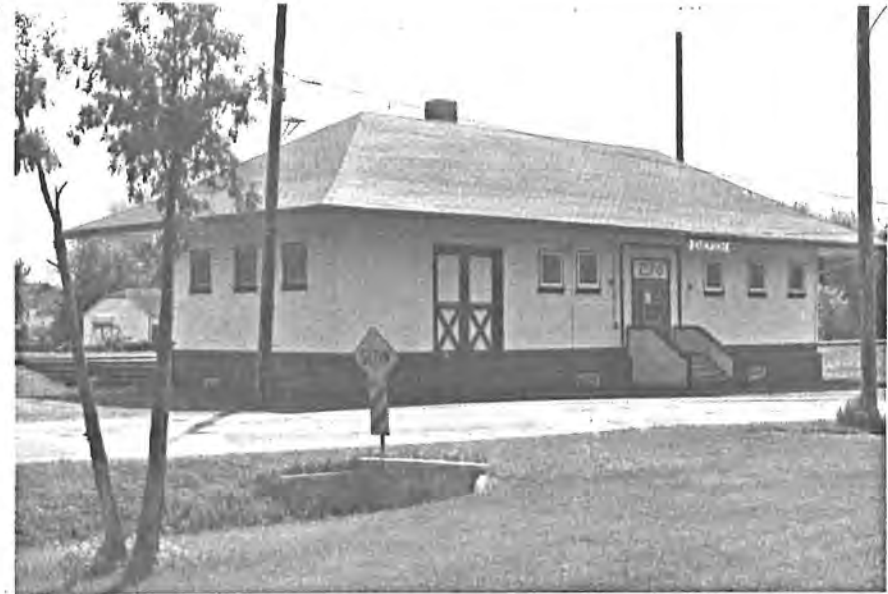
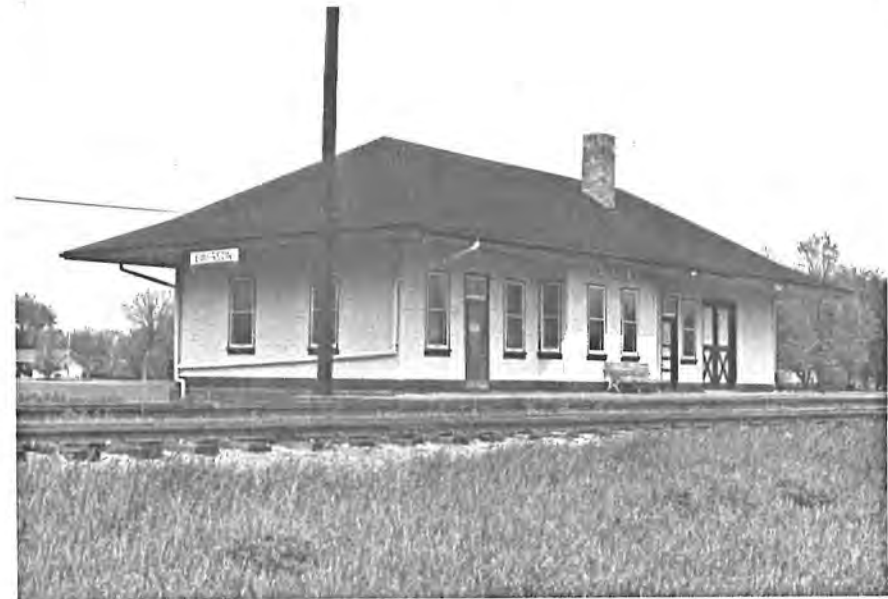
# EMERSON

General Condition of Building: Very Good

GENERAL: -this station has probably been  
a customs station  
-platform is still intact and in  
good condition

-overhang slightly bellcast  
-no brackets

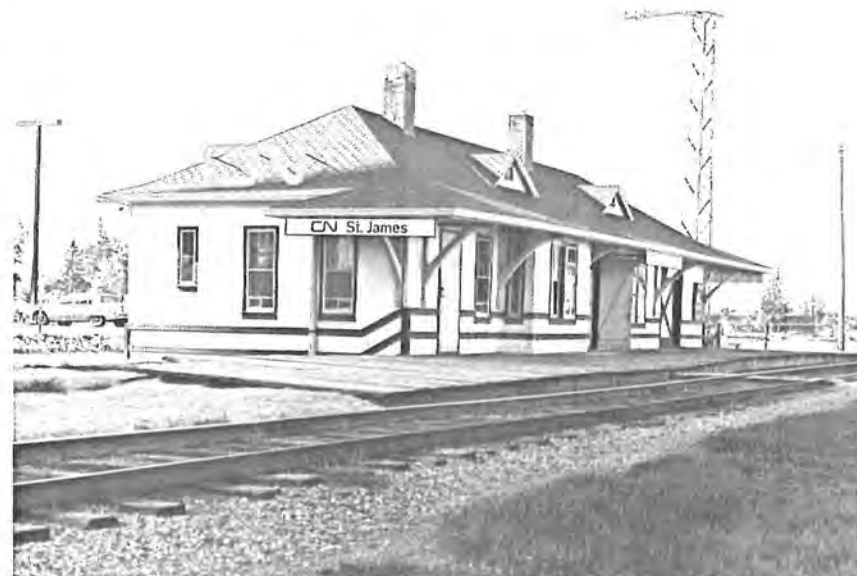
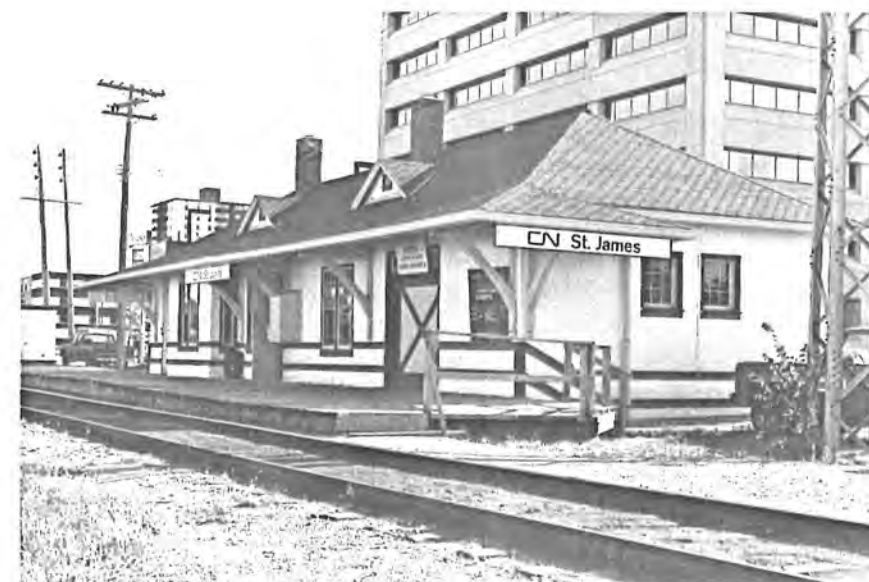
# ST. JAMES

General Condition of Building: Excellent

-two windowless dormers on each  
side

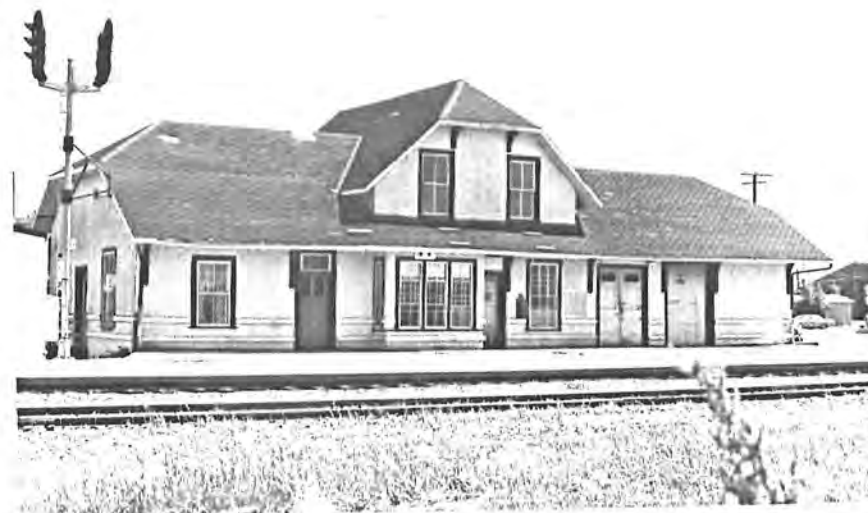
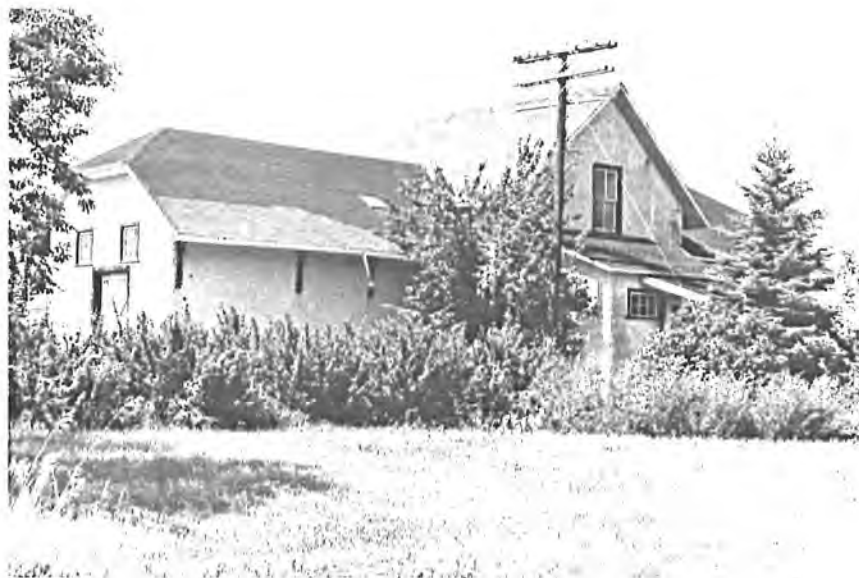
General Condition of Building: Poor

INTERIOR: -appears very deteriorated  
-details unavailable as building closed

BOHI: -stucco added in 1928
