# RAILWAY STATIONS OF MANITOBA: A BUILDING INVENTORY

Patricia Trainor  
Farhad Rahbary  
David Butterfield

1987

This report on Manitoba's railway buildings is divided into two sections. The first provides a brief historic background of rail line and specific station design developments in the province. The second, comprehensive, section is a catalogue of extant railway buildings in Manitoba. The first section is organized according to station types, while the information in the second part is grouped according to ownership. For easier reference, this second section will also be subdivided according to specific station types. Photographs of the stations in the catalogue section are accompanied by basic data sheets. Information given for each station includes: date built; past and present locations; present owner and use, as well as facts relative to renovations and noteworthy features.

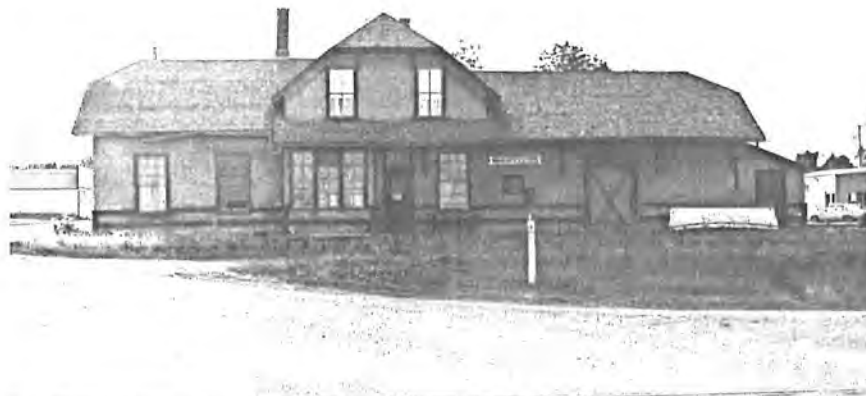
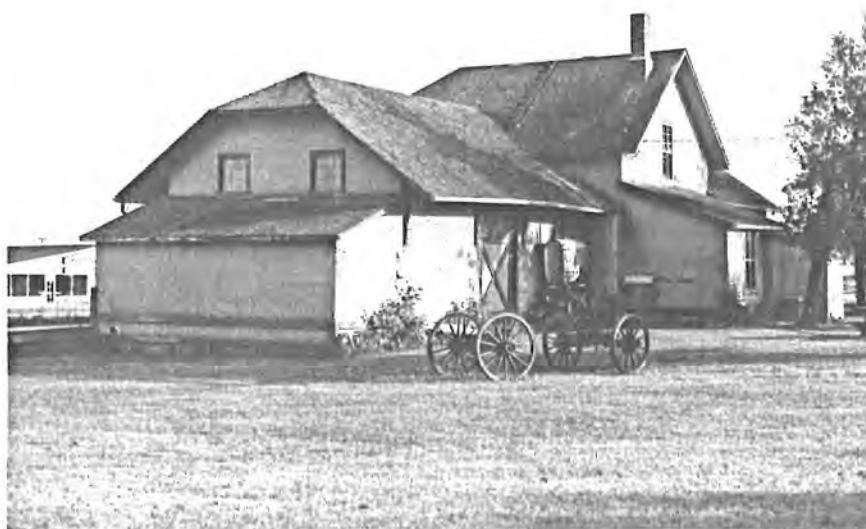
# WINNIPEGOSIS

General Condition of Building: Fair

BOHI: -stucco was added in 1923  
-insulation was added in 1928

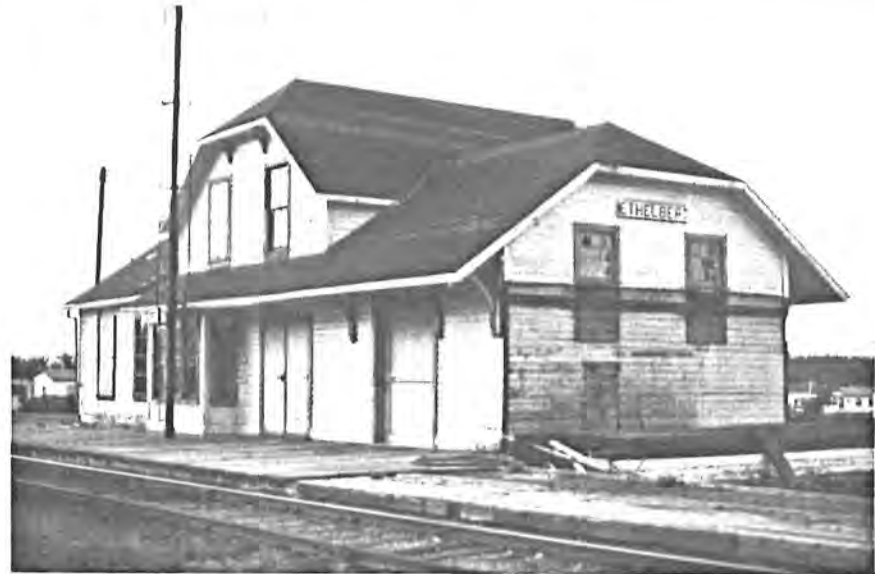
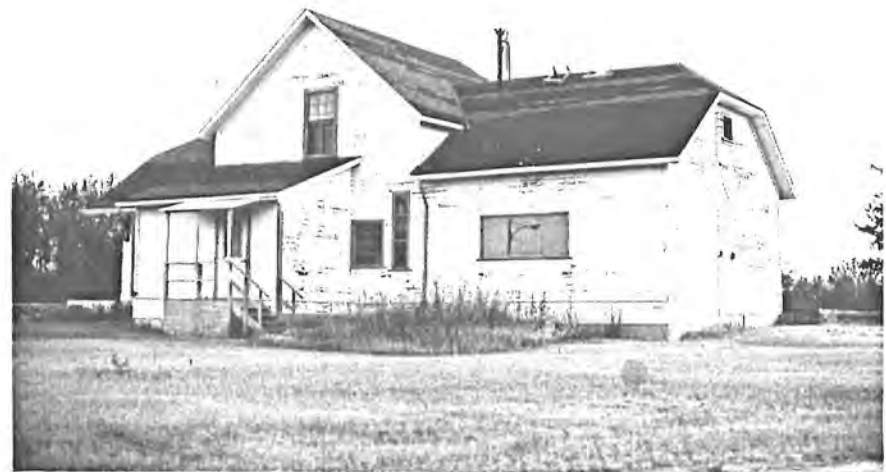
# ETHELBERT

General Condition of Building: Poor

INTERIOR: -quite deteriorated

-specifics unavailable as building closed at time of visit

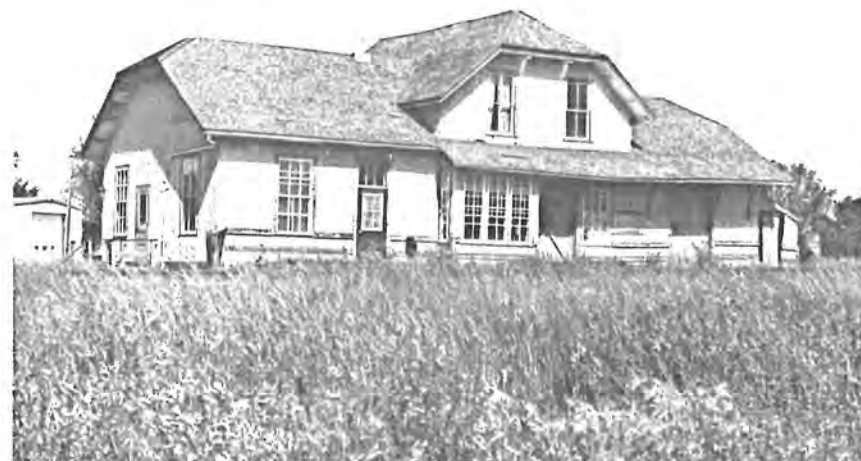
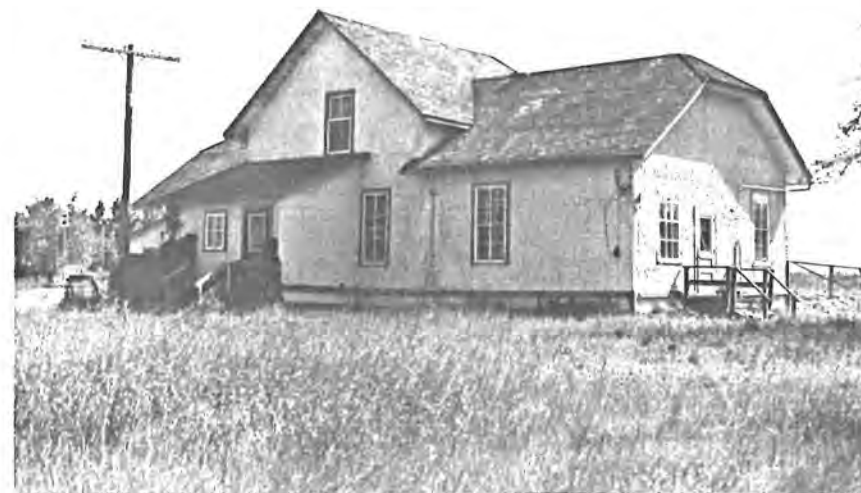
# SWAN RIVER

General Condition of Building: Fair  
(CN survey)

-no bay window (Bohi)

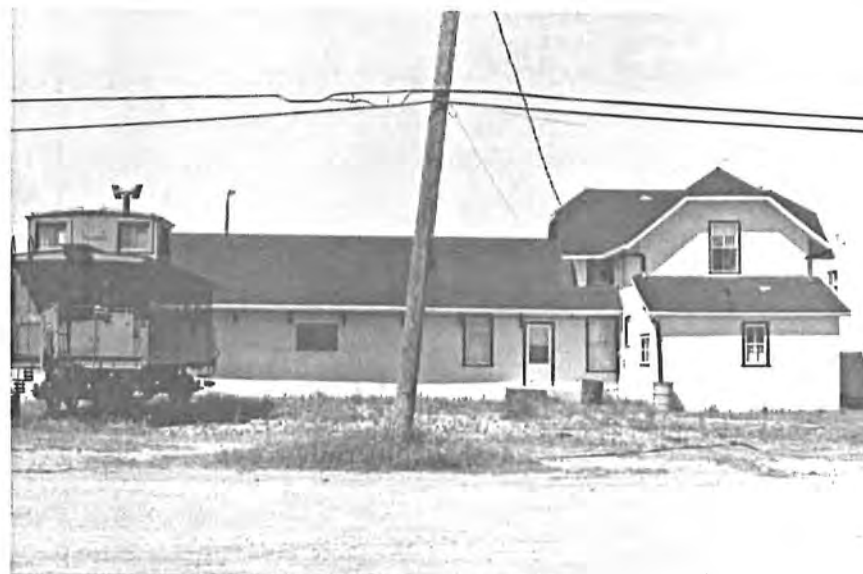
## WOODRIDGE

General Condition of Building: Poor

-perennial purple iris are all  
that remain of station gardens

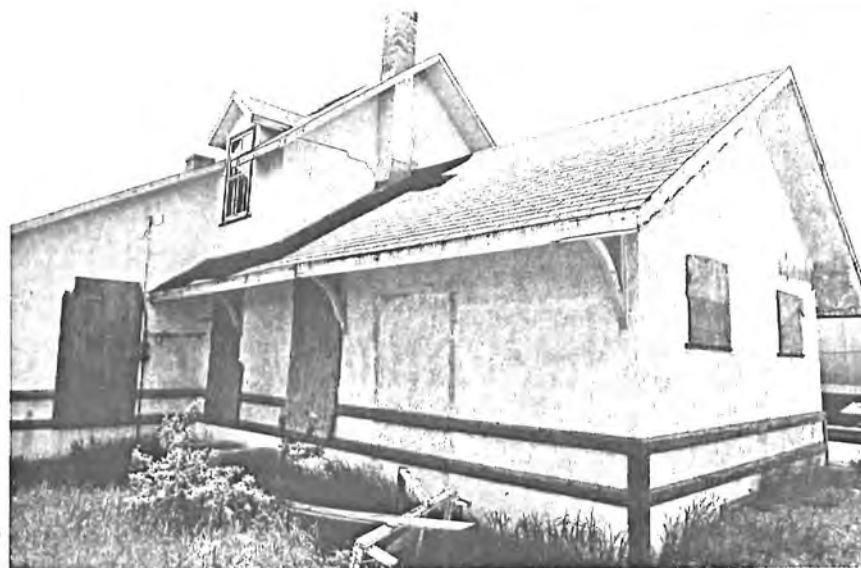
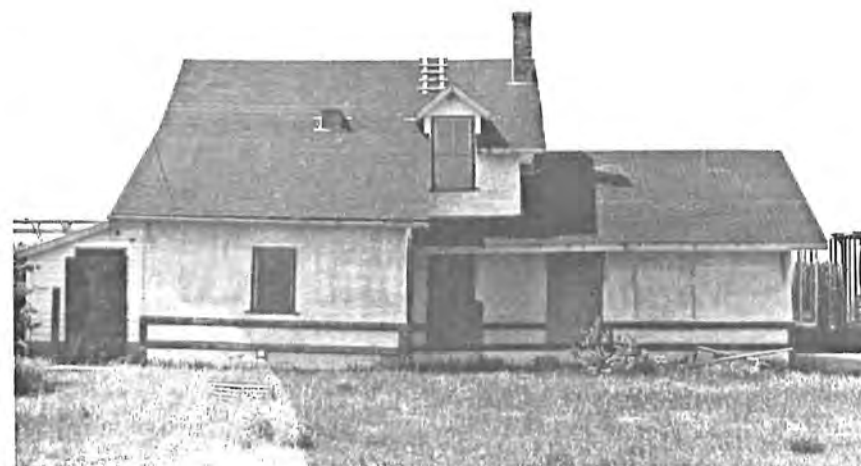
# ROSEISLE

General Condition of Building: Very Good

-new front deck

INTERIOR: -some redecorating, leaving  
little original

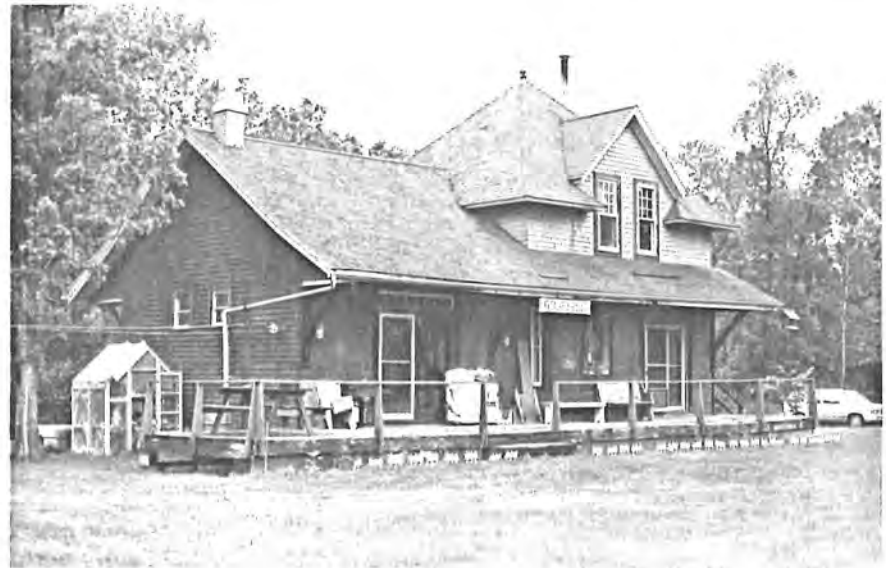
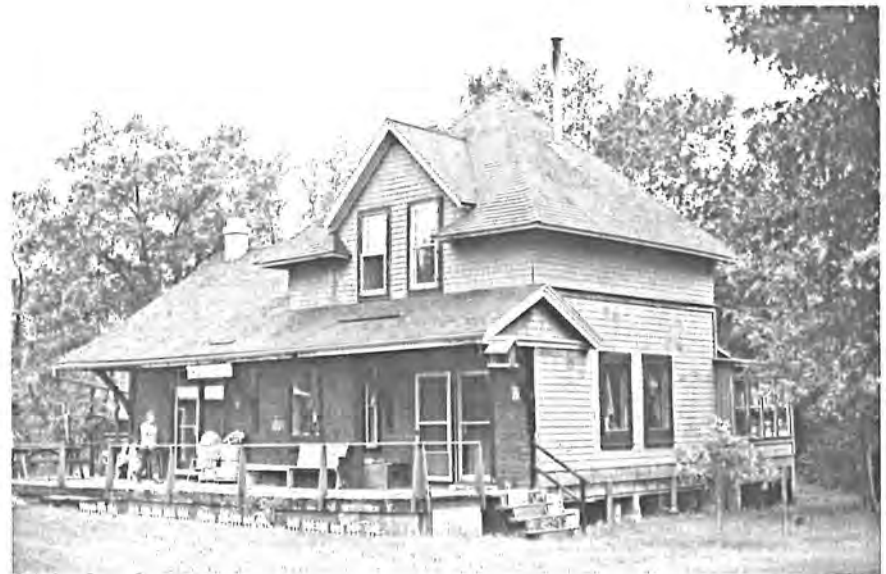
# ST. JEAN BAPTISTE

General Condition of Building: Excellent

EXTERIOR: -new garage added  
-new roof  
-new storms over original windows  
-new sidings: stucco and  
horizontal wood  
-new front deck

INTERIOR: -freight shed was renovated into  
a LR, new fireplace  
-smallest upper BR renovated into

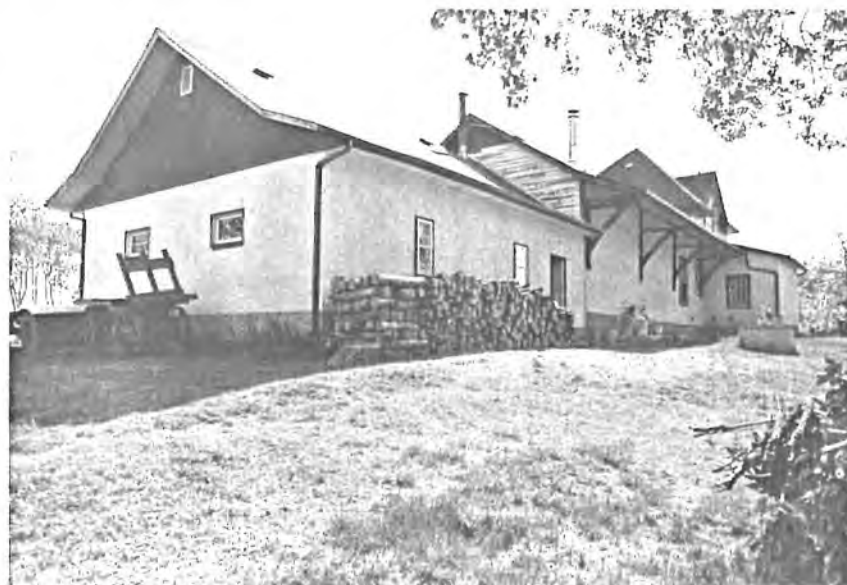
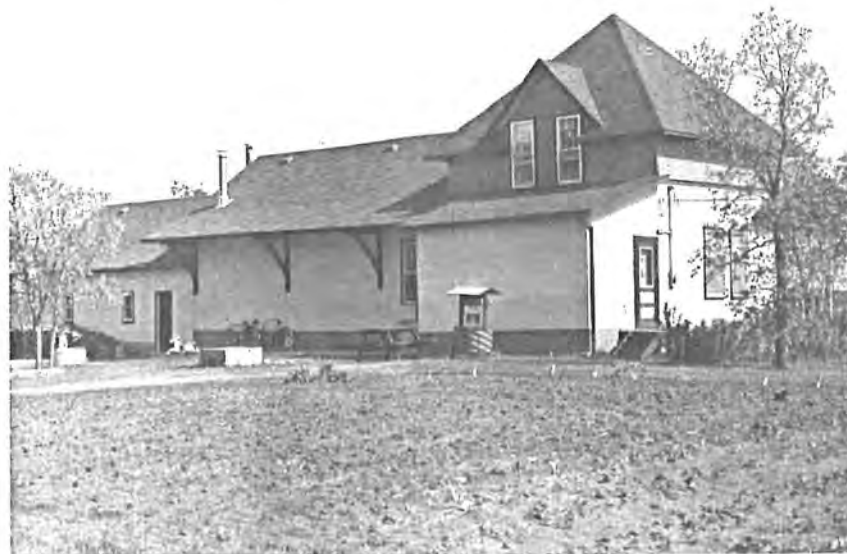
# LAKE FRANCIS

General Condition of Building: Excellent

EXTERIOR: -caboose attached as family  
room  
-office window replaced by front  
door  
-new stucco siding on lower floor  
-new back deck and front porch

INTERIOR: -freight shed has been renovated  
into a LR; the office to an  
entryway; the waiting room to  
a DR

-after the Gregorys renovated  
the station, there was a fire,  
and most of the upper floor had  
to be reconstructed. Because

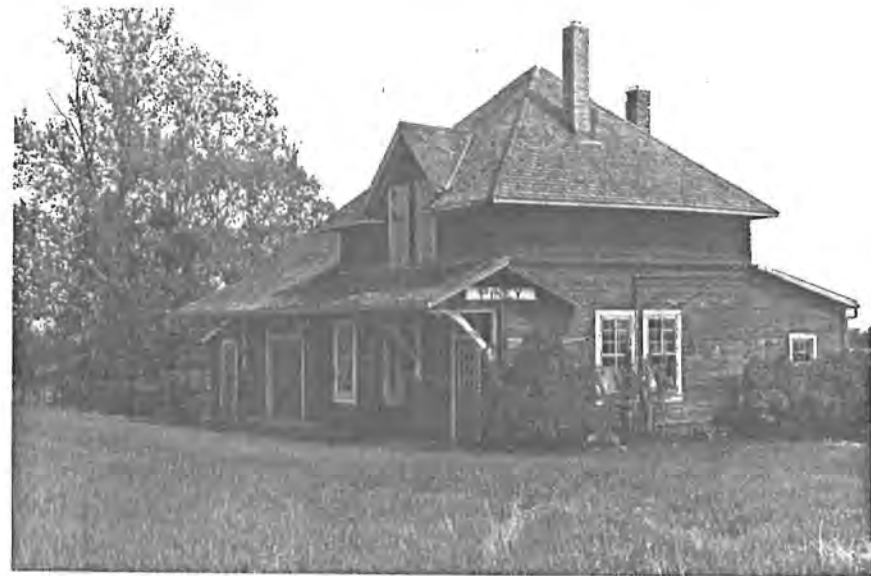
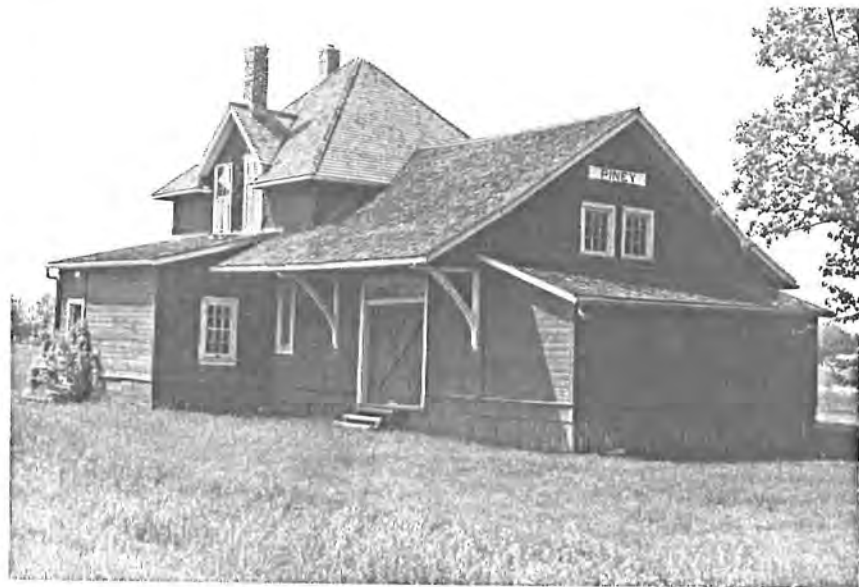
# ROBLIN

General Condition of Building: Fair to Good

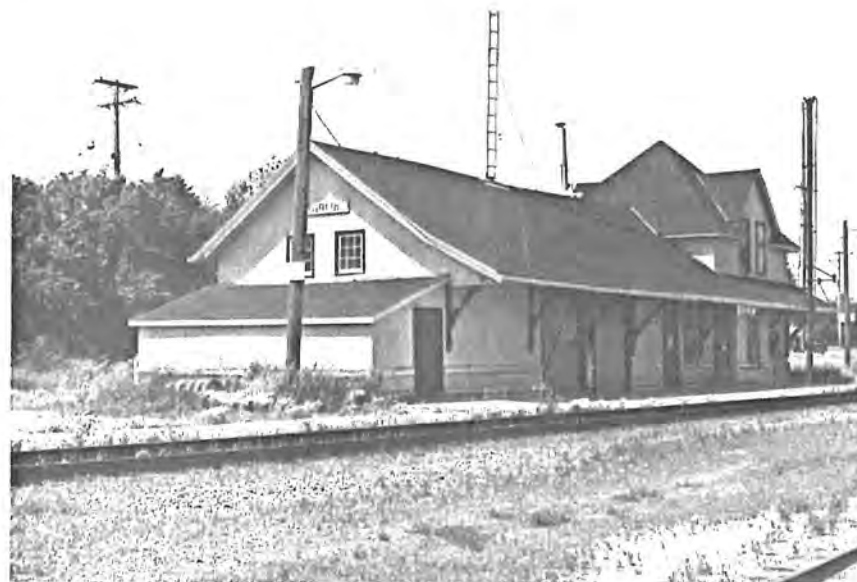
# SOMERSET

General Condition of Building: Very Good

EXTERIOR: -appears unchanged

INTERIOR: -was redecorated at one point by  
CPR. Linoleum floors and carpets  
probably to be removed soon.

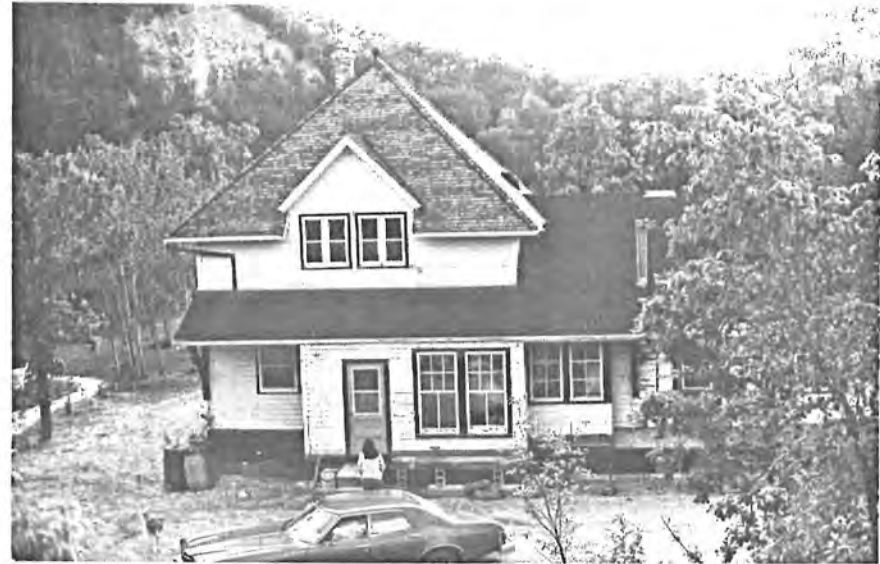
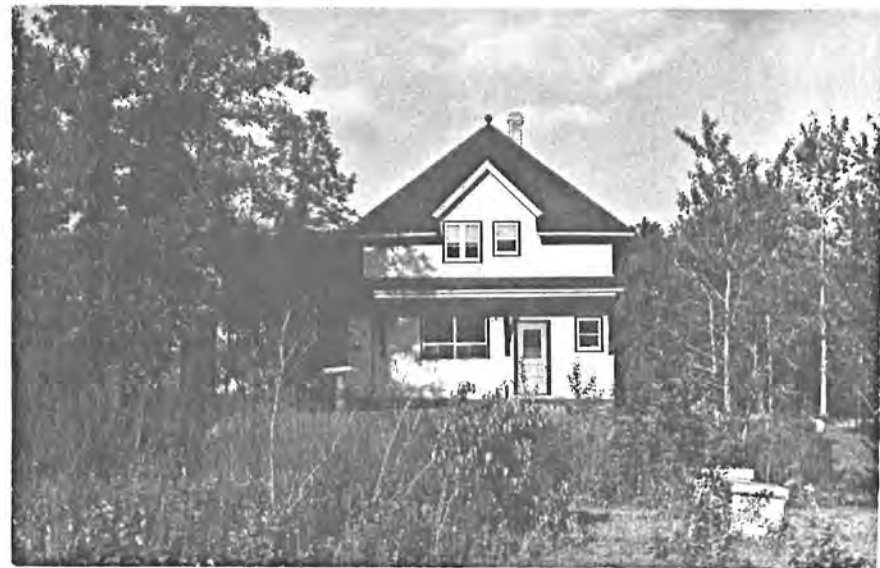
# ROSSBURN

General Condition of Building: Fair to Poor

EXTERIOR: -ground floor windows and doors  
all filled in except rear  
freight shed door  
-otherwise unchanged, but  
deteriorated

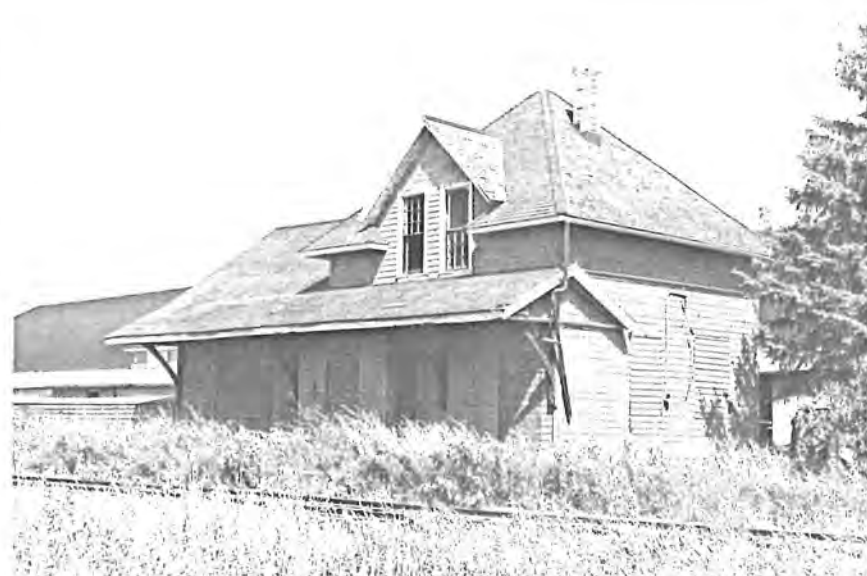
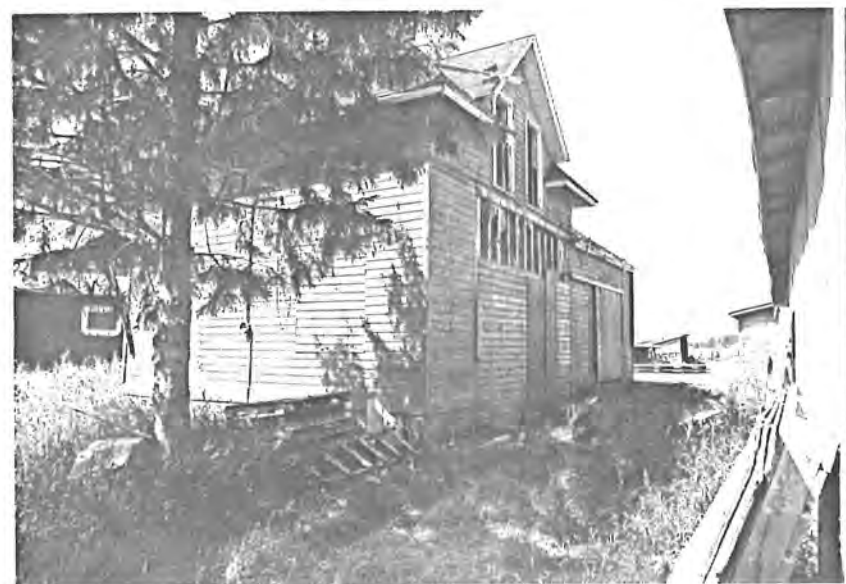
# MARIAPOLIS

General Condition of Building: Excellent

-metal finial  
typical (but now lost) on most  
stations of this type, is  
clearly visible here

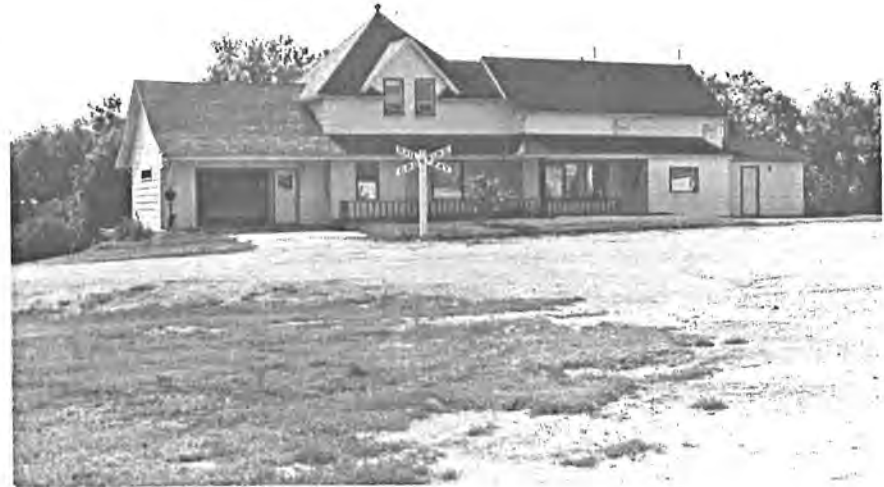
# LAVENHAM

General Condition of Building: Fair to Poor

EXTERIOR: -original shingles need repair  
-appears unchanged

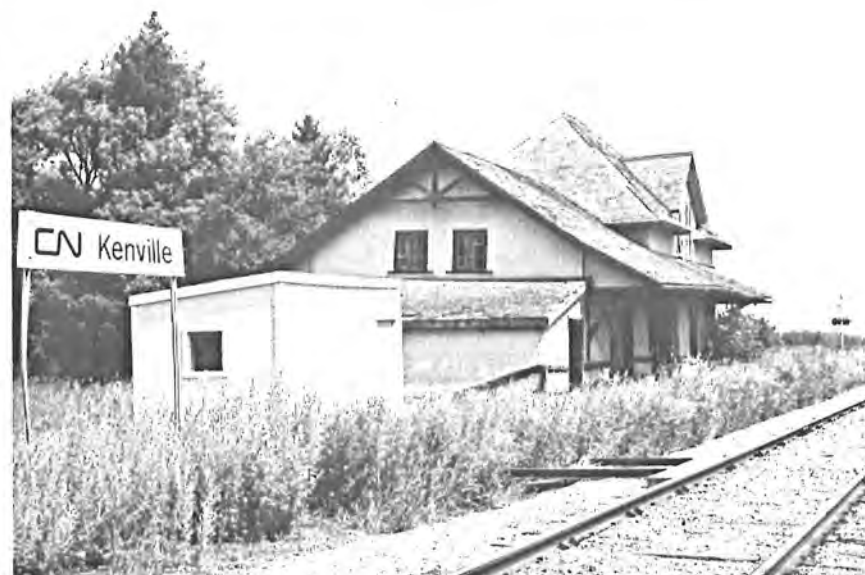
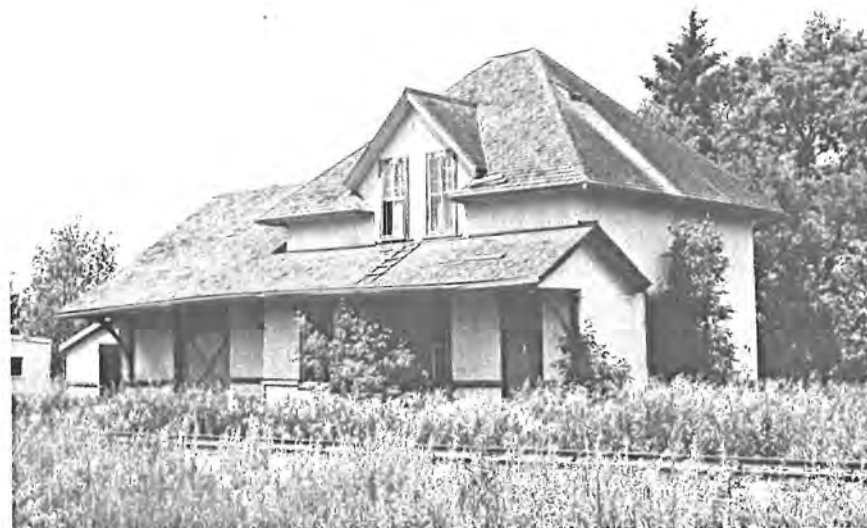
# McCONNELL

General Condition of Building: Very Poor

- GENERAL: -tracks have been removed  
-McConnell now seems to be a  
genuine ghost town  
-stations is literally falling  
down
- EXTERIOR: -exterior walls falling off of  
the studs  
-freight shed doors are missing  
-windows are all broken
- INTERIOR: -interior is as deteriorated as  
the exterior

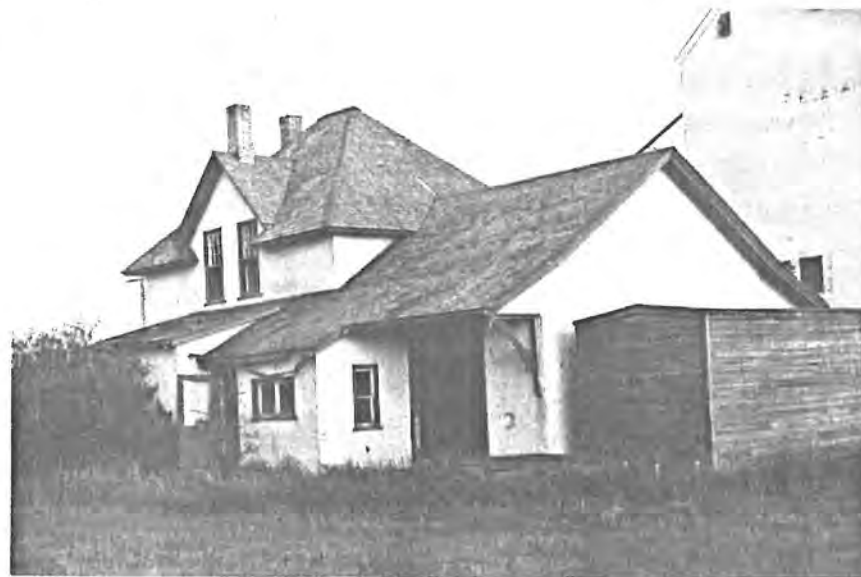
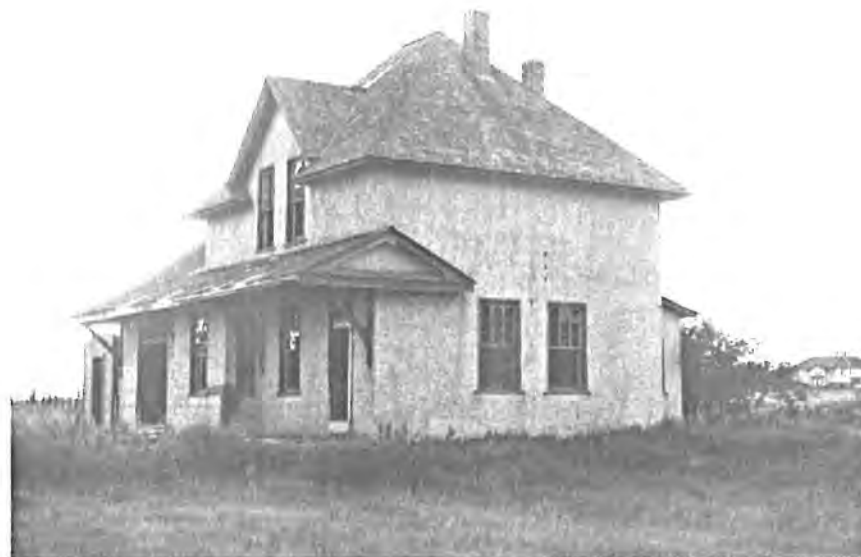
# BENITO

BOHI: -stucco and insulation added in  
1935

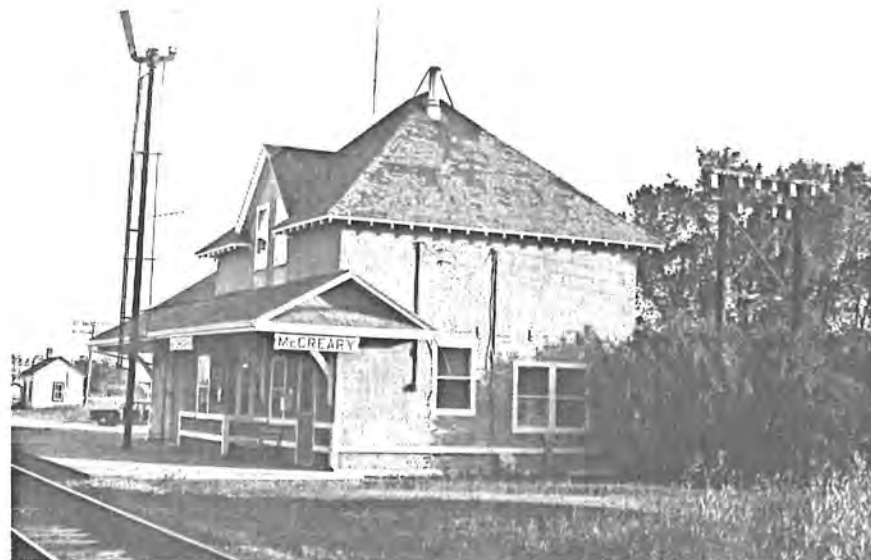
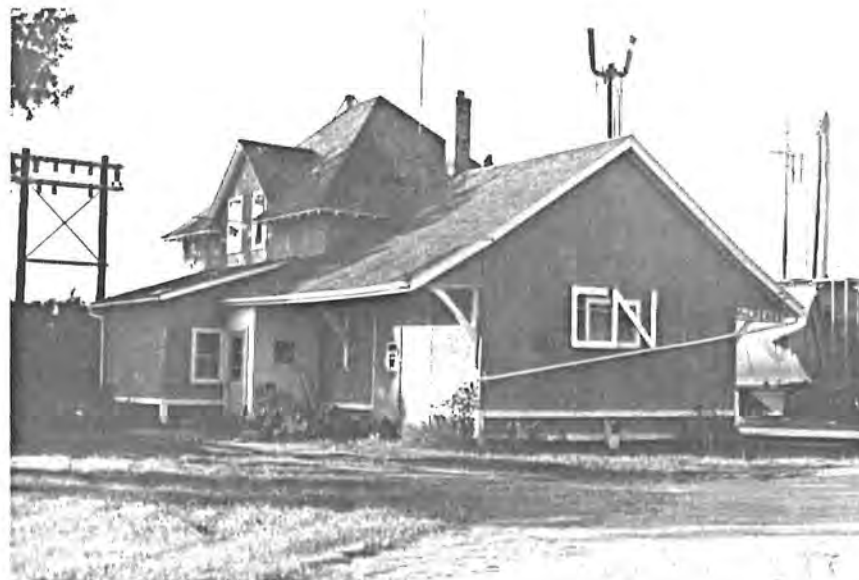
# SWAN LAKE

BOHI: -stucco was added in 1936  
-insulation was added in 1936  
-plumbing was installed in 1966

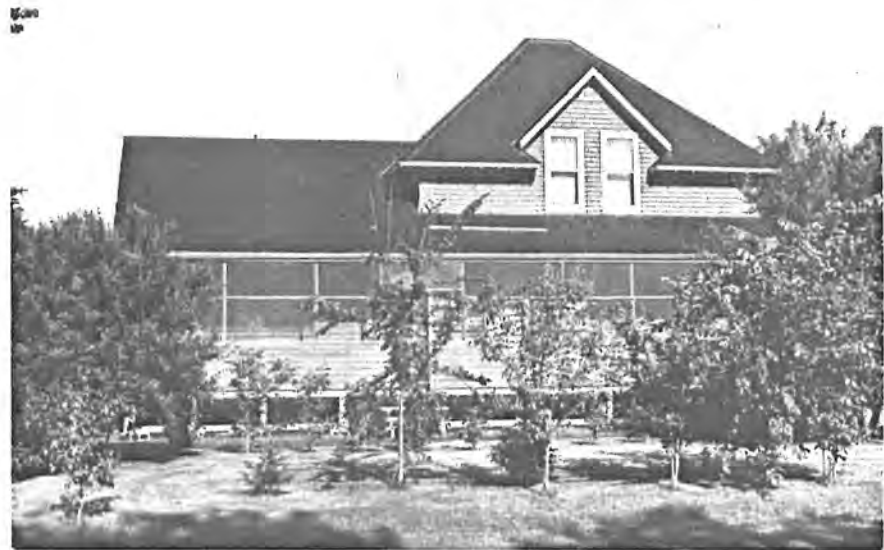
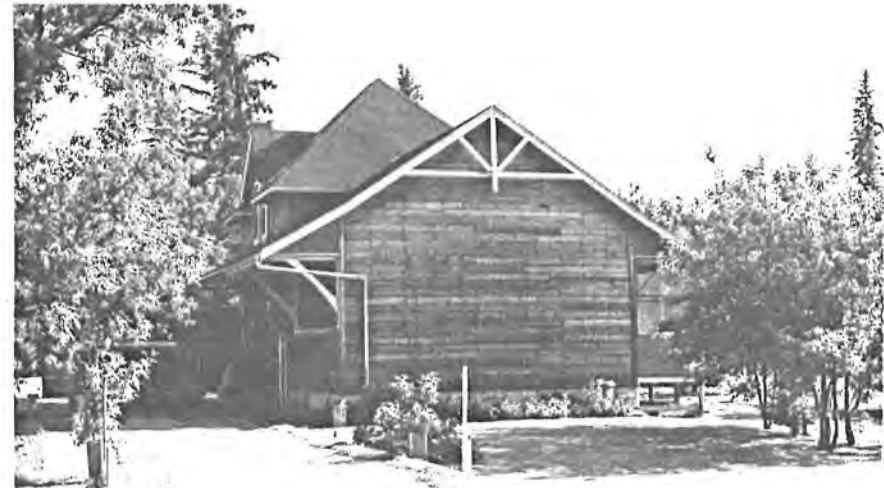
General Condition of Building: Very Good

-simple bargeboard

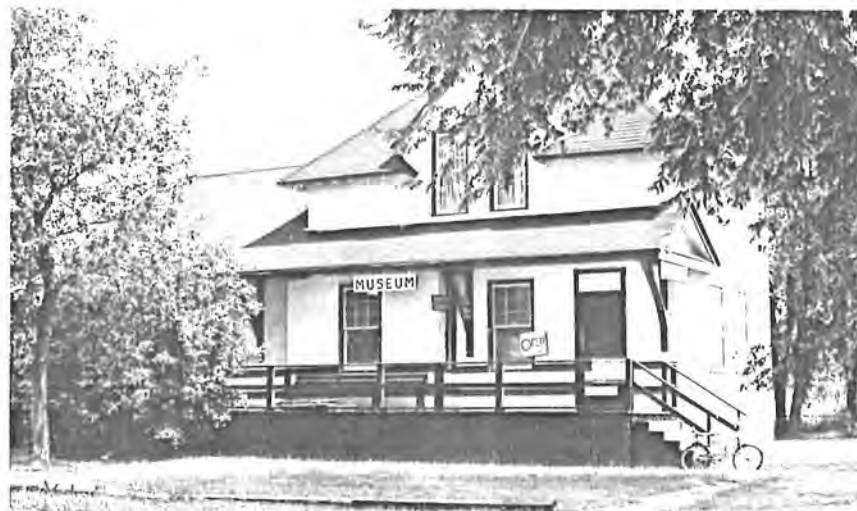
General Condition of Building: Good

EXTERIOR: -basically unchanged

INTERIOR: -the wall between the former  
waiting room and the living  
quarters has been removed  
-remainder is unchanged

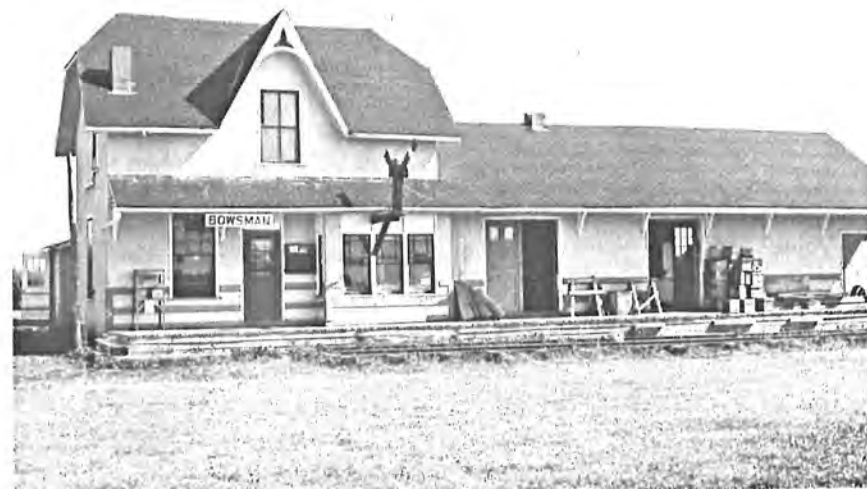
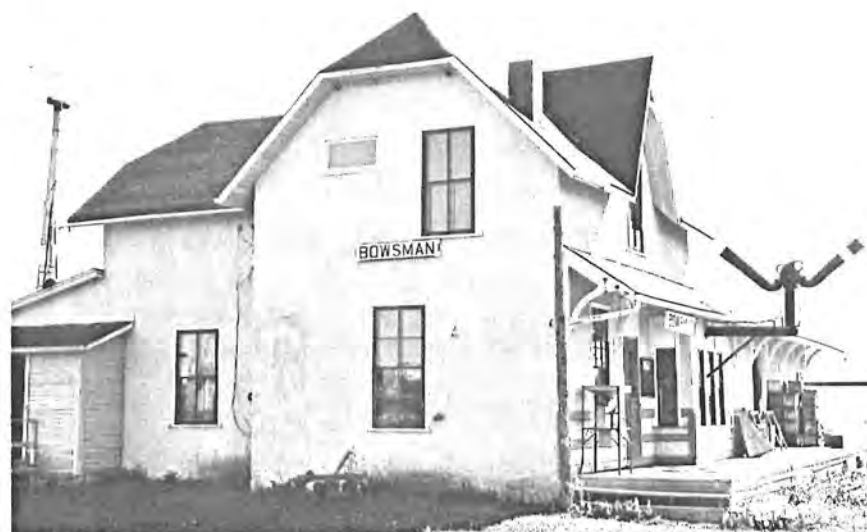
General Condition of Building: Very Good

EXTERIOR: -needs paint  
-appears unchanged

INTERIOR: -very well maintained  
-the wall between the living quarters and the office has been knocked down, as has the one between the office and the waiting room  
-kitchen has been modernized  
-original staircase

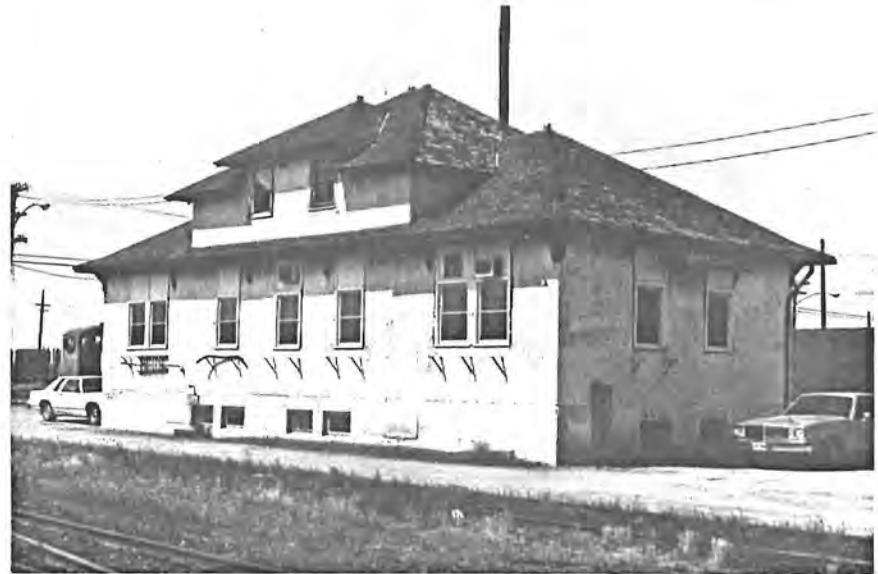
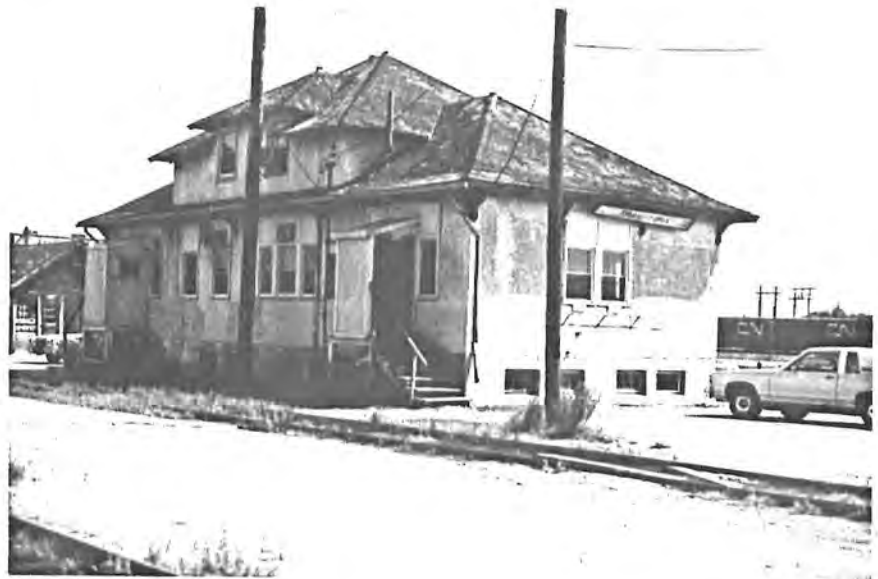
# TRANSCONA

General Condition of Building: Good

- GENERAL:
- this appears to be a unique design
  - the original location of the station was less than a mile to the SE of its present location: "just east of the malt plant," off the Dugald Road
- EXTERIOR:
- the bay window of the station was removed after the station was moved
  - new wind shelters around the two front doors
  - new windows
  - needs paint

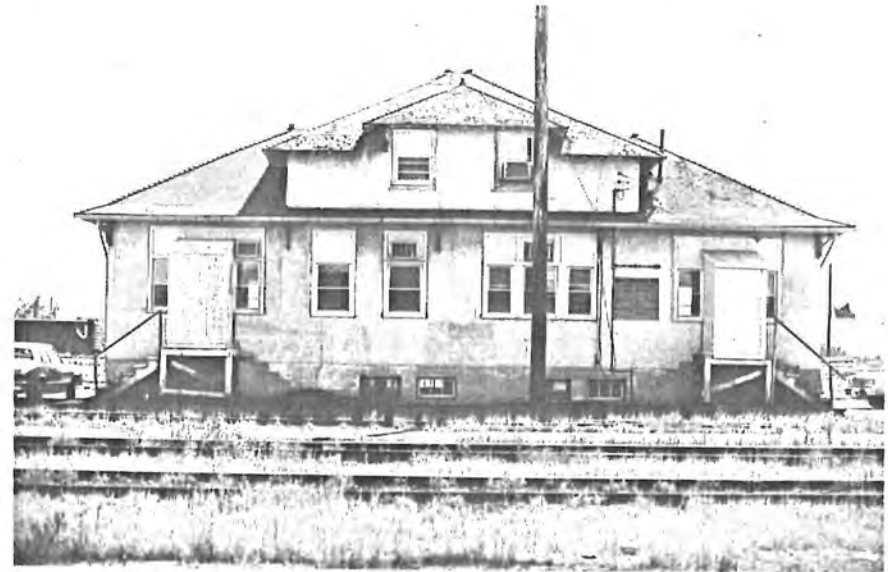
TRANSCONA (cont'd)

-small metal decorative finials  
on roof points

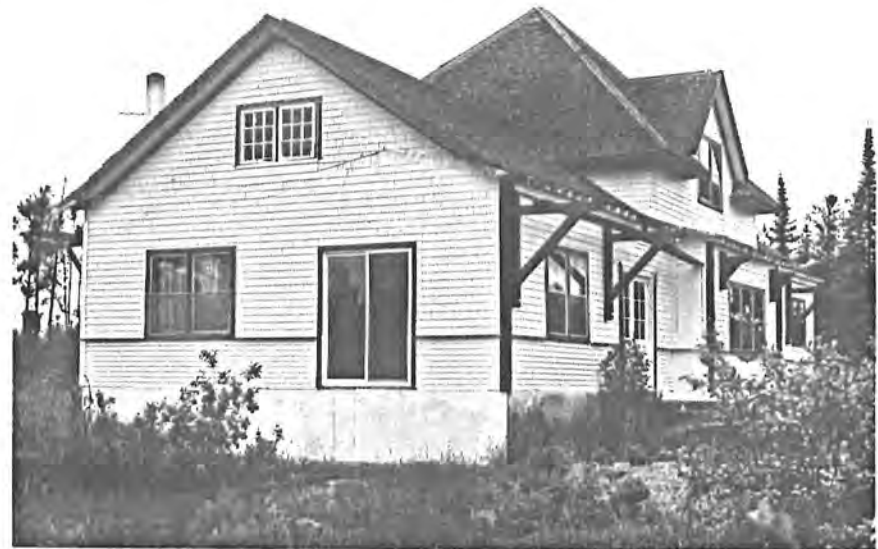
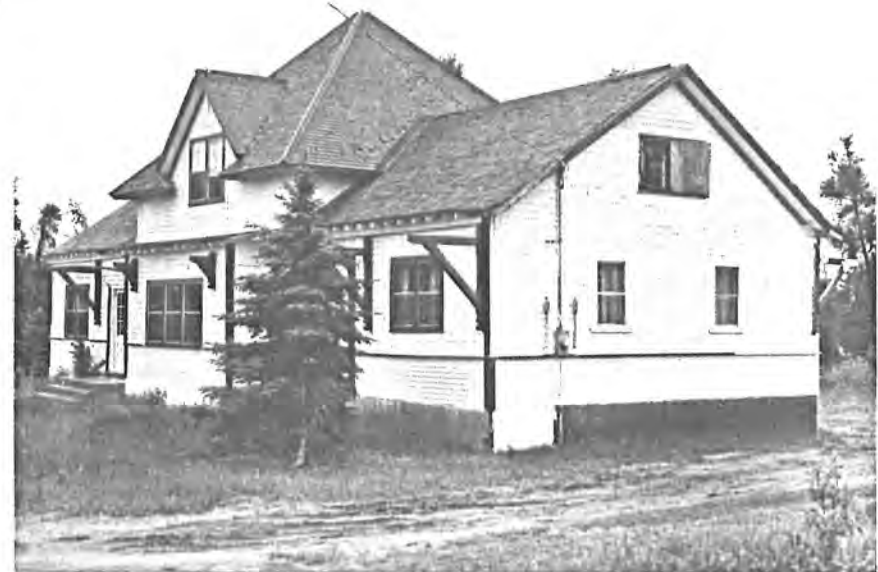
# VICTORIA BEACH

General Condition of Building: Fair

EXTERIOR: -the overhang has been cut off, and the brackets now support

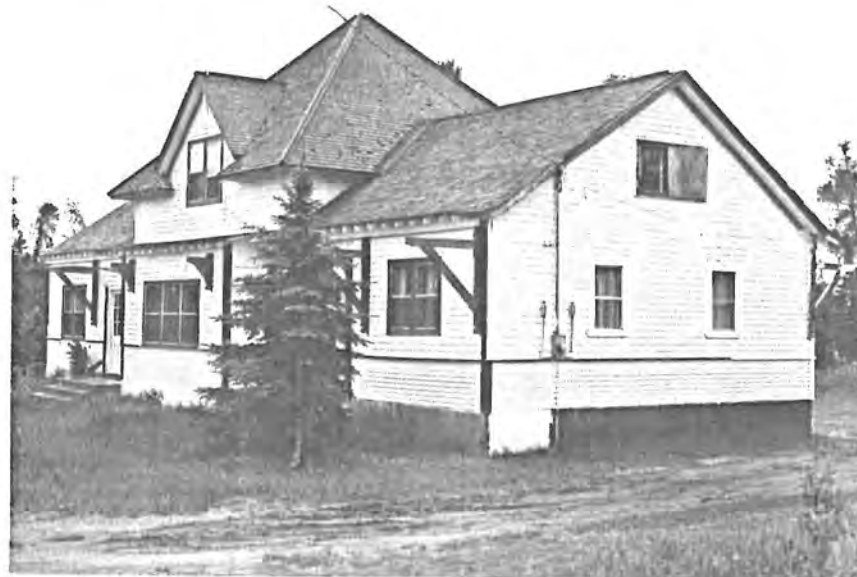
VICTORIA BEACH (cont'd)

- either loose boards or nothing
- many windows appear new,  
including patio door at one end

- double exterior door into the  
waiting room
- very small brackets in top  
points of dormers

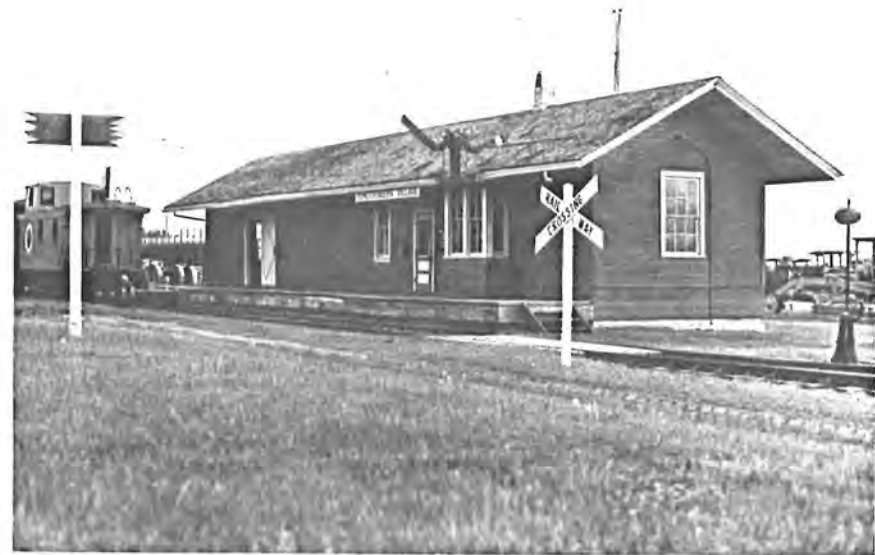
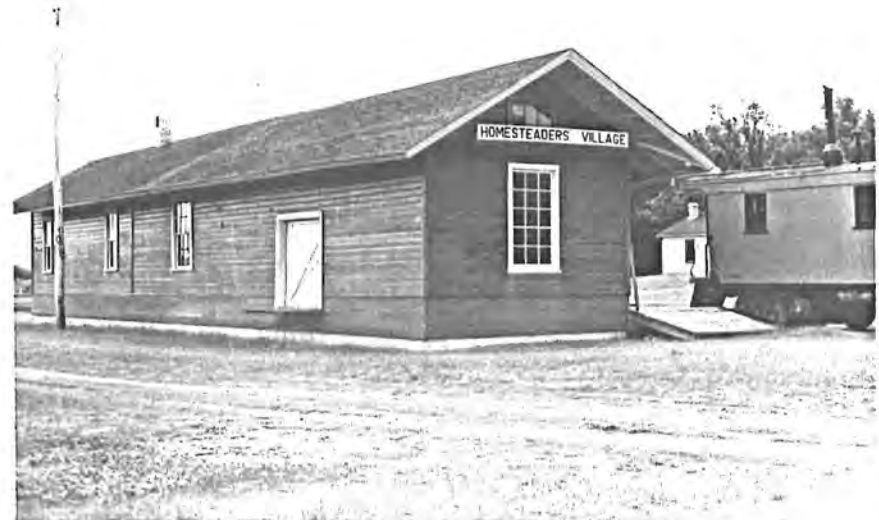
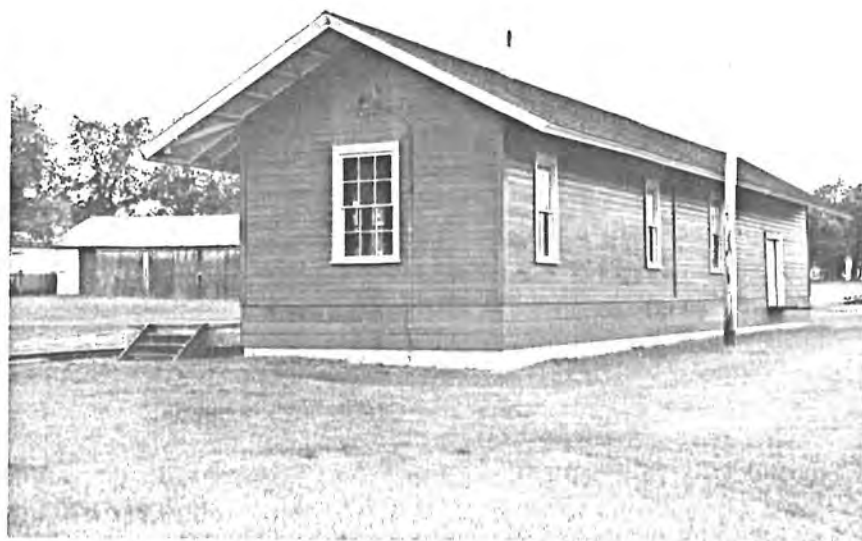
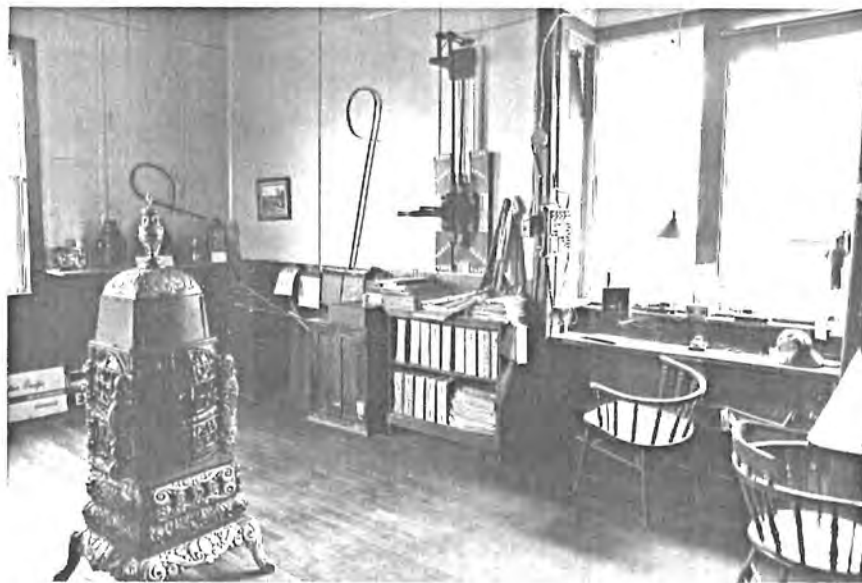
BALDUR (cont'd)

-Museum contains: ticket book of Dominion City station, from May of 1951-December of 1955; various railway notices; office desk and telegraph equipment;

flag equipment and mechanism;  
various CNR lanterns; various  
record books; woodwork; (stove  
in photograph is not a station  
stove)

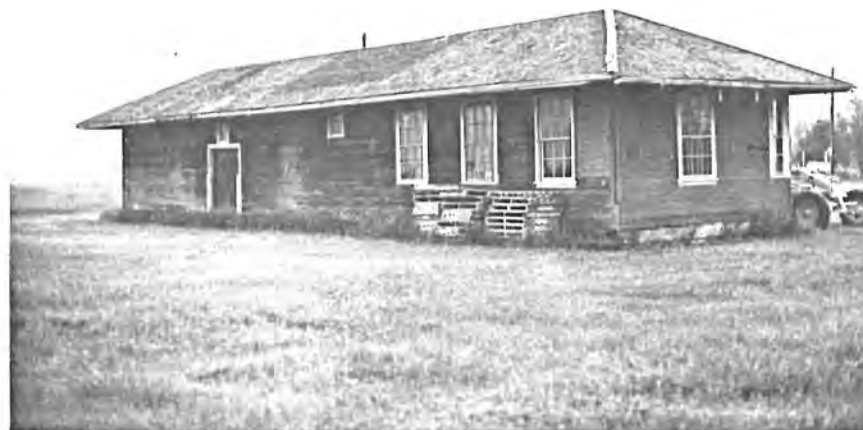
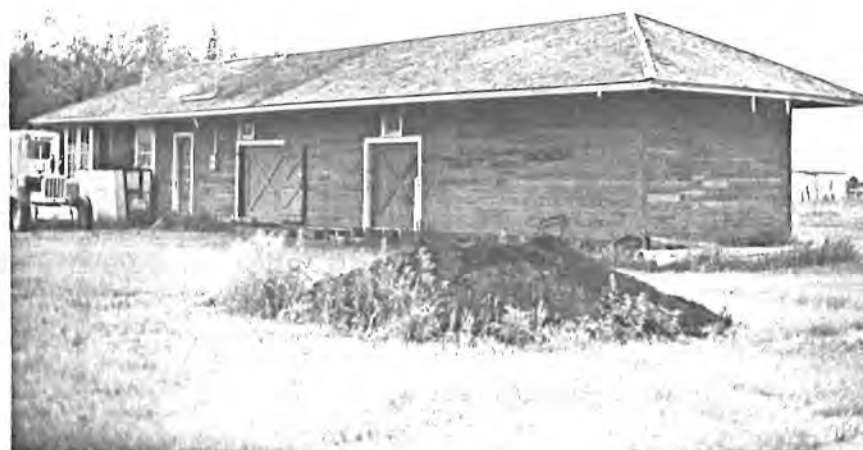
# HARTNEY

General Condition of Building: Good

- GENERAL: -though a "special" station design, NP special, 100-26 is comparable with other stations designated "4th class"
- compare with Baldur, which has had an addition, probably to the office
- EXTERIOR: -appears to be little changed
- INTERIOR: -wood flooring
- other details unavailable as building closed at time of visit

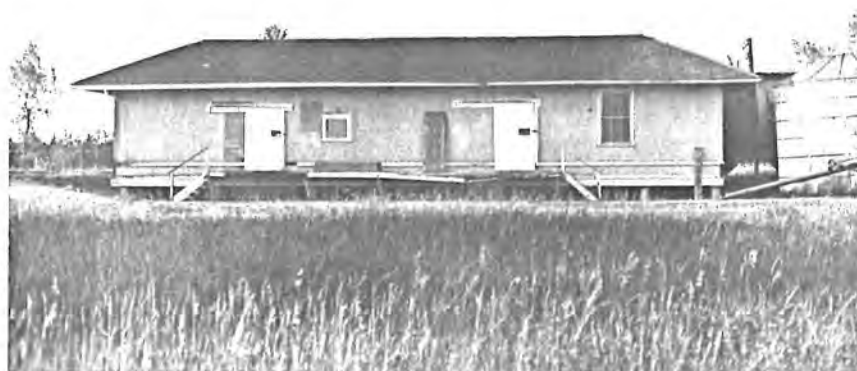
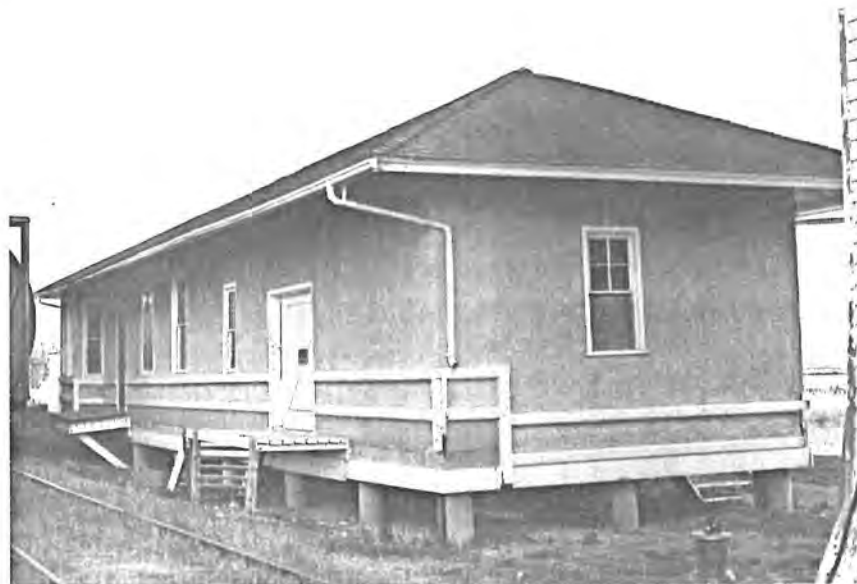
# BEAVER

General Condition of Building: Fair

-large freight doors at rear may be recent additions

INTERIOR: -details unavailable
