# RAILWAY STATIONS OF MANITOBA: A BUILDING INVENTORY

Patricia Trainor  
Farhad Rahbary  
David Butterfield

1987

This report on Manitoba's railway buildings is divided into two sections. The first provides a brief historic background of rail line and specific station design developments in the province. The second, comprehensive, section is a catalogue of extant railway buildings in Manitoba. The first section is organized according to station types, while the information in the second part is grouped according to ownership. For easier reference, this second section will also be subdivided according to specific station types. Photographs of the stations in the catalogue section are accompanied by basic data sheets. Information given for each station includes: date built; past and present locations; present owner and use, as well as facts relative to renovations and noteworthy features.

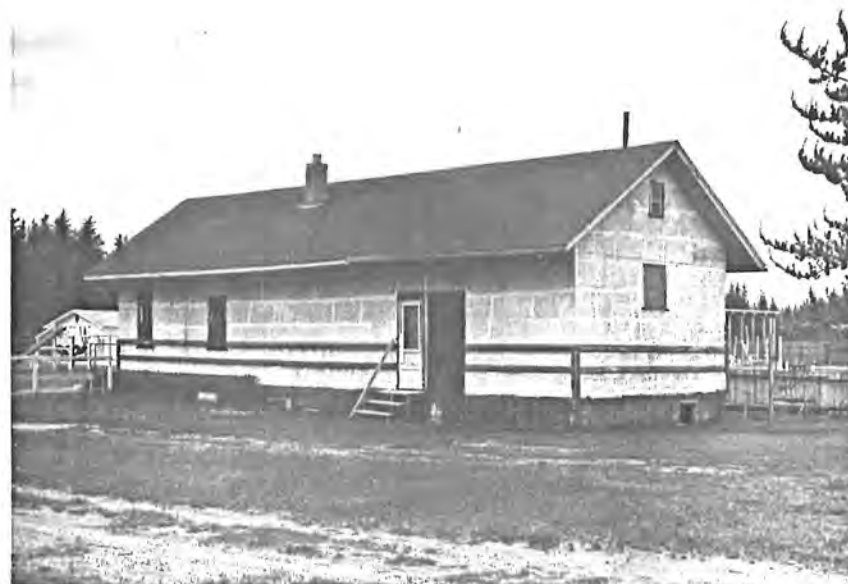
# VASSAR

General Condition of Building: Fair

EXTERIOR: -many doors and windows have been relocated, removed, or replaced (the windows in front are now smaller, and all in a row, in the common fashion of community clubs facing a hockey rink)

-the freight and baggage shed used

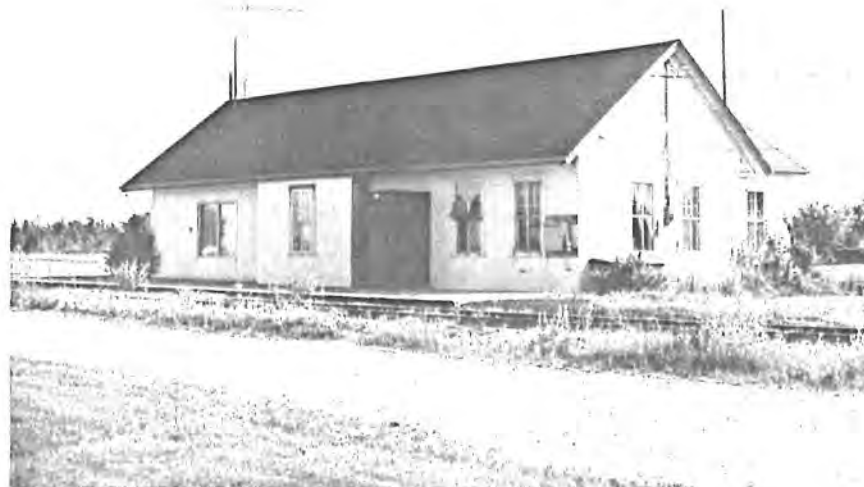
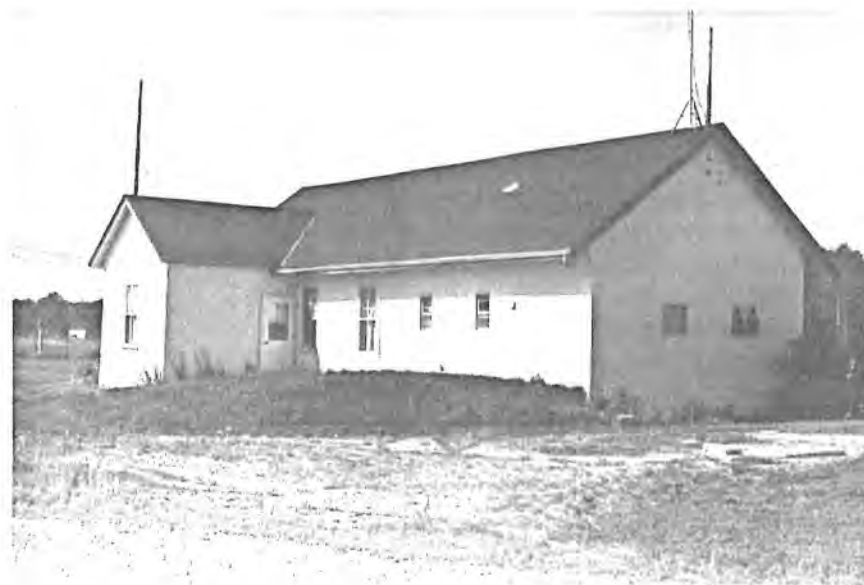
## STEEP ROCK

General Condition of Building: Good

EXTERIOR: -freight shed door has been  
replaced by a window  
-many new windows  
-relatively new asphalt shingles

-this station has no large  
rear addition and no side shed  
addition

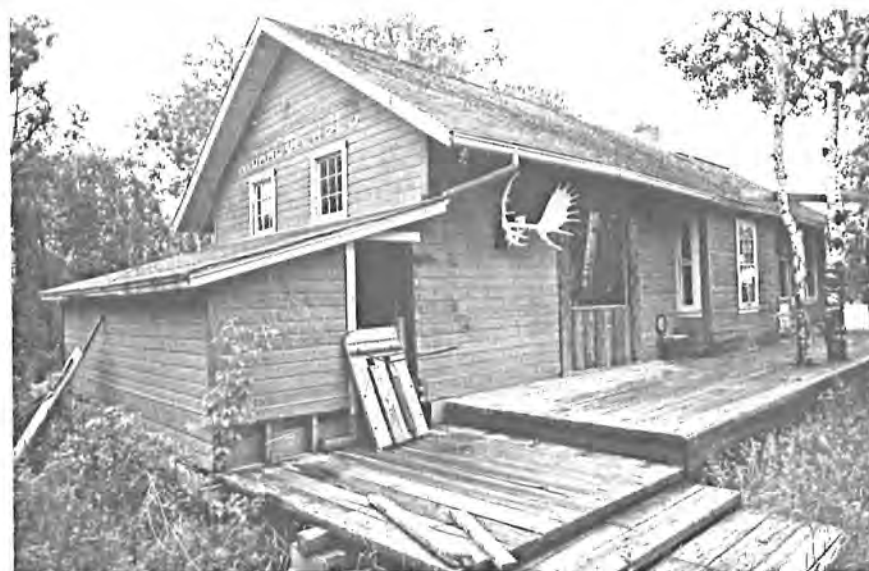
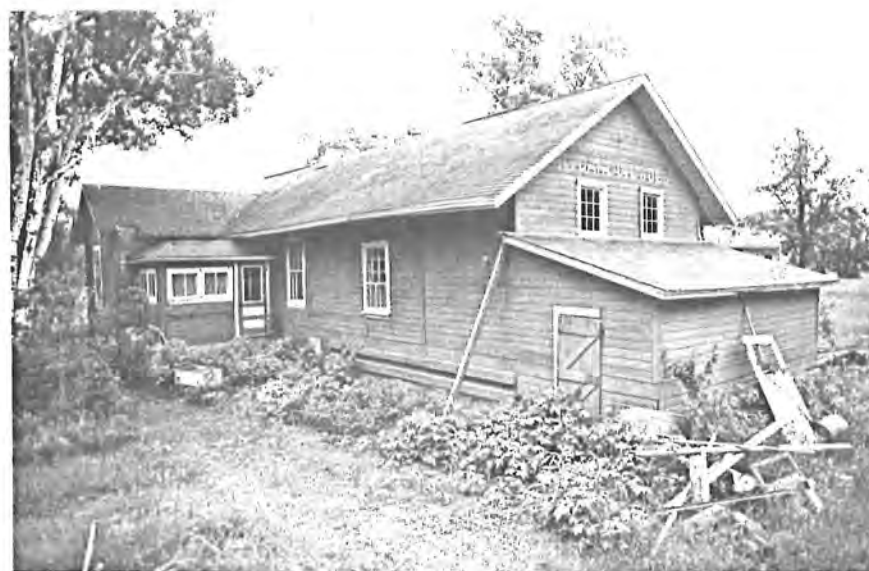
# NOTRE DAME

General Condition of Building: Good

EXTERIOR: -freight shed doors have been replaced by windows

INTERIOR: -the former freight shed is now a ski rental and repair shop; former office is now the ski shop office; former waiting room is used for storage

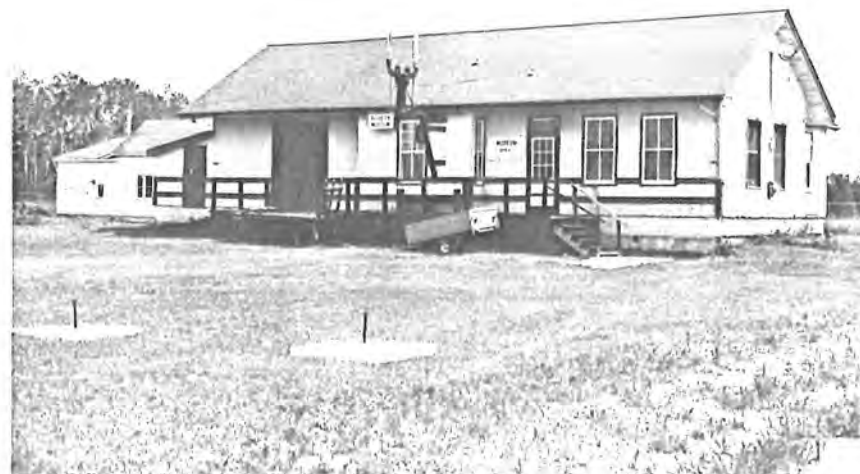
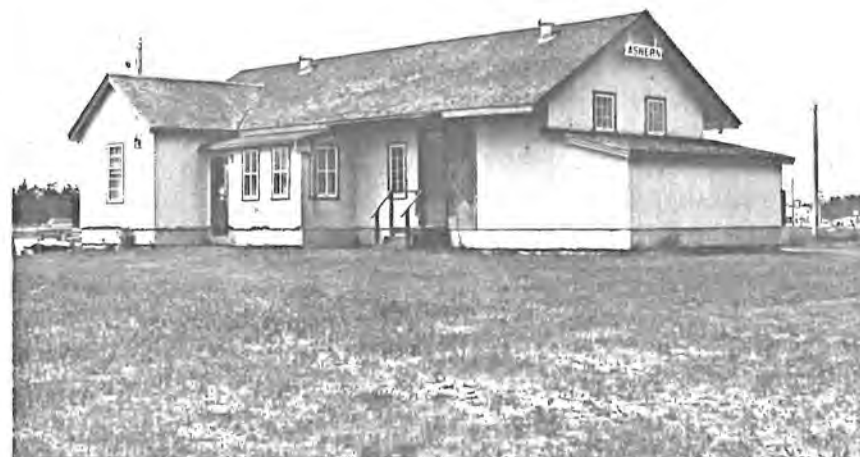
# ASHERN

General Condition of Building: Good

-in the office is the original  
Canadian Northern Railway safe  
from Ashern

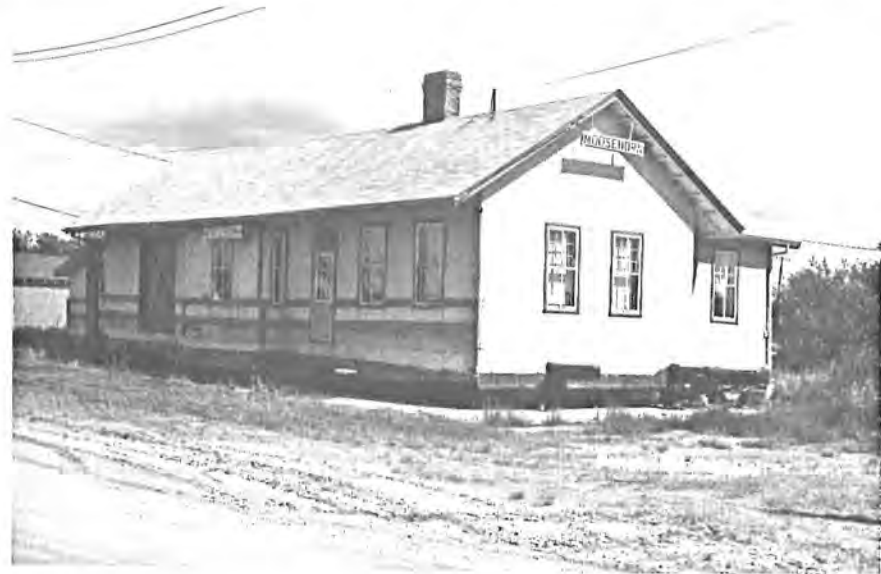
# MOOSEHORN

General Condition of Building: Poor

-when the building was moved from its original location, the insufficiently supported rear kitchen addition was quite damaged

EXTERIOR: -relatively new asphalt shingles  
-appears to be fundamentally unchanged

INTERIOR: -linoleum has been poorly laid over the wood floors in some rooms

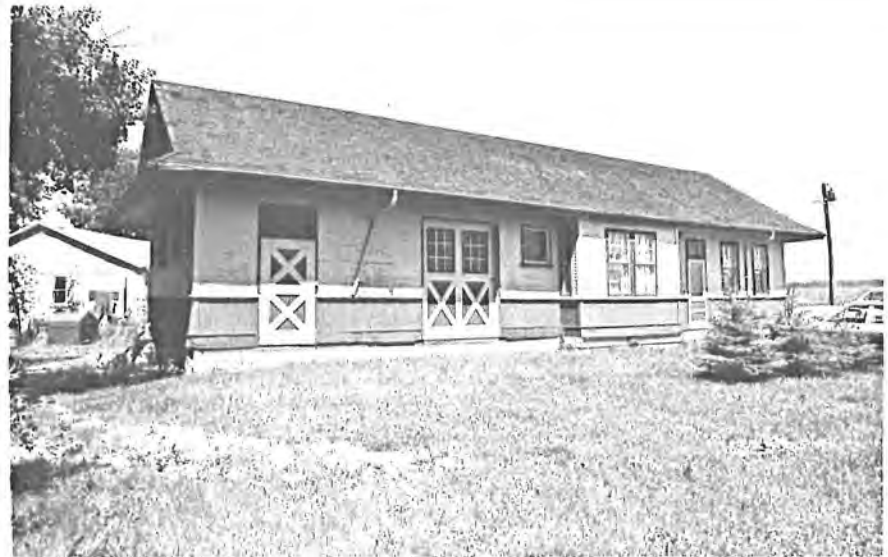
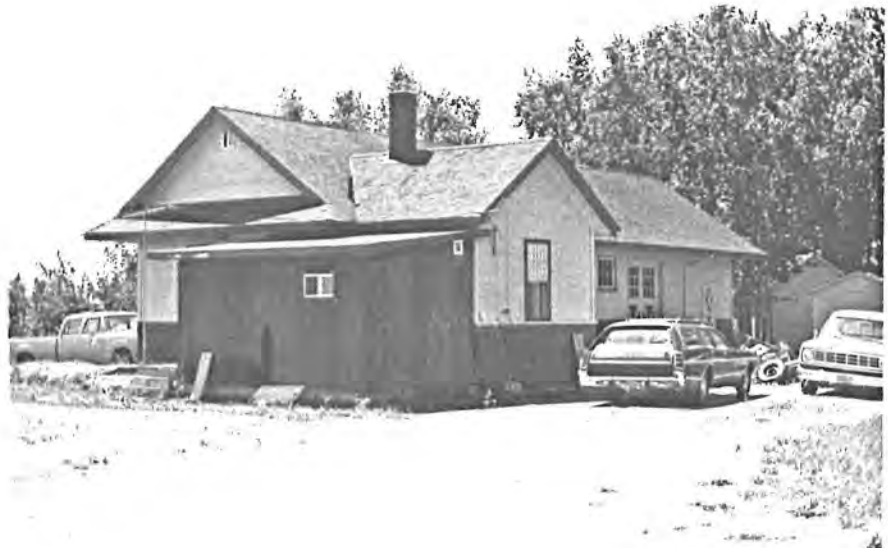
# BETHANY

General Condition of Building: Fair

-appears to be unchanged

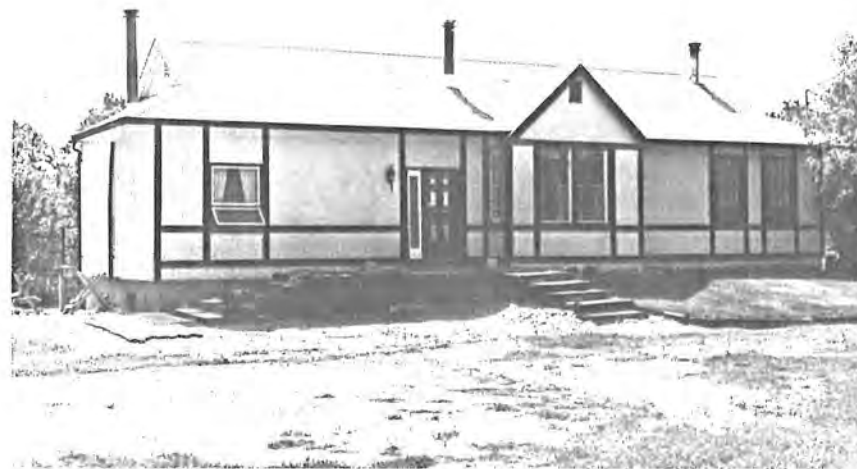
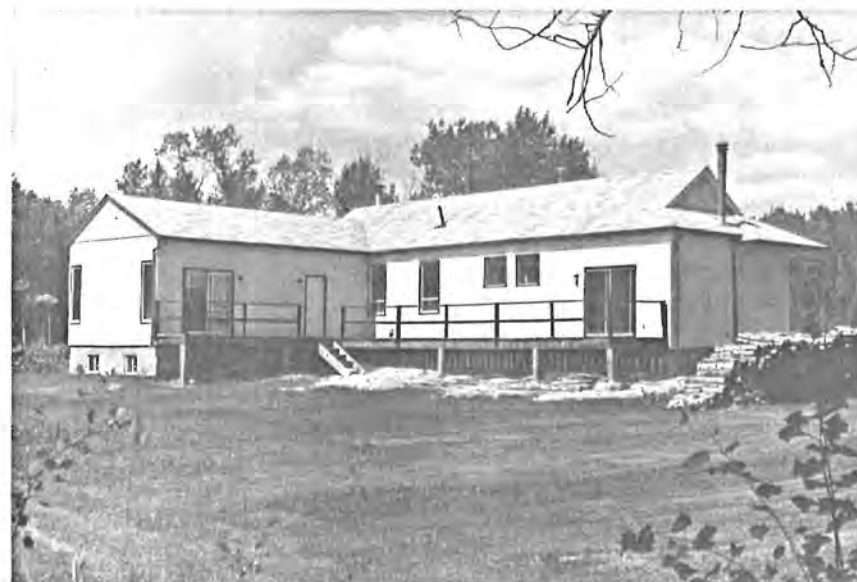
# GIROUX

General Condition of Building: Excellent

GENERAL: -this was the second station  
building at Giroux. The first,  
built in 1923, burned down in  
1945

EXTERIOR: -substantially changed  
-has been re-roofed  
-new siding (stucco)  
-new windows  
-rear addition may be new

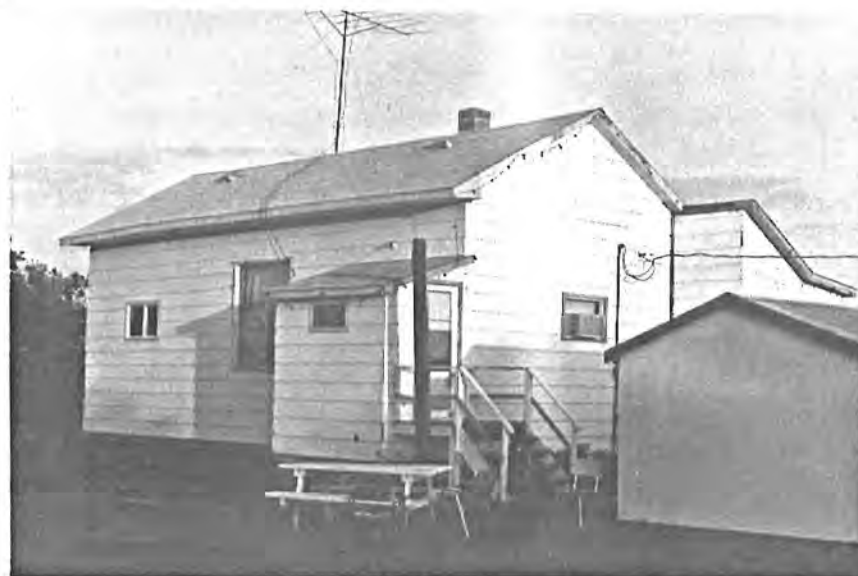
# UNO

General Condition of Building: Good, but  
masked

- GENERAL:
- the station building was moved to this location in 1968
  - the station was a very small, one-storey station, but not as small as an average portable station
  - the original station is only a part of the present structure, and is so heavily modified as to be almost unrecognizable

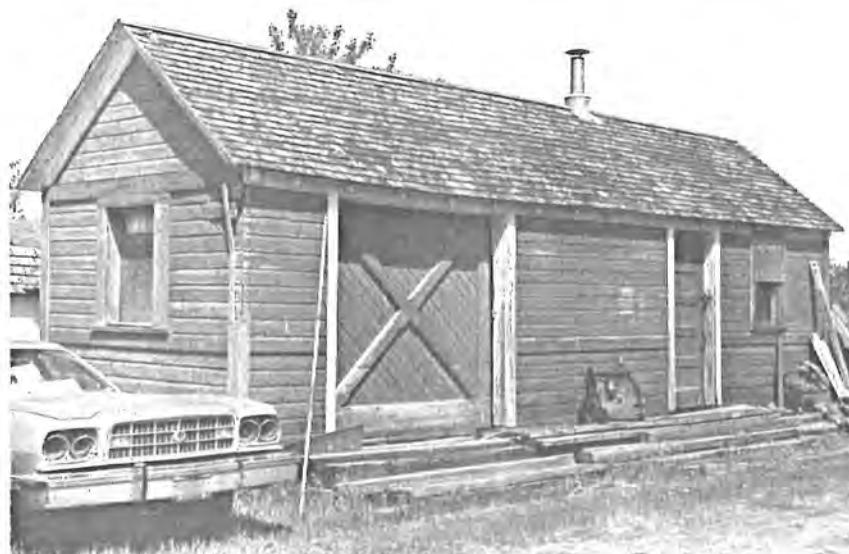
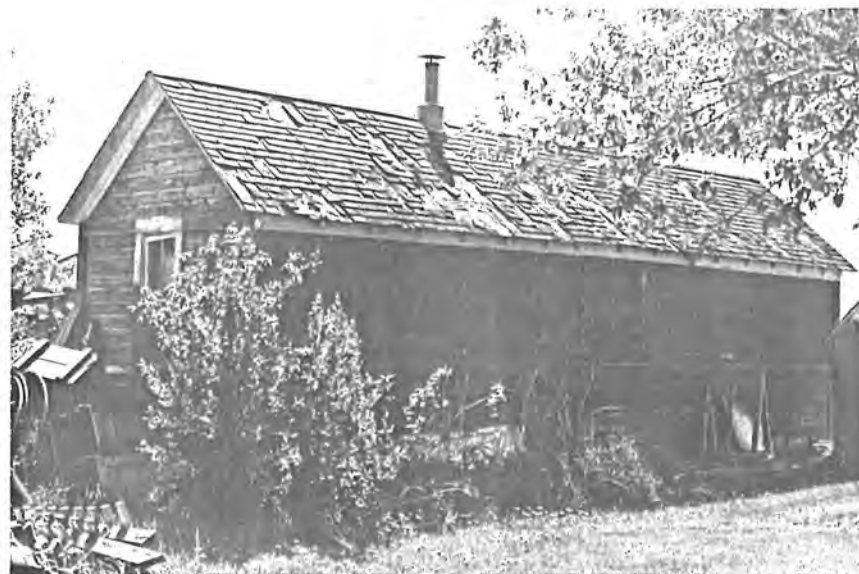
# TOLSTOI

General Condition of Building: Poor

- GENERAL:
- this station is an example of one of Canadian Northern's standard portable designs
  - compare with Menisino and other portables, both CNR and CPR

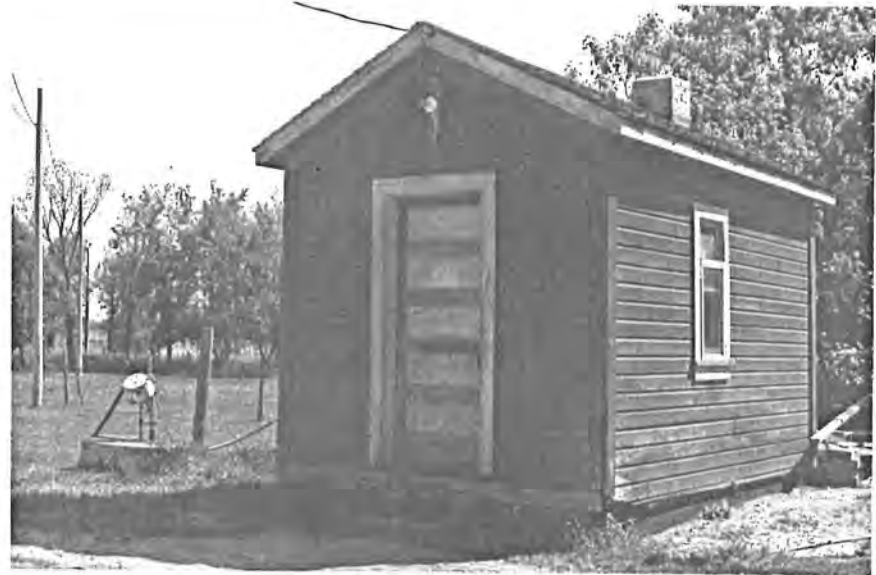
# OVERSTONEVILLE

General Condition of Building: Fair

- GENERAL:
- this station is an example of one of the smallest Canadian Northern standard portable station designs
  - compare with other CNR portables, and also with CPR portables

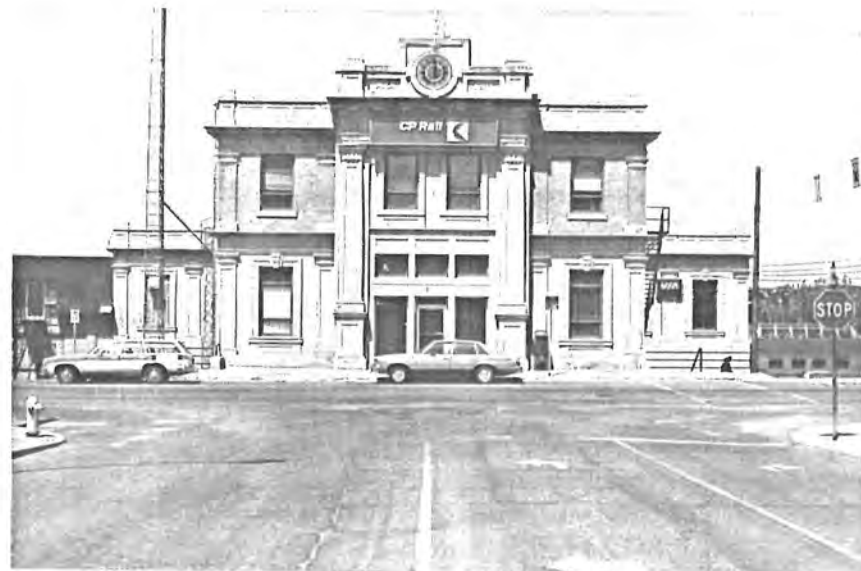
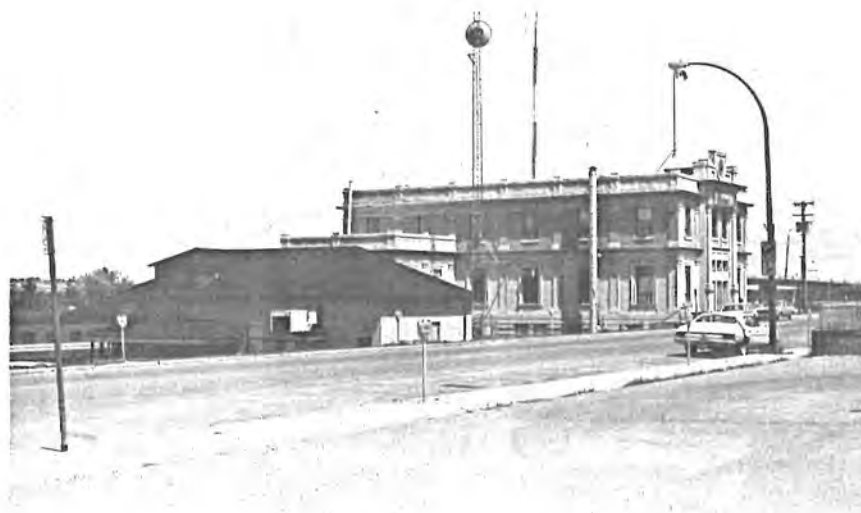
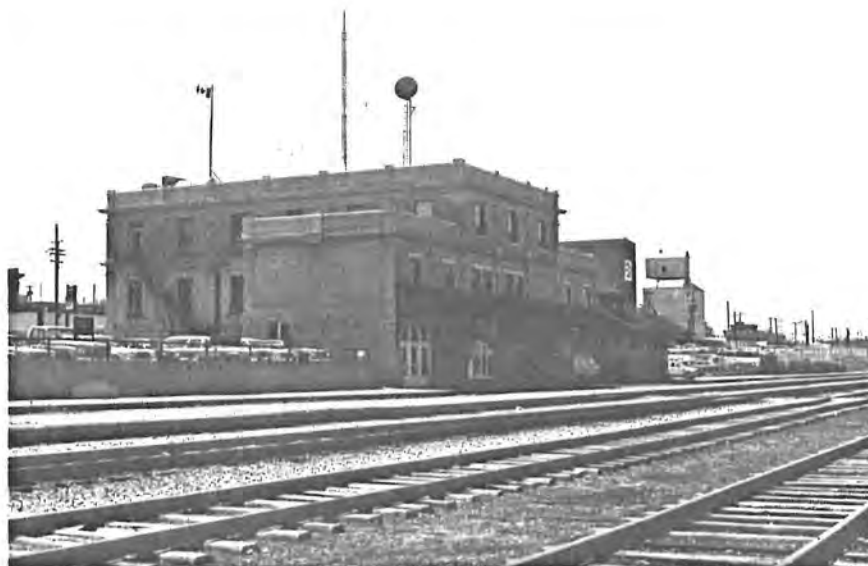
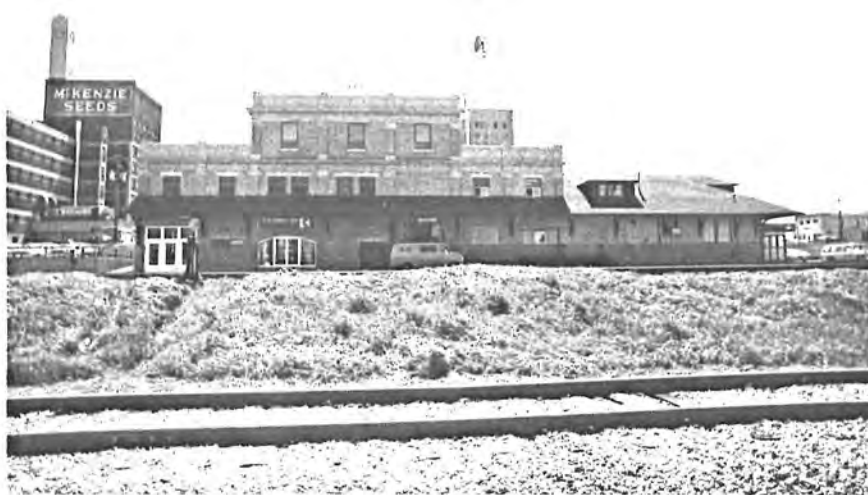
# BRANDON

General Condition of Building: Very Good

- brick and stone construction
- see photos

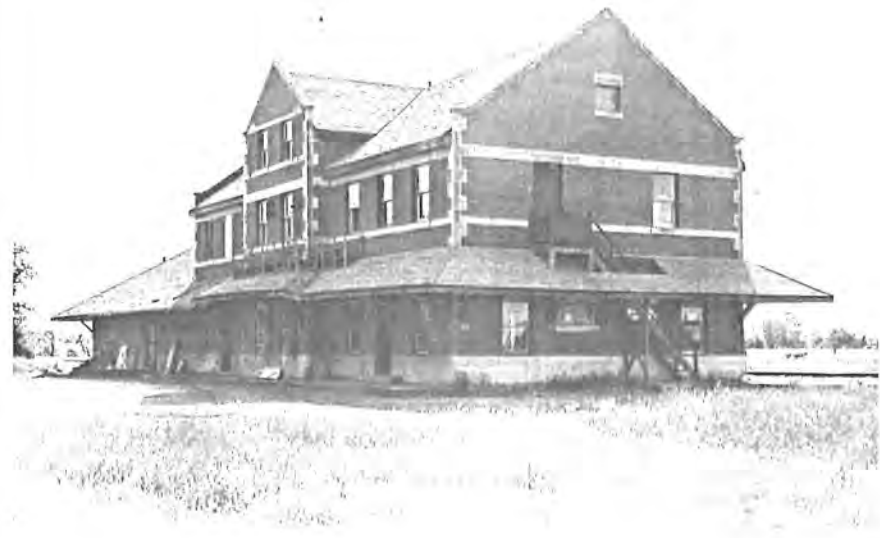
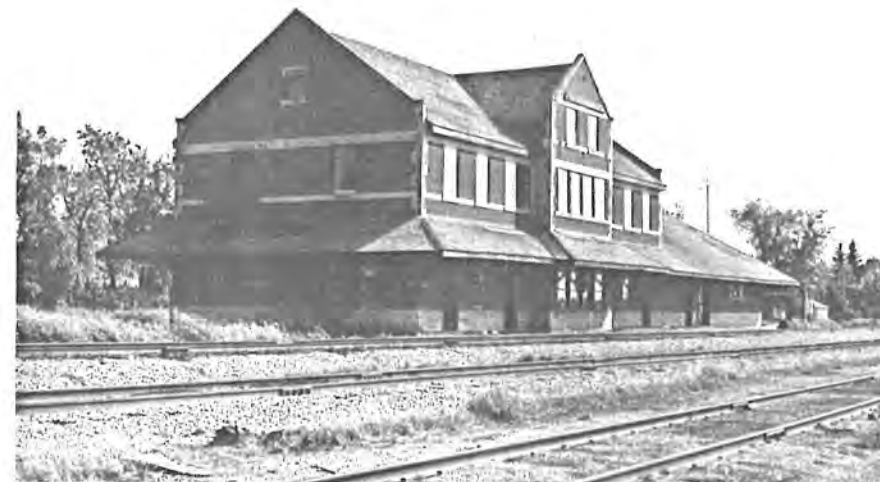
# SOURIS

General Condition of Building: Structure- Good  
Mainten.- Poor

EXTERIOR: -most track-side windows are broken and/or boarded up

INTERIOR: -according to CP records, the upper floor was renovated in 1953

-wall partitions in the main part of the station have been torn

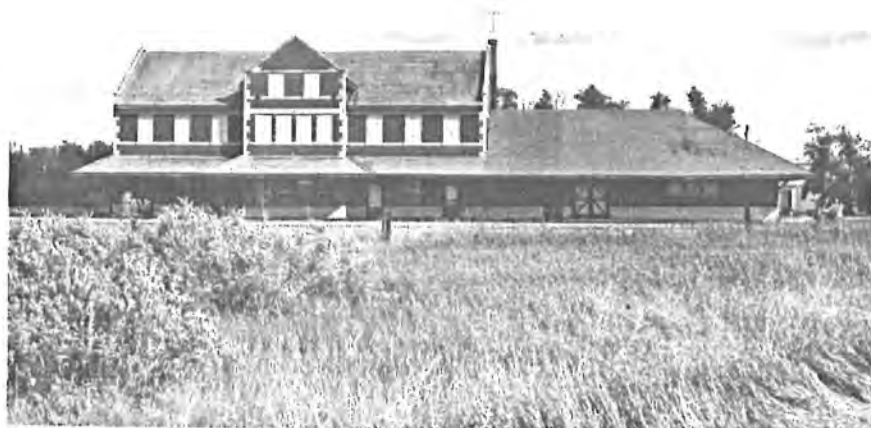
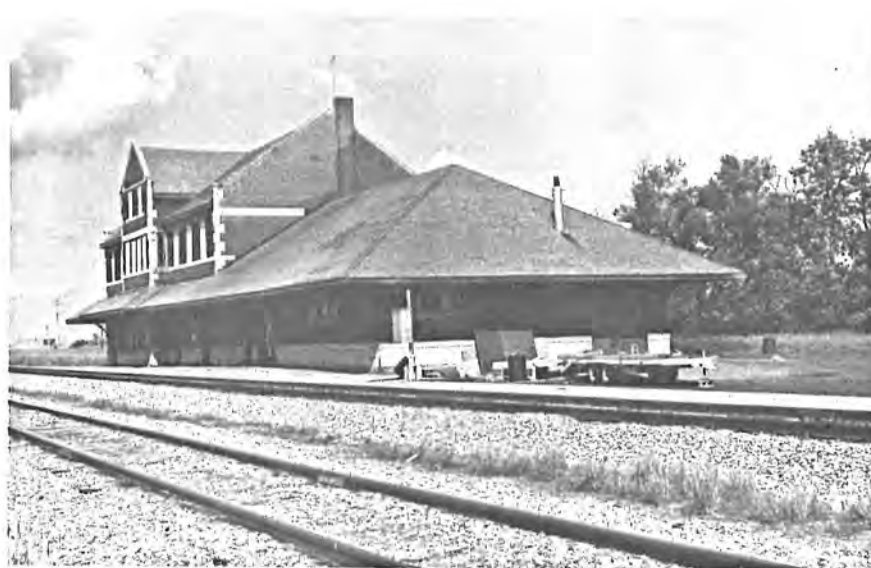
- brick construction
- flat-arched window openings
- parapets on gable ends
- two interior wooden benches: built in a circular form around two main support columns. One remains

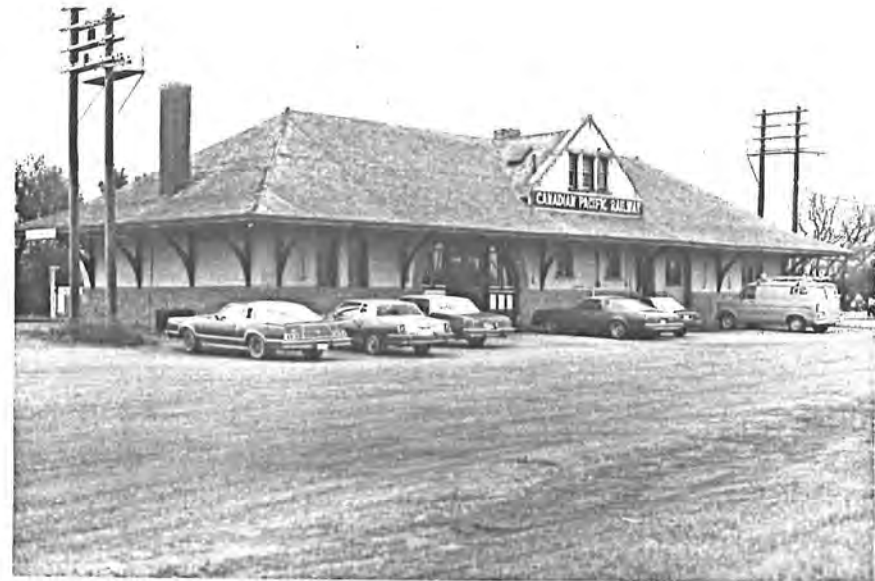
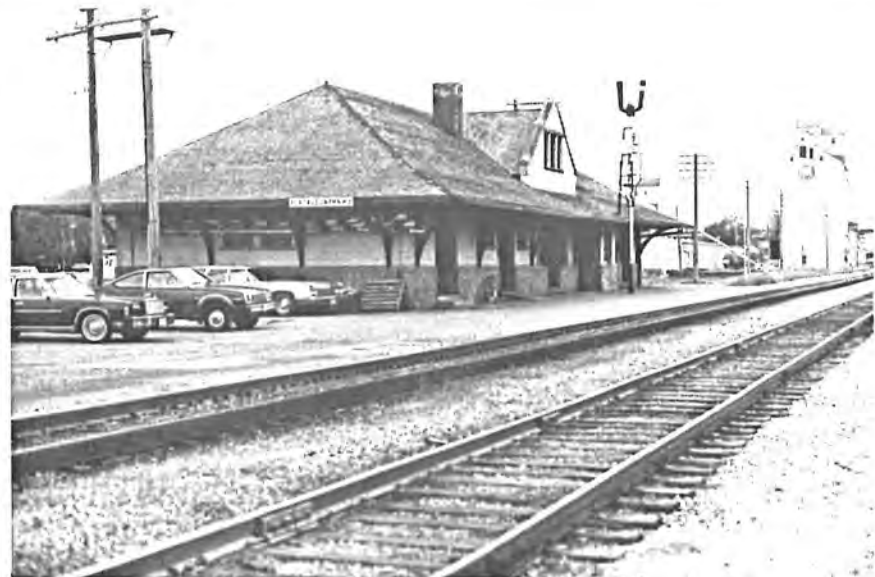
EXTERIOR: -two town-side freight shed doors  
have been boarded up and  
replaced by small windows

- brick construction
- track and town-side brick  
entryway arches

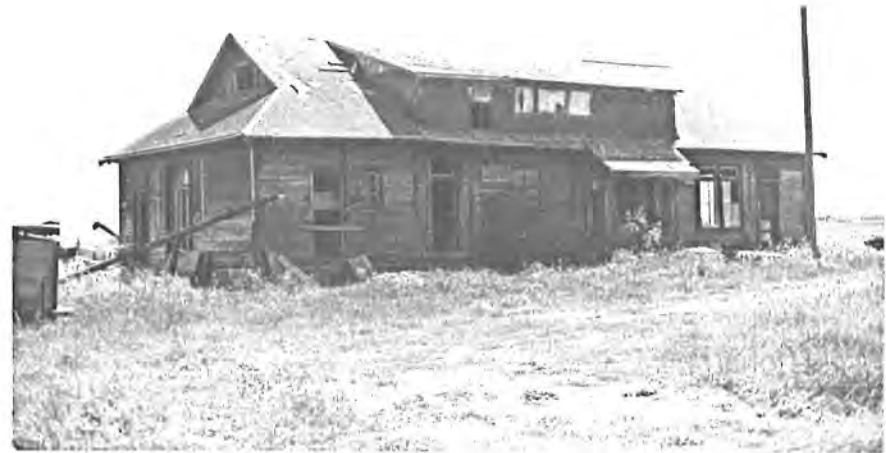
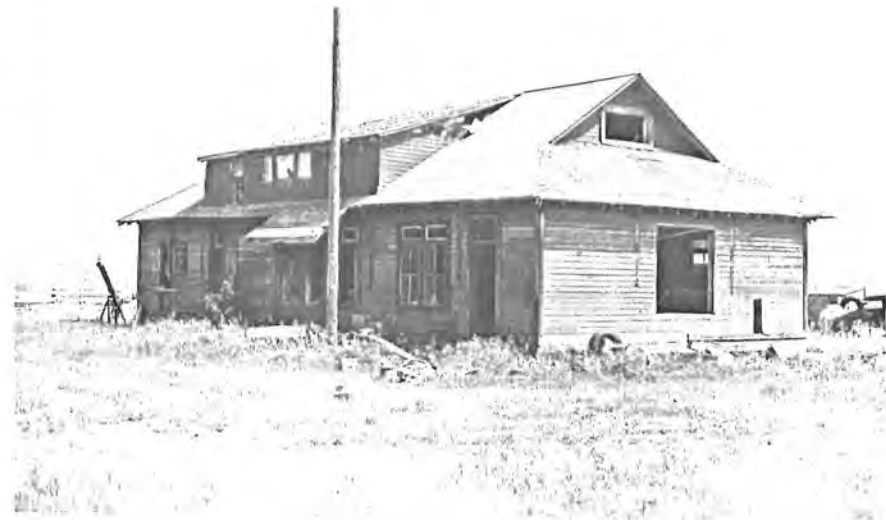
General Condition of Building: Very Poor

GENERAL: -Norman Walls' father, Bill, moved the station, and because of its size, found it necessary to cut it in half to move it. The upper floor was somewhat destroyed in the process. In putting it back together, a shed-dormer-type upper roof was improvised. It had formerly been either pyramidal or quite hipped

EXTERIOR: -windows and doors are mostly missing

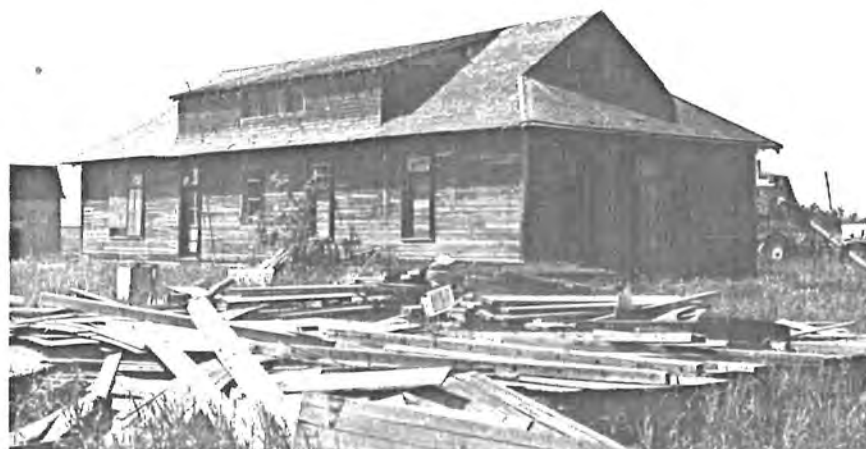
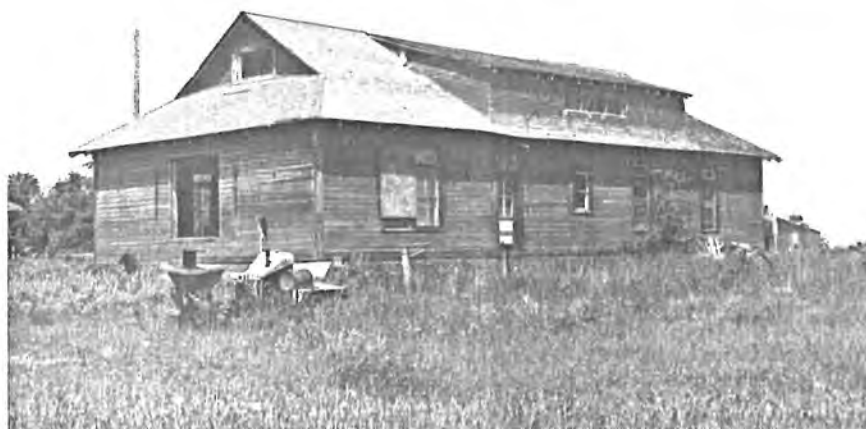
KILLARNEY (cont'd)

-brackets are missing

INTERIOR: -the interior walls are all  
half torn down and the building  
is quite deteriorated

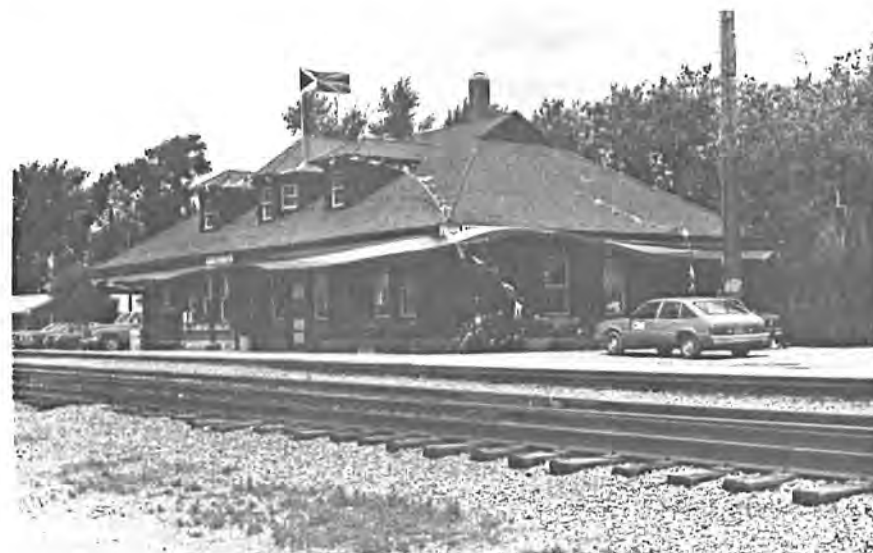
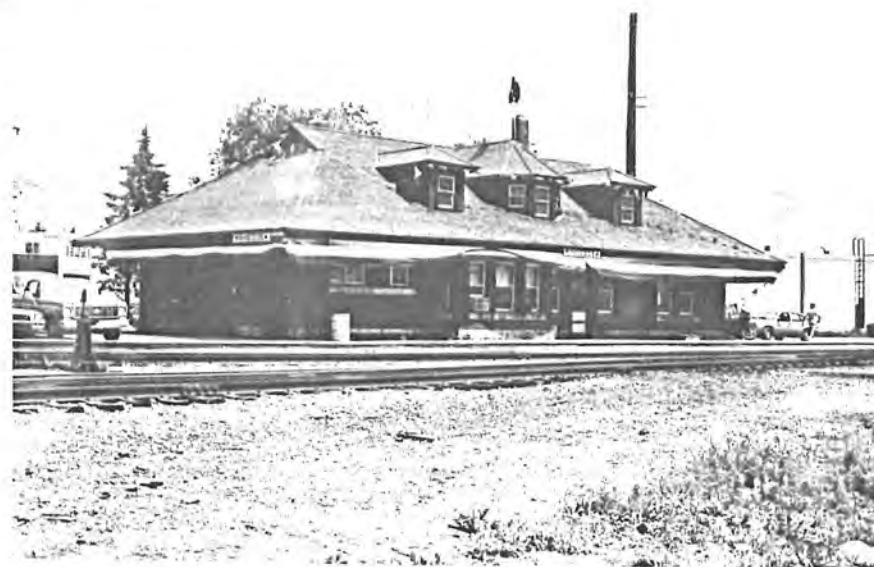
- unusual dormer: middle front
- brackets smaller than usual
- large old freight scale still in locker room (former freight shed)

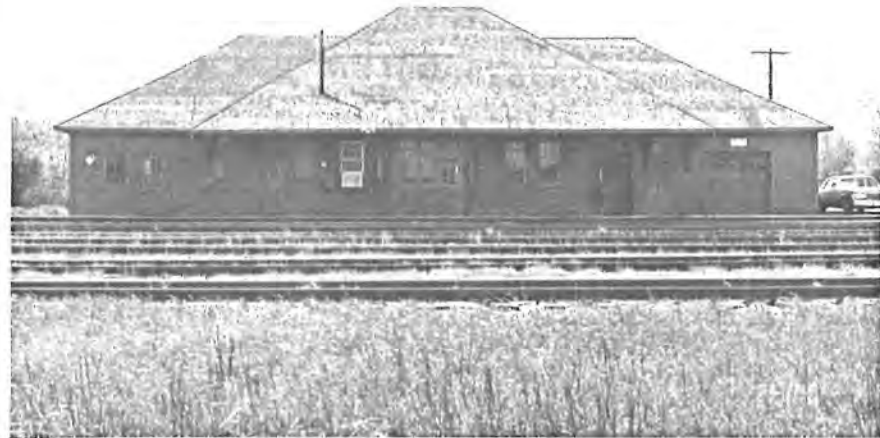
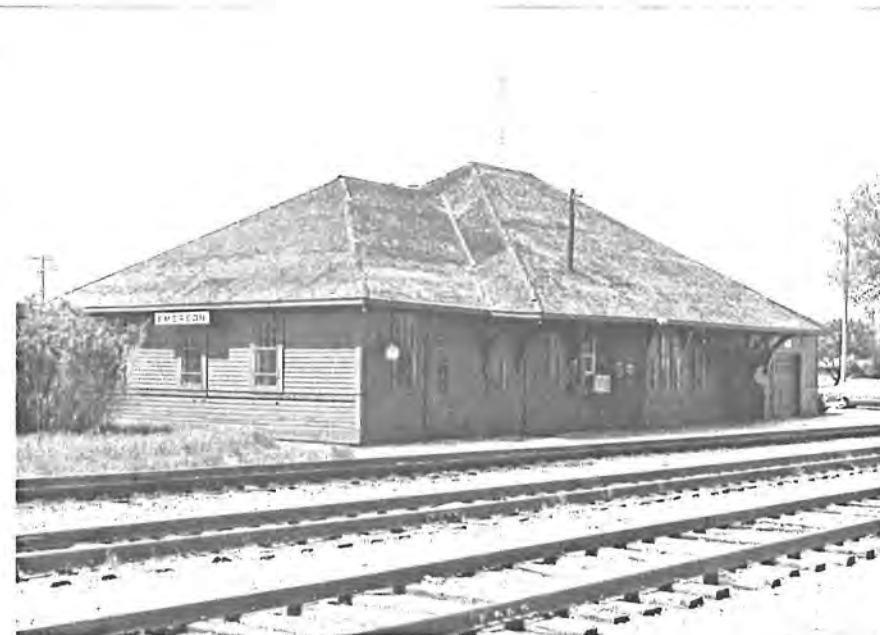
INTERIOR: -most of the building (including former customs area) is unused and in serious disrepair

-used portion has been modernized to allow for compact office and computer/communications areas

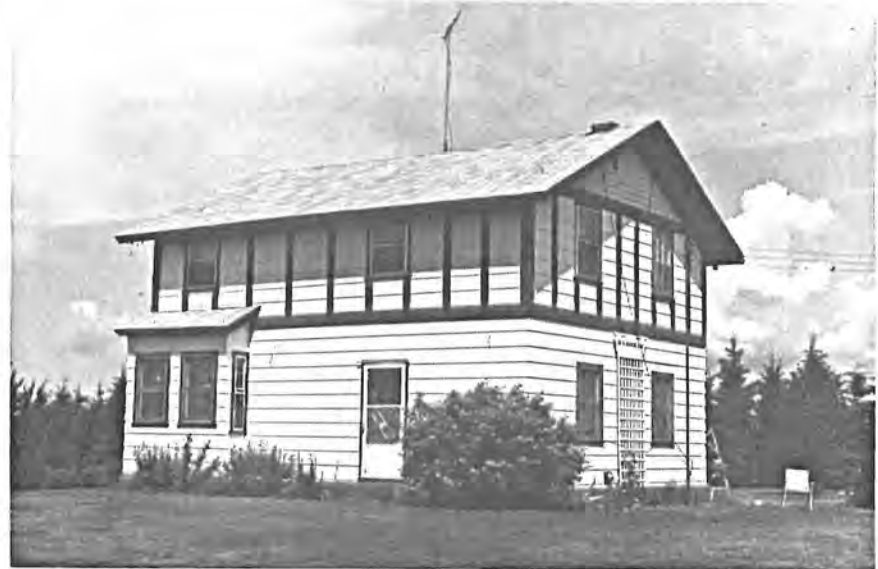
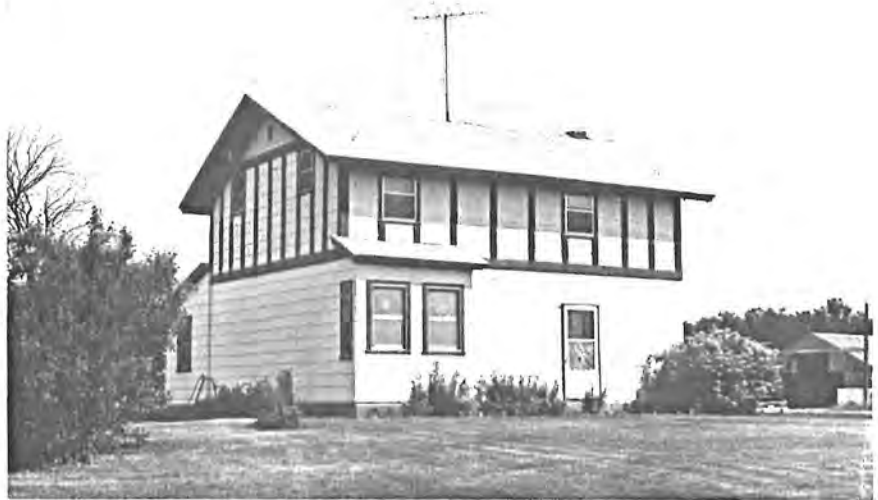
EXTERIOR: -freight shed has been removed  
-siding is new  
-some windows are new

INTERIOR: -has now been extensively  
renovated, after being almost  
gutted by fire about 1980  
-present wood floor is one of the  
originals. It was hardly damaged  
in the fire because over the  
years, six layers of flooring  
had been put down, and the fire  
did not reach it

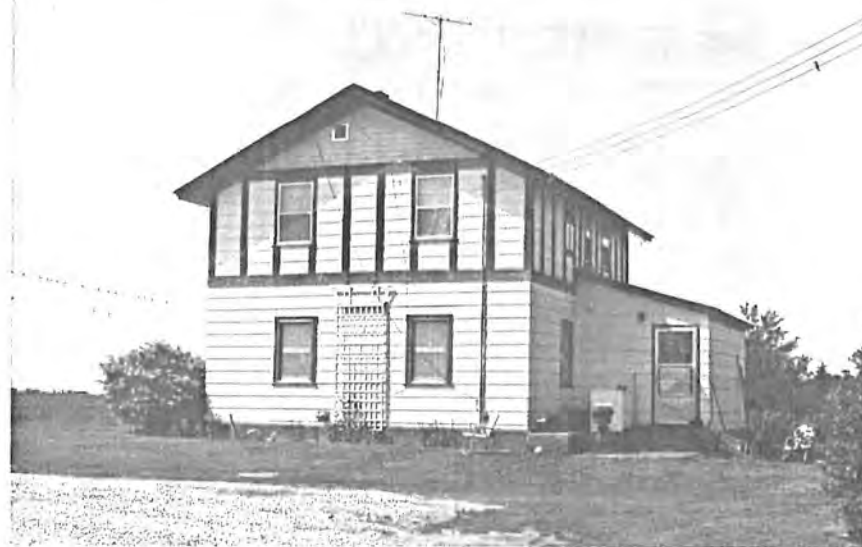
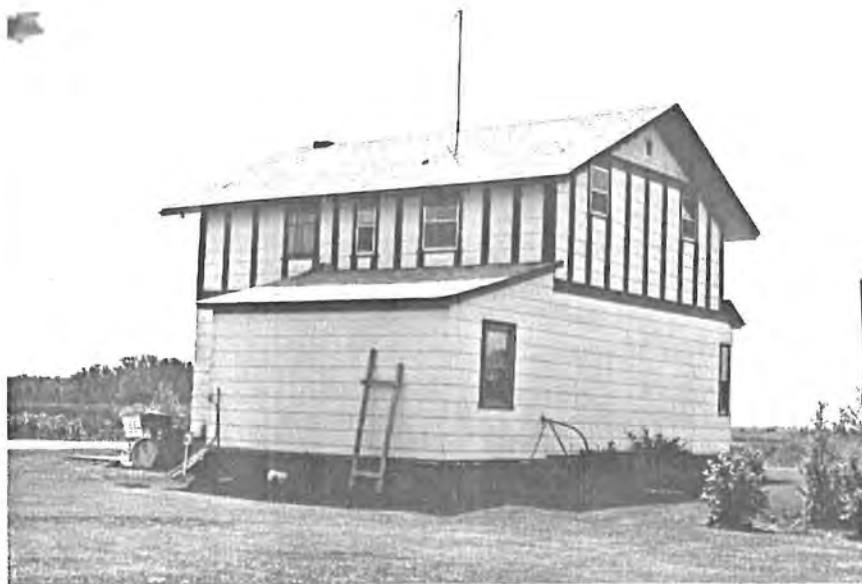
-there were originally either fascia or bargeboards that were "fancy" (Mrs. Warburton was unclear) but they were apparently too delicate to clean, and so were covered

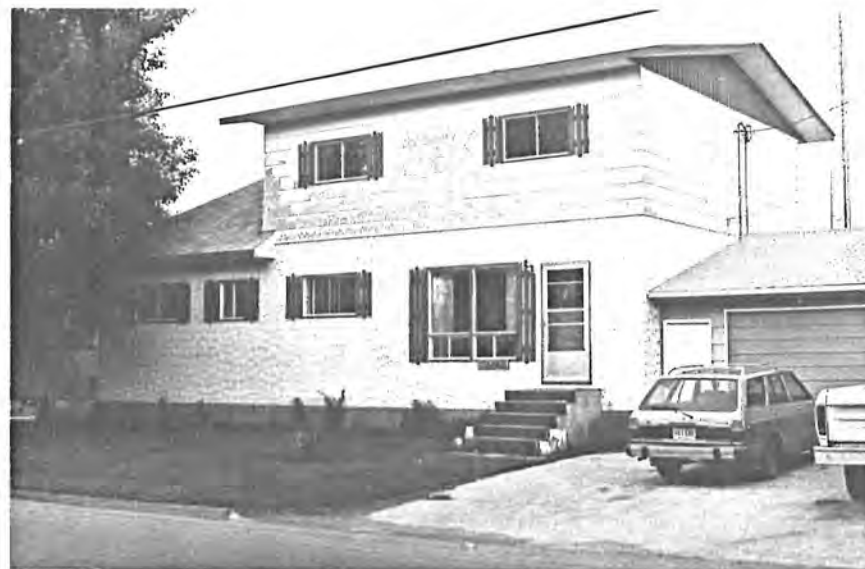
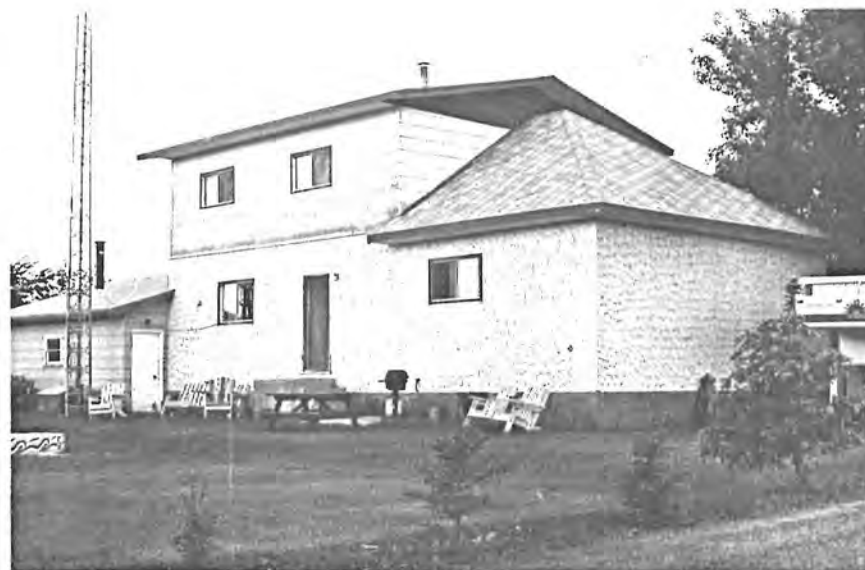
GENERAL: -this building has had two other owners before Mr. King, and after CPR. The first, Mr. Harvey Jones of McGregor, stripped the original building down to the studs and rebuilt from there, thus the present building bears little resemblance to the original

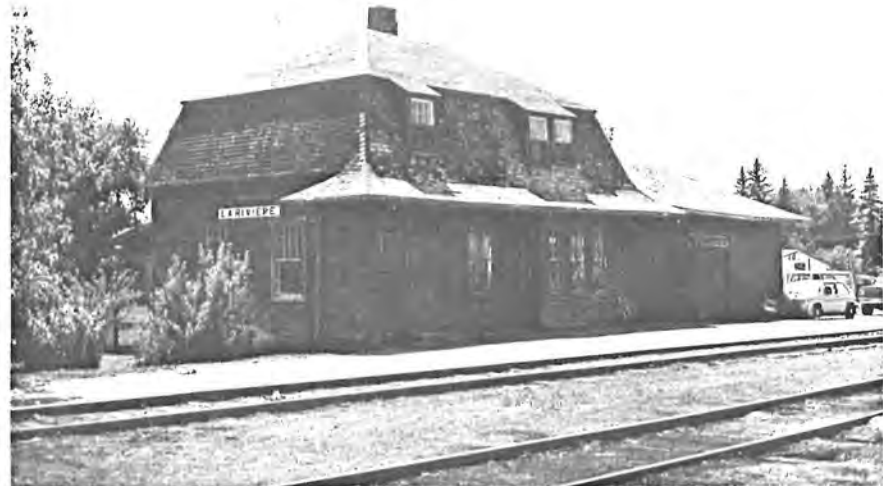
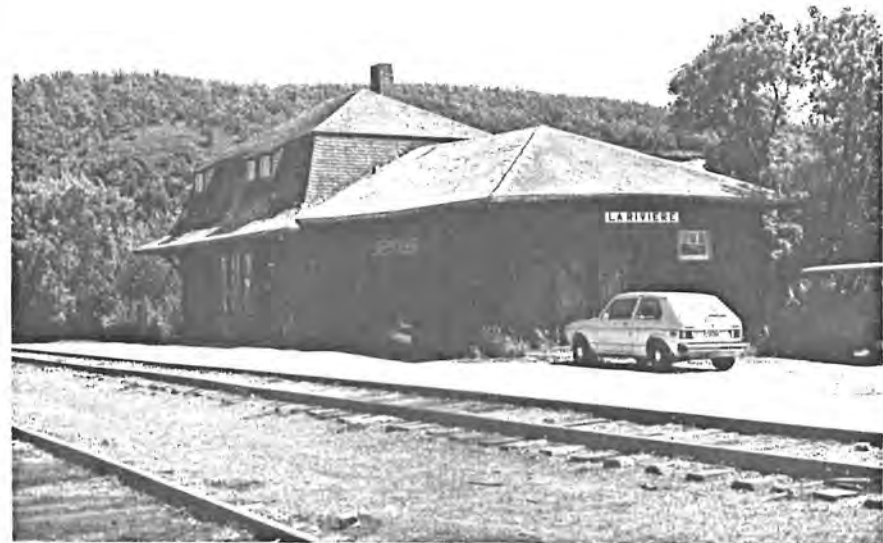
-roof form is unique

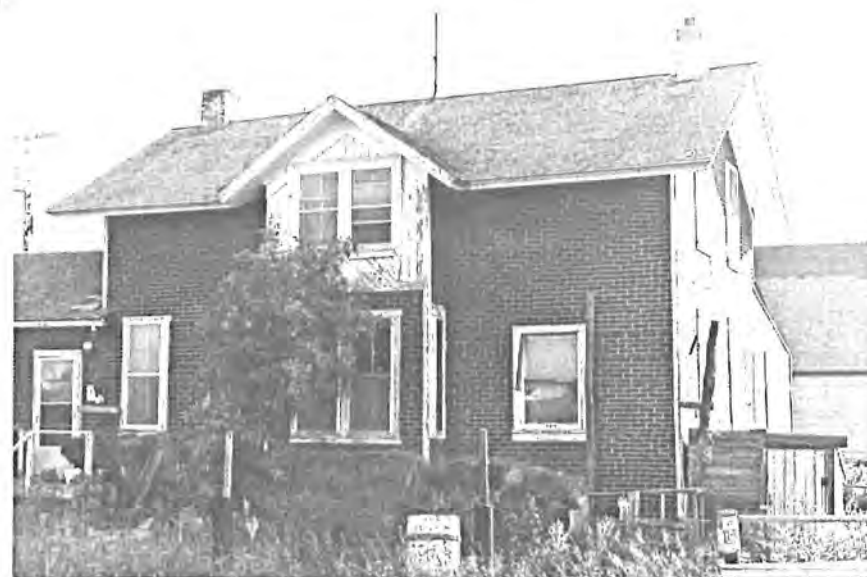
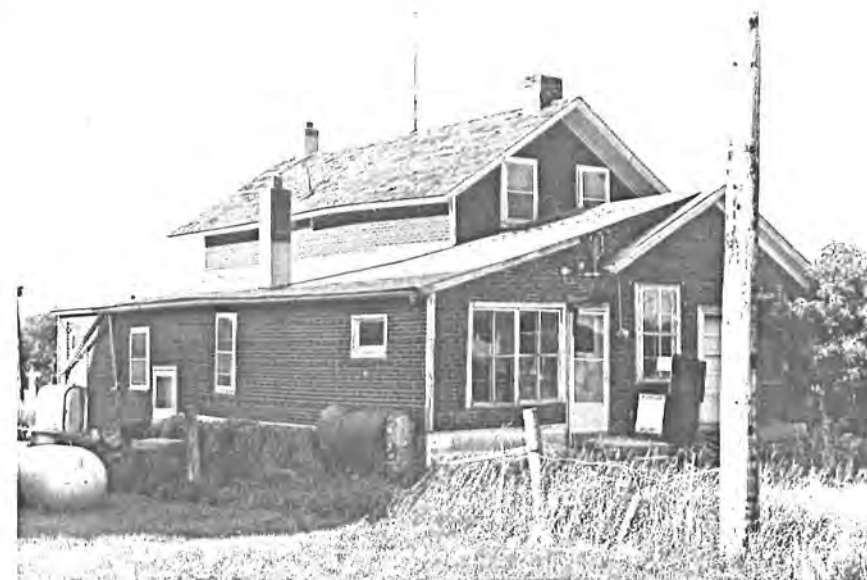
-bay "window" extends to second storey

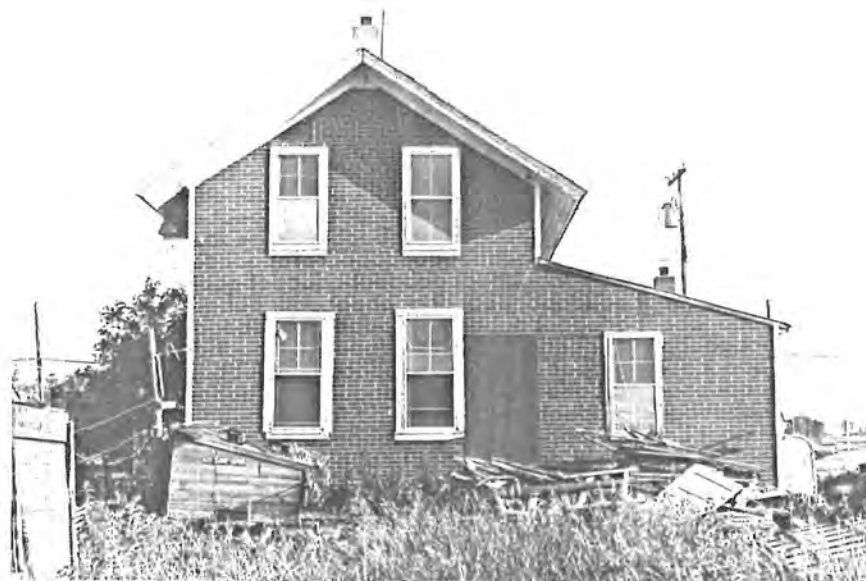
WESTBOURNE (cont'd)

-diagonal wood siding under  
second storey dormer windows
