# RAILWAY STATIONS OF MANITOBA: A BUILDING INVENTORY

Patricia Trainor  
Farhad Rahbary  
David Butterfield

1987

This report on Manitoba's railway buildings is divided into two sections. The first provides a brief historic background of rail line and specific station design developments in the province. The second, comprehensive, section is a catalogue of extant railway buildings in Manitoba. The first section is organized according to station types, while the information in the second part is grouped according to ownership. For easier reference, this second section will also be subdivided according to specific station types. Photographs of the stations in the catalogue section are accompanied by basic data sheets. Information given for each station includes: date built; past and present locations; present owner and use, as well as facts relative to renovations and noteworthy features.

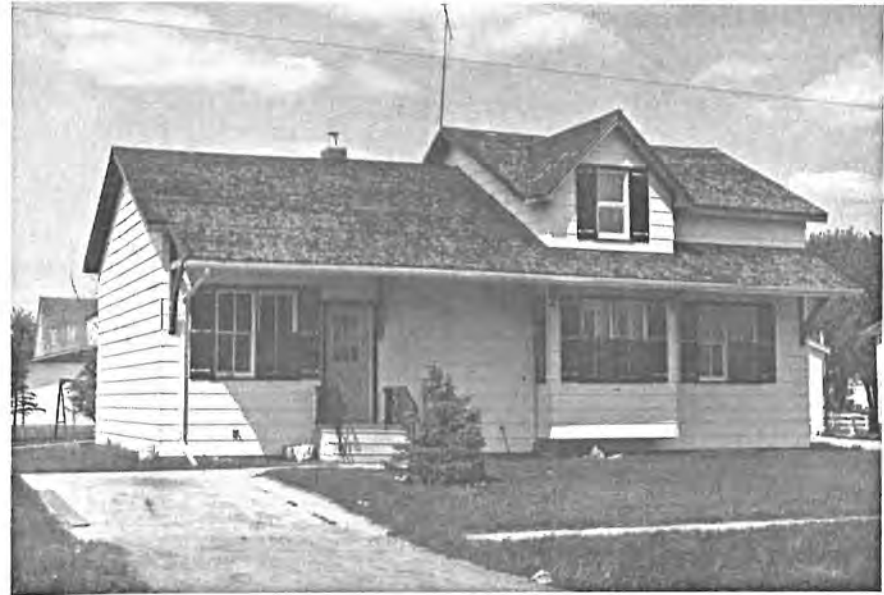
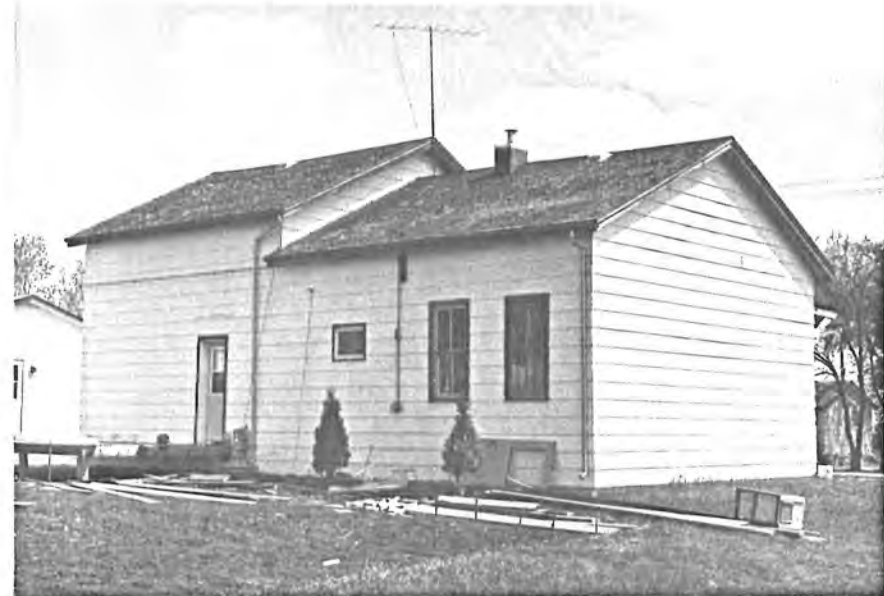
EXTERIOR: -new clapboard siding  
-new decorative false shutters  
-new back deck presently being  
added (1983)

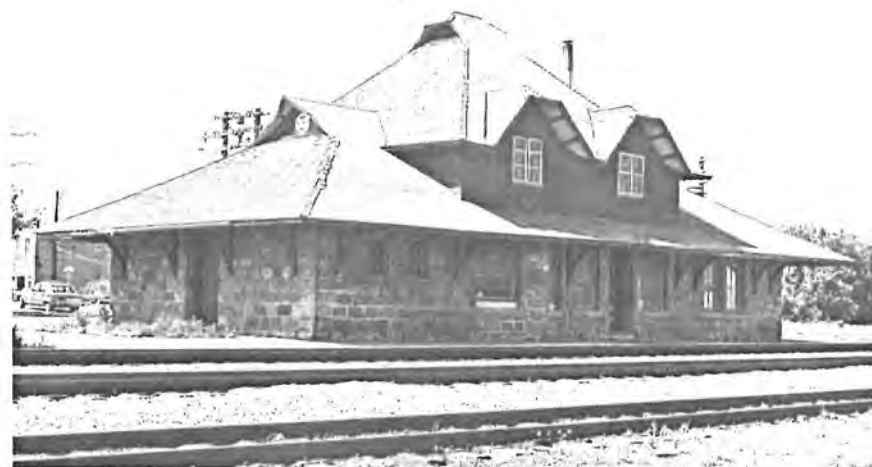
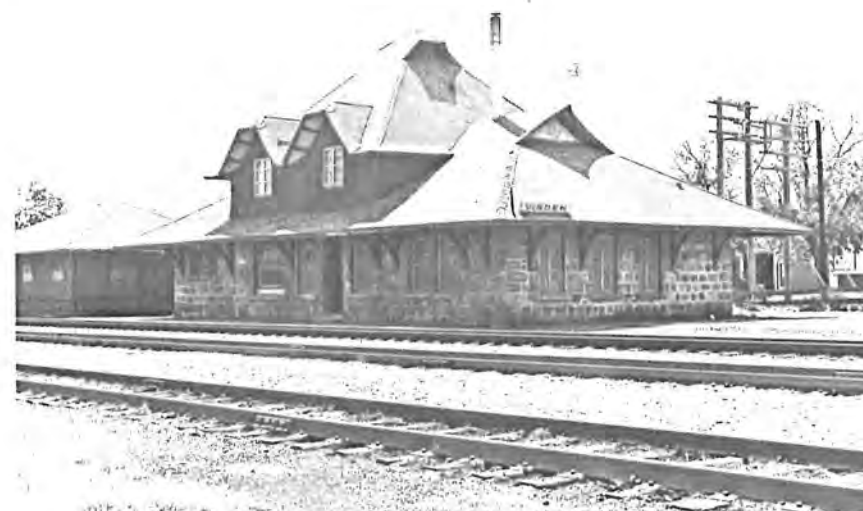
EXTERIOR: -unchanged  
-roof needs some repairs

-this is the only station of this  
design which has fieldstone  
construction

-roof shape is what makes this  
standard plan distinctive

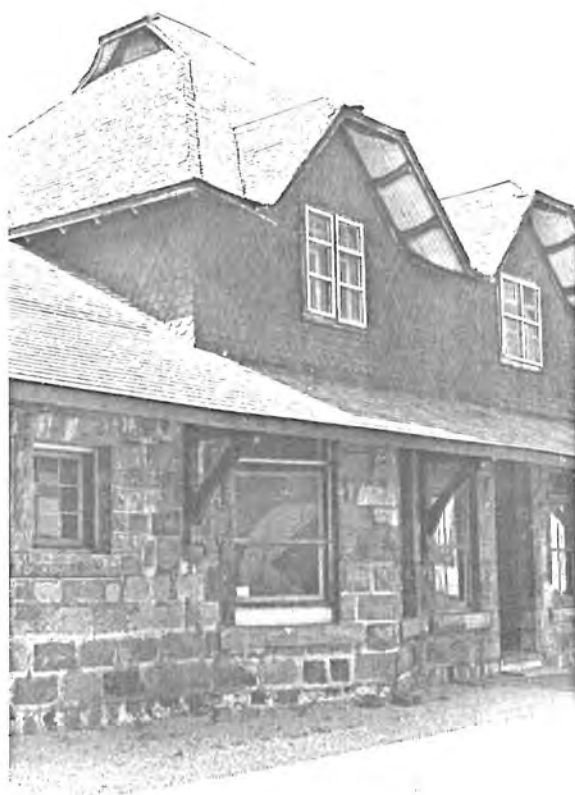
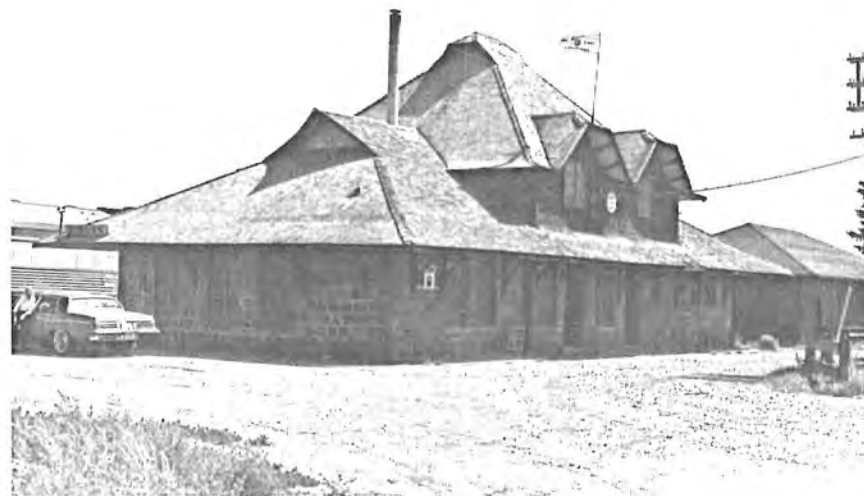
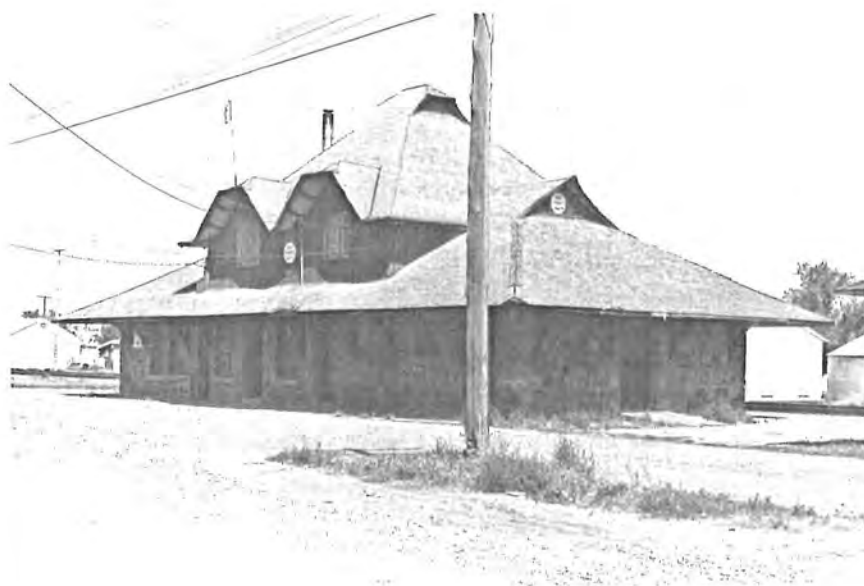
VIRDEN (cont'd)

-unusual decorative shingles  
on second storey exterior

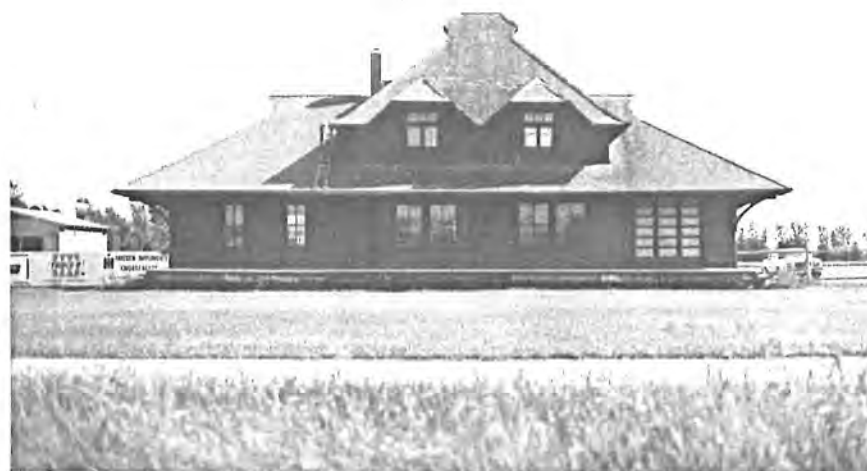
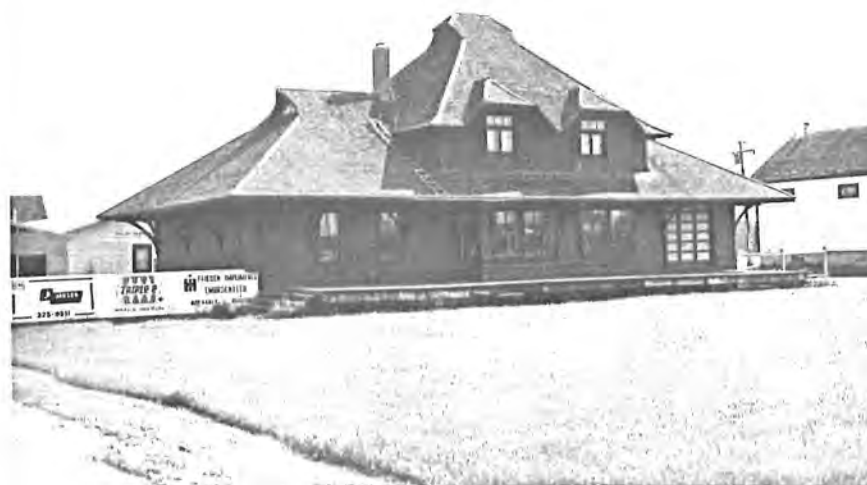
- GENERAL: -architect: Ralph B. Pratt  
(Martin, pp. 22-25)
- the same plan was used for the  
CP station at Virden, Manitoba,  
but the Virden station was made  
of stone instead of wood
- EXTERIOR: -appears basically unchanged
- INTERIOR: -mostly unchanged; fireplace  
location is slightly different  
(fireplace has been rebuilt)
- upstairs kitchen was  
modernized at some point
- original wood flooring, other  
woodwork, wainscotting, stair-  
case, ticket window/counter,  
agent's desk, various RR files

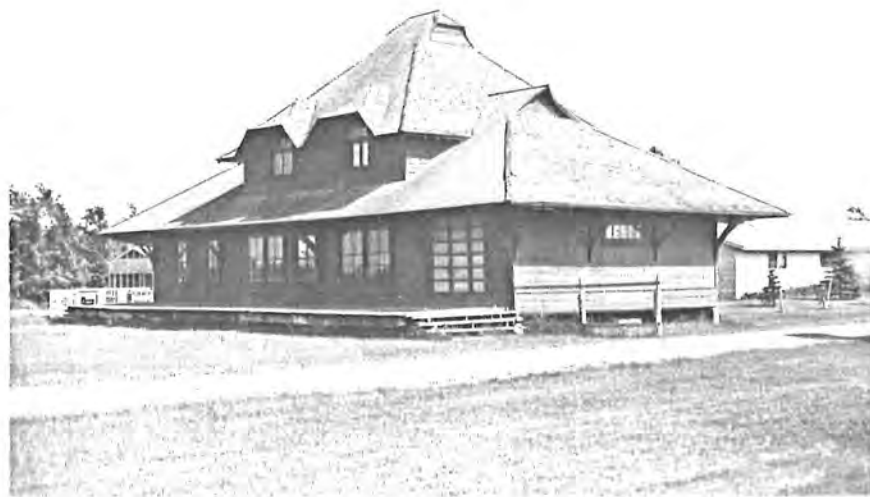
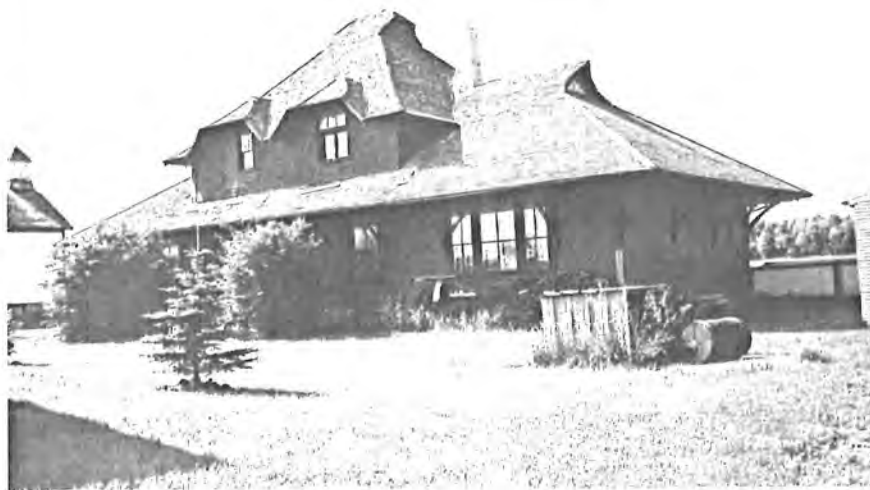
MORDEN (cont'd)

- furnishings also include: roll-top ticket desk, three original radiator covers of ornate cast-iron grillwork, two cast iron stoves, one of which was cast with "CPR" on it, and the other of which says "Station Heater." The former is apparently the original Morden stove, but the latter may be from elsewhere
- interesting roof form allows for pseudo-skylights in two upper bedrooms

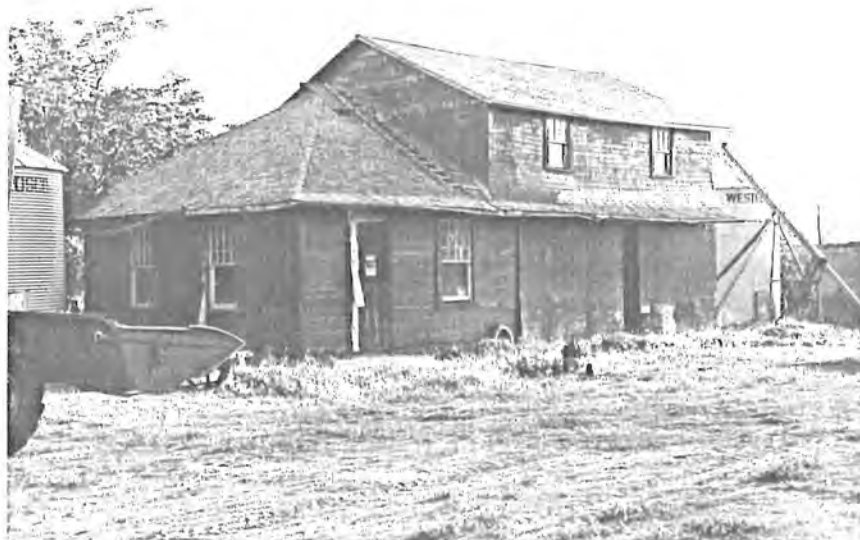
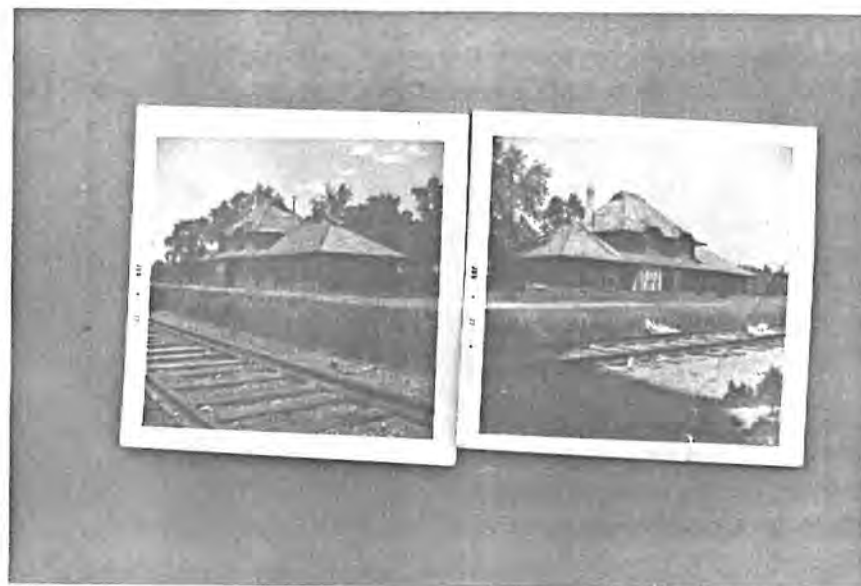
- GENERAL:
- the station was bought and moved by the owner in 1972
  - originally this station was similar to the stations in Virden and Morden, as evidenced by the photographs of its original appearance
  - the station's second floor roof was cut in order to move the building. The roof was later rebuilt using the original shingles, as well as some from the old Quadra station (now demolished)
  - the freight shed was also cut off at the time of moving, and is now sitting separately in the

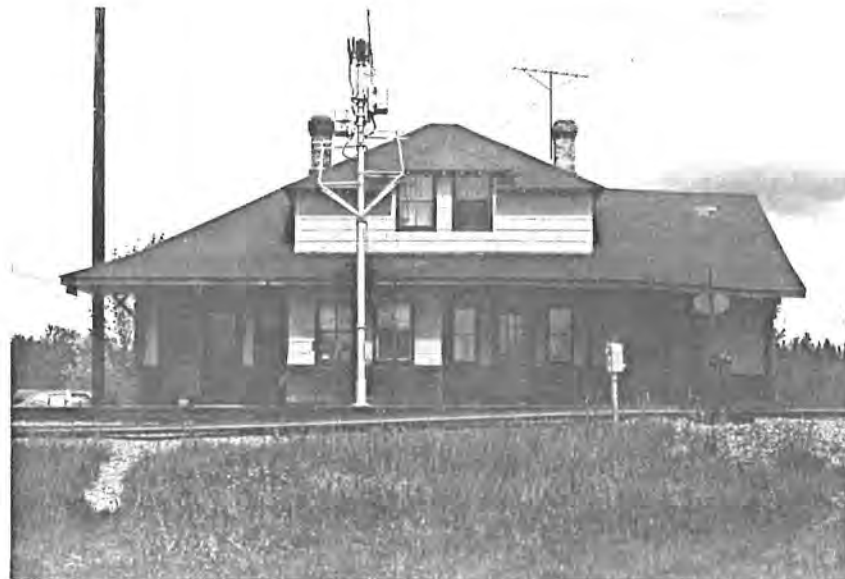
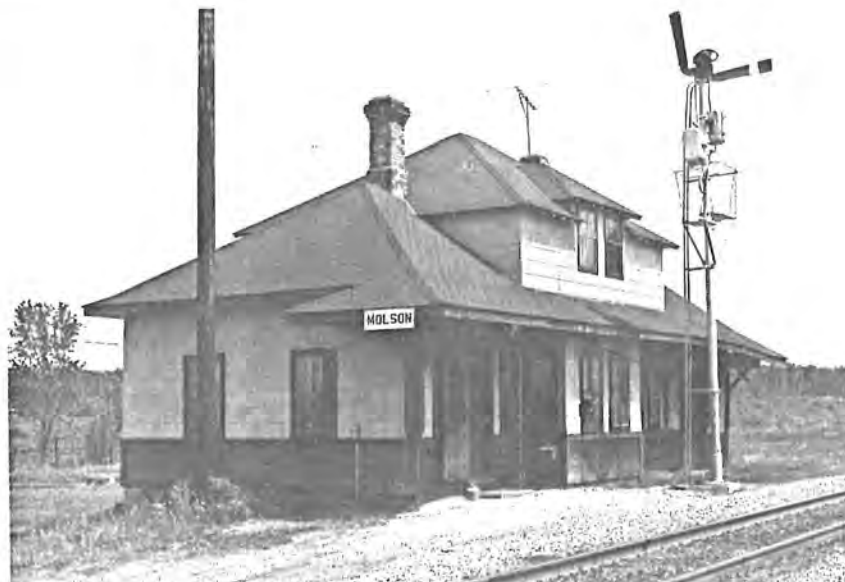
# MOLSON

General Condition of Building: Fair

GENERAL: -this is the second station that was built at Molson. The first was built ca. 1885, about a half a mile west of the present station. True to the decision that the mainline would go through Winnipeg instead of Selkirk, the mainline trackage dips SW towards Winnipeg at Molson. The new station was later built to the east of the old so that it would be on the mainline. The first station was demolished for its lumber, only within the last twenty years (1960s or 70s)

-water tower foundation and traces of a wooden pipeline to a nearby swamp are still visible east of the station. Water shortage was always a problem at Molson, and the swamp water helped ensure that the steamers would run

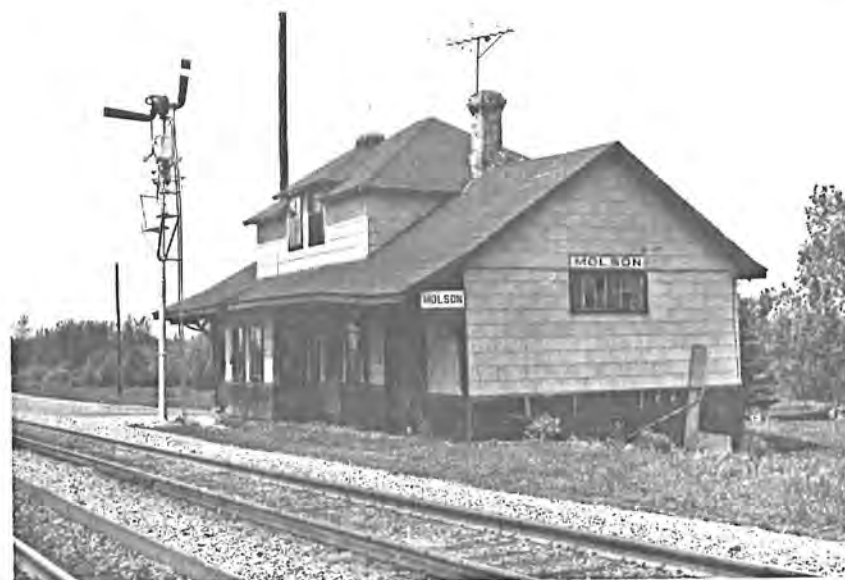
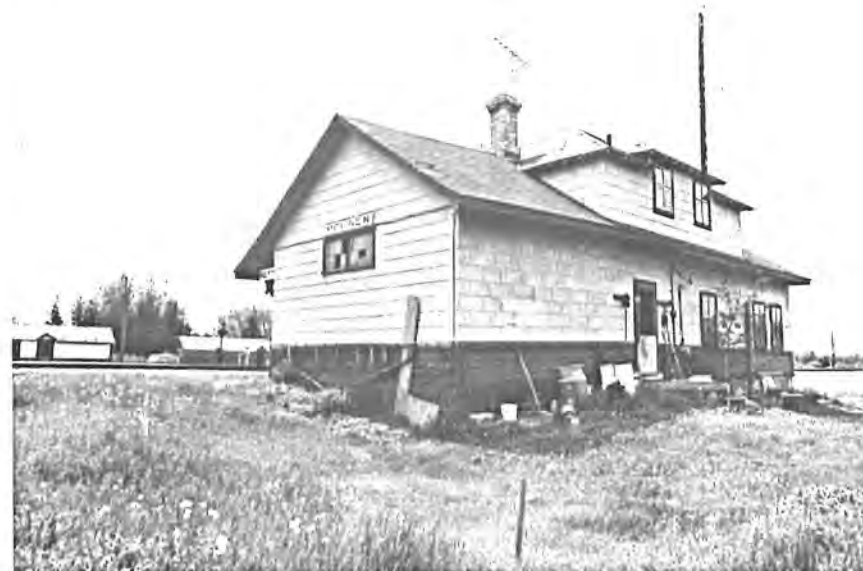
MOLSON (cont'd)

- the station still has no insulation (except ceiling)
- brackets have some decoration (see detail)
- 2 x 12 frame construction, apparently common in all but the quite recent stations, because lumber was more plentiful

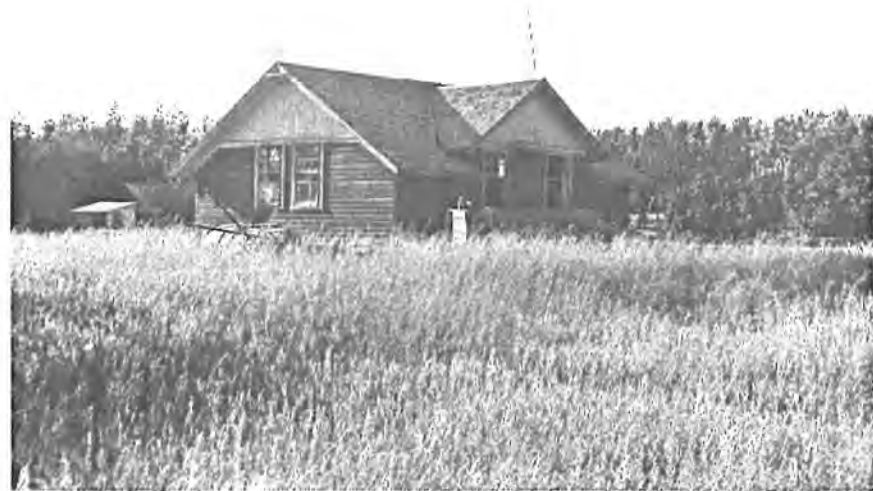
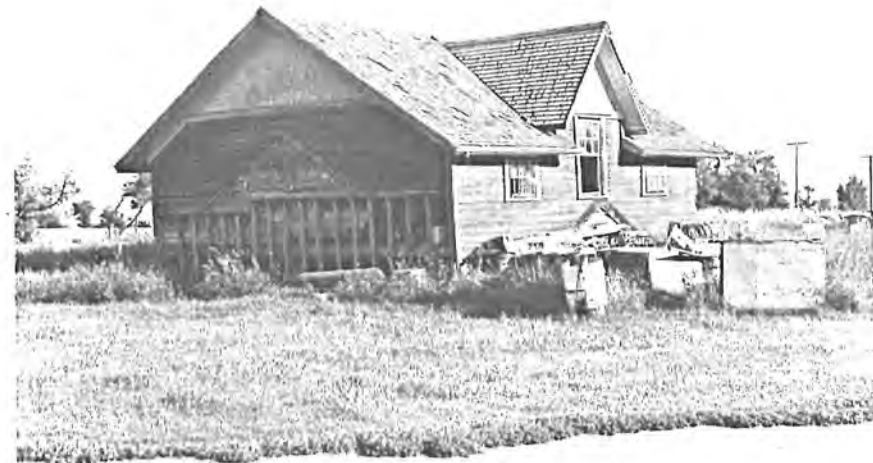
General Condition of Building: Very Poor

- GENERAL:
- this structure is in fact only the second storey of the station. The rest was demolished. The existing part was intended for use as a garage, but it has never been used
  - this is the only confirmed example of a Western Lines "A" station that was found. However, the station from Austin, Manitoba, also a W. L. "A" design, very likely exists near Austin, probably in a more complete form. Also, the station at Mowbray appears to be a W.L. "A", though this is unconfirmed by CP records. Both its appearance and its date point to this classification

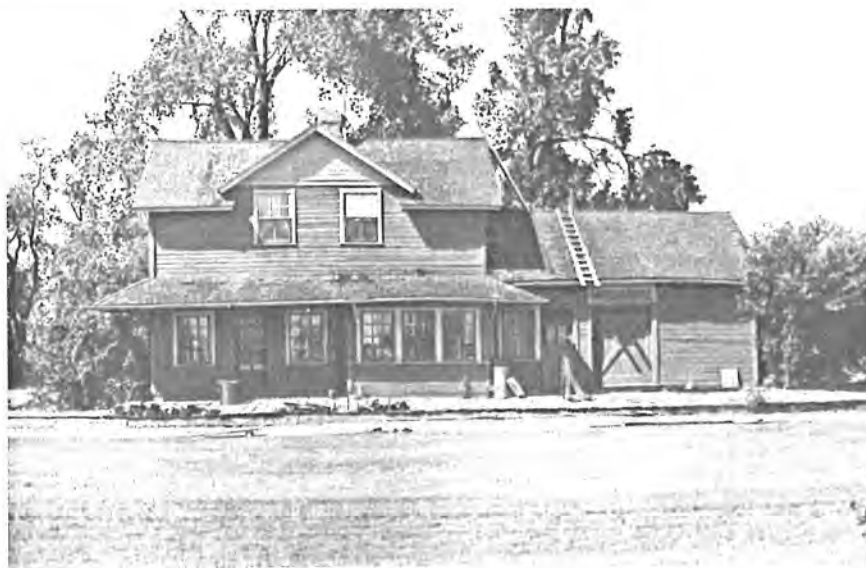
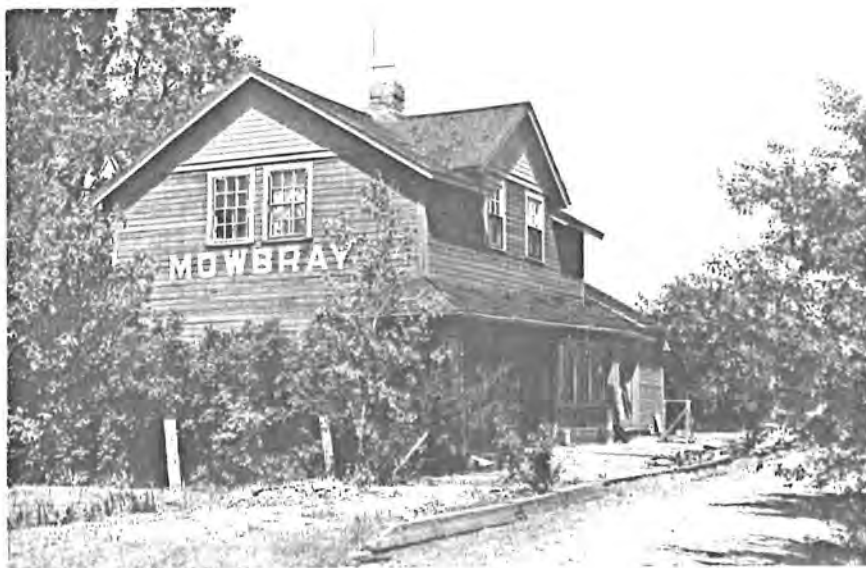
# MOWBRAY

General Condition of Building: Fair to Good

GENERAL: \*-unique, or relatively unique  
 design, possibly W.L. "A"

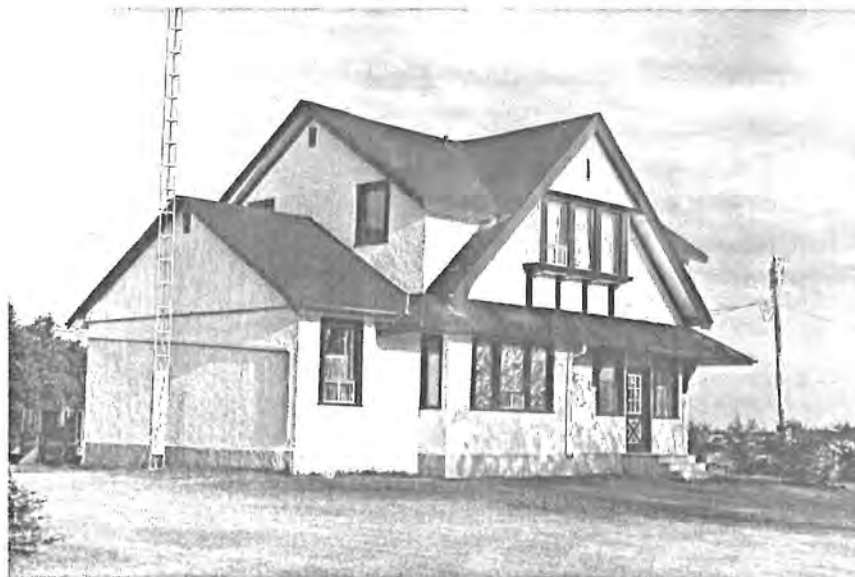
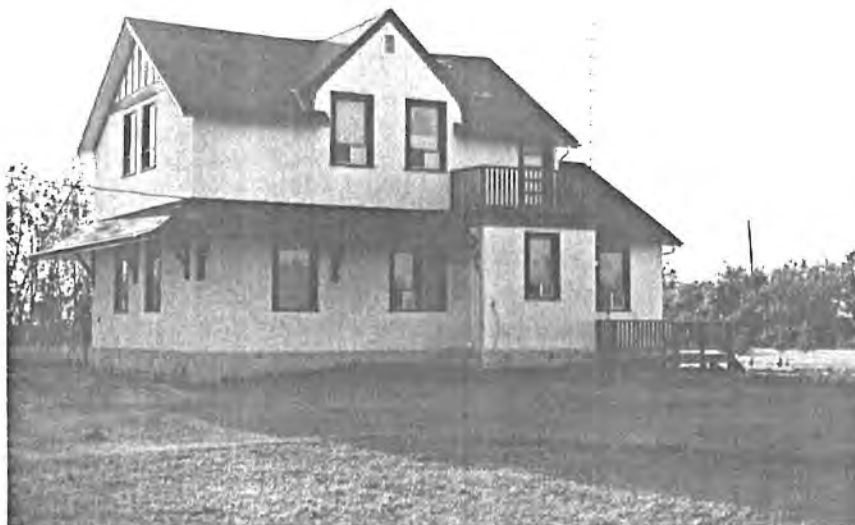
# FOXWARREN

General Condition of Building: Excellent

EXTERIOR: -new stucco  
-new windows  
-otherwise unchanged

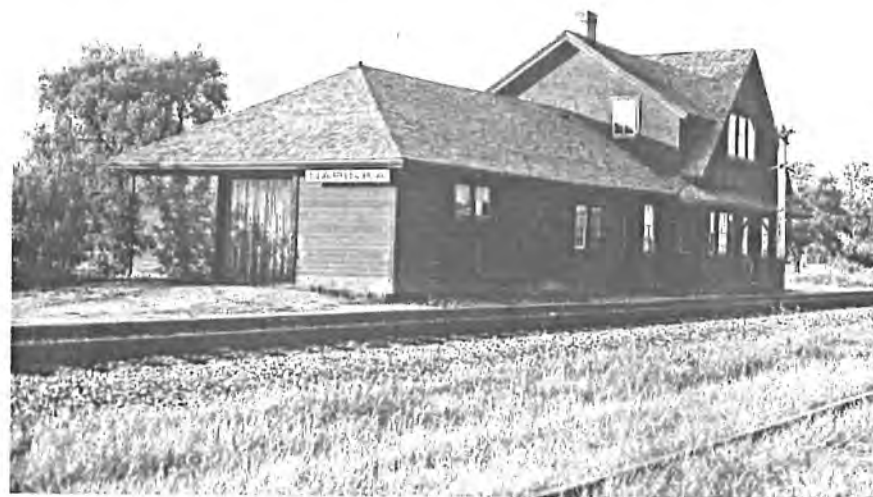
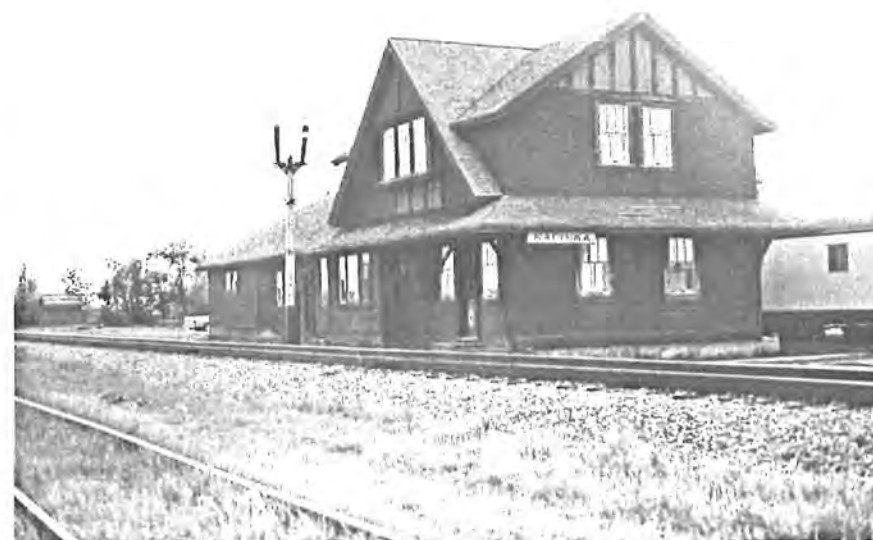
# NAPINKA

General Condition of Building: Fair

EXTERIOR: -needs paint

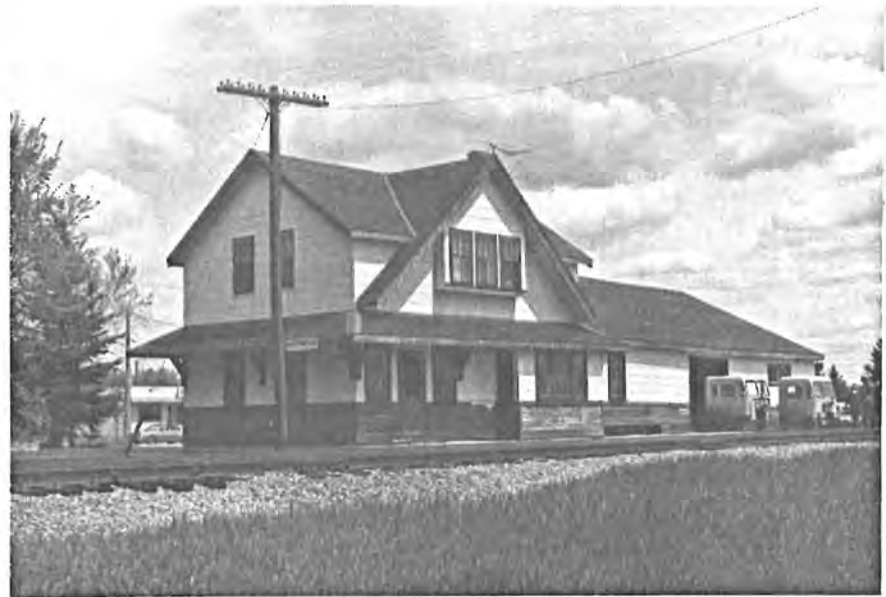
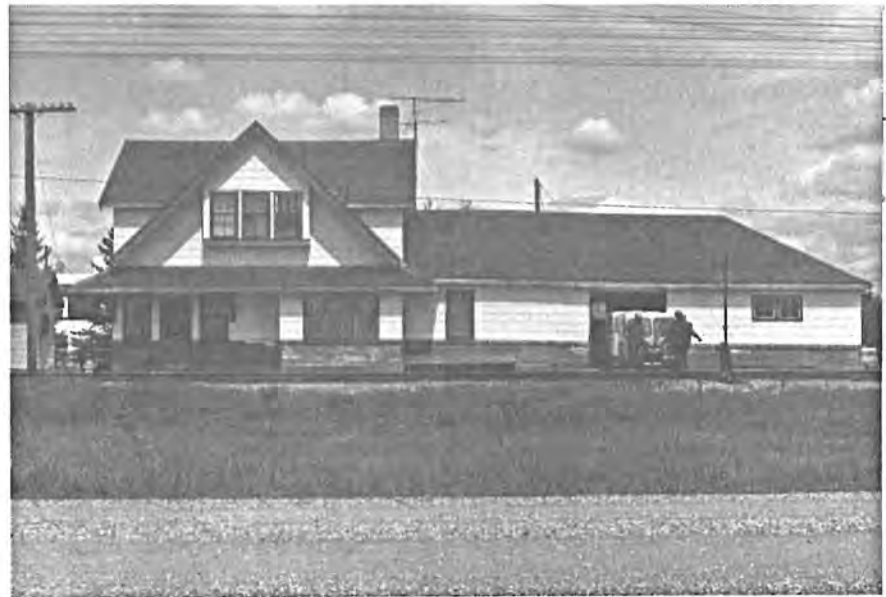
# WHITEMOUTH

General Condition of Building: Fair

- the freight shed has been altered to a "dolly-car" shed
- station has had new paint
- original bench on platform is very dilapidated

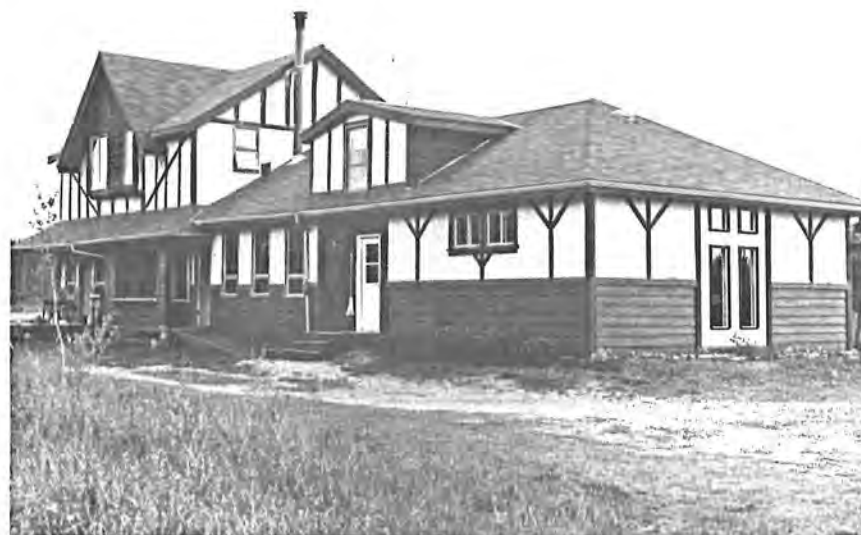
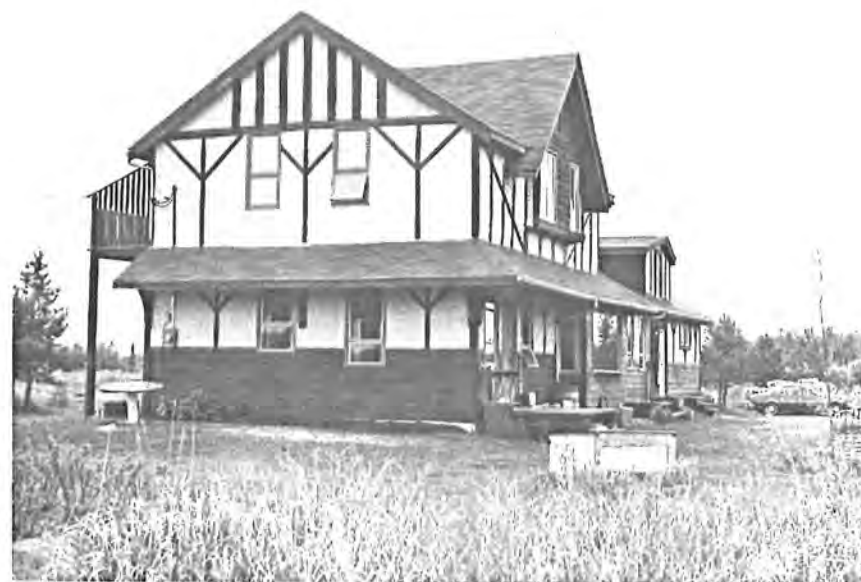
# LAC DU BONNET

General Condition of Building: Excellent

-new siding

-new windows

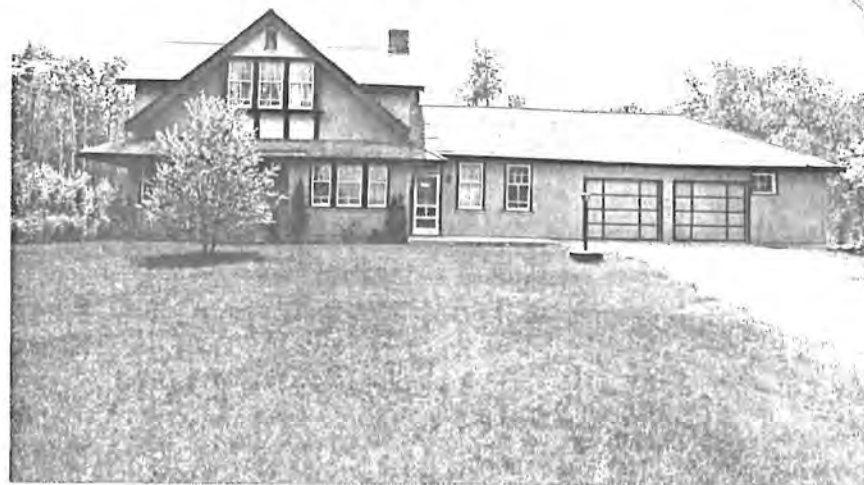
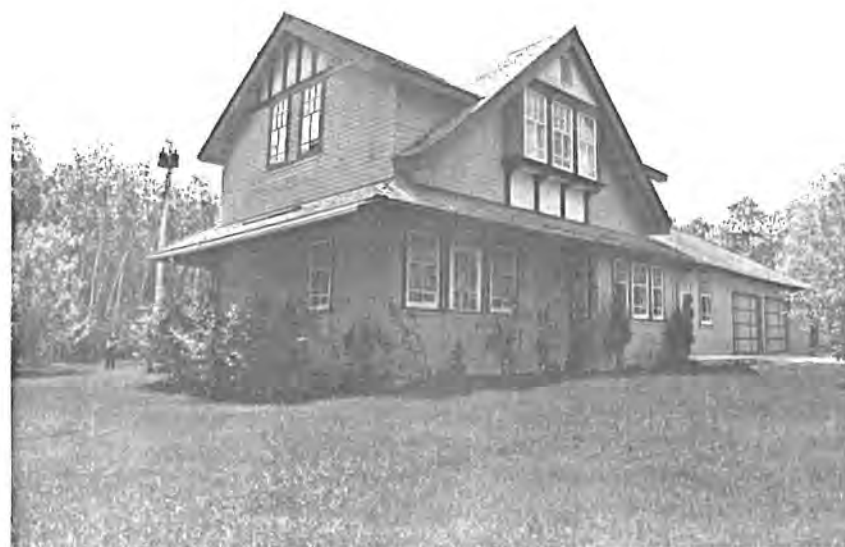
General Condition of Building: Very Good

-extra door added to freight  
shed for garage. Also,  
existing freight shed door was  
widened

-exterior door to waiting room  
permanently closed, though not  
covered

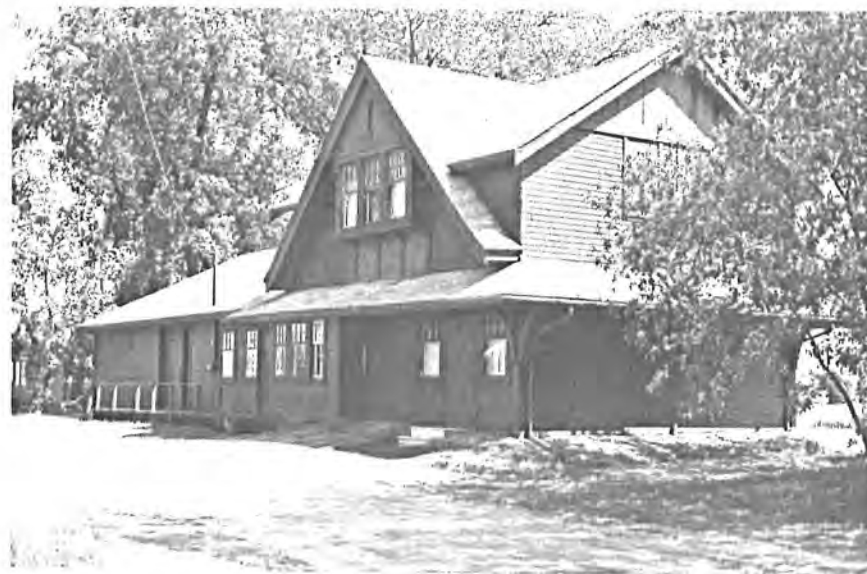
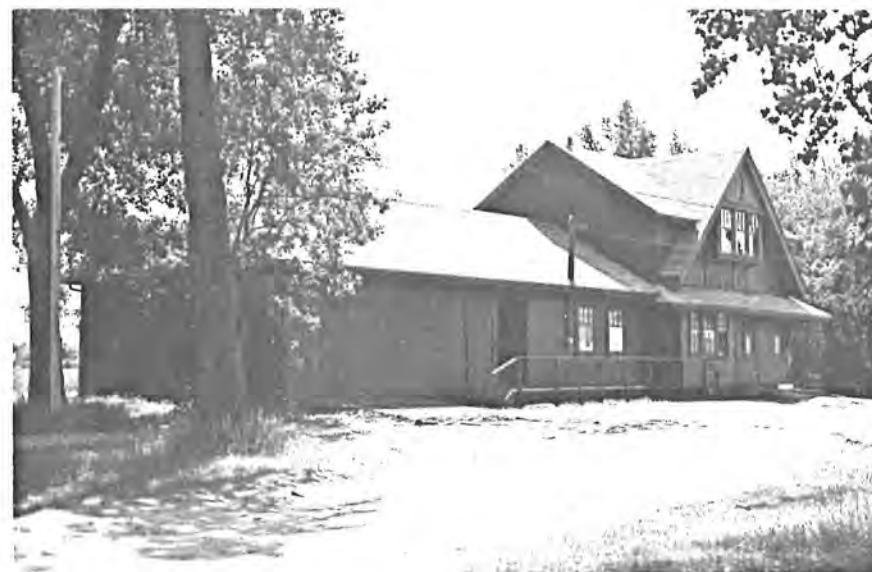
# ST. CLAUDE

General Condition of Building: Good

- EXTERIOR:
- some upper windows broken by recent vandalism
  - all rear and side doors and windows are very tastefully boarded up
  - has been re-roofed
  - original hardware on front door
- INTERIOR:
- freight shed contains a display of miscellaneous museum pieces, and has not been altered
  - waiting and living areas have been carpeted and contain museum displays
  - office contains some original fixtures, e.g. agent's desk,

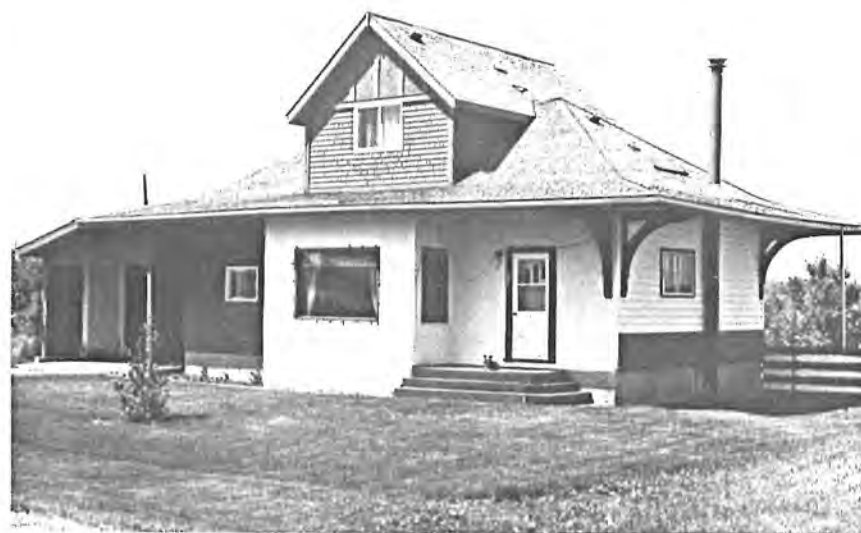
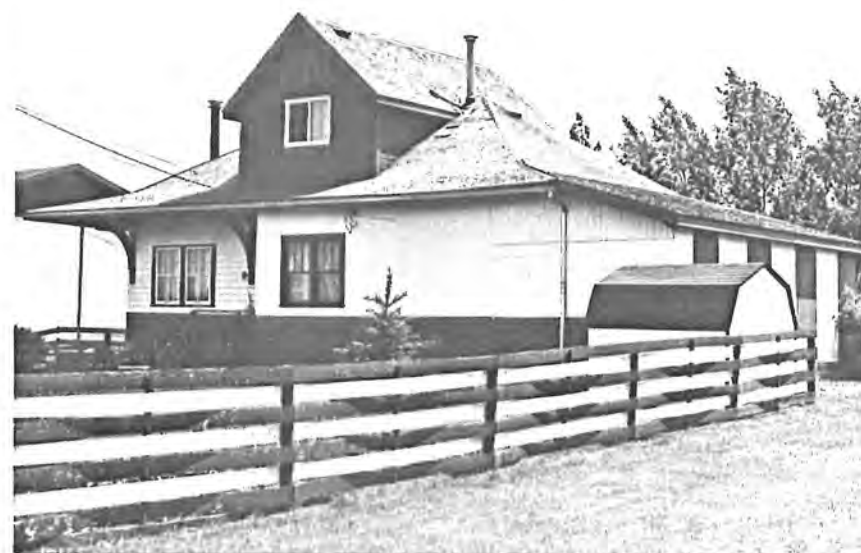
# PETTAPIECE

General Condition of Building: Very Good

EXTERIOR: -new windows (glazing) and doors  
 -new siding (lower)  
 -new garage attached

INTERIOR: -waiting room has been renovated  
 to a LR, panelled, carpeted.  
 Office is now a DR, lino floor.  
 Former kitchen is now full bath  
 and hallway. Upper floor is  
 basically unchanged, closets

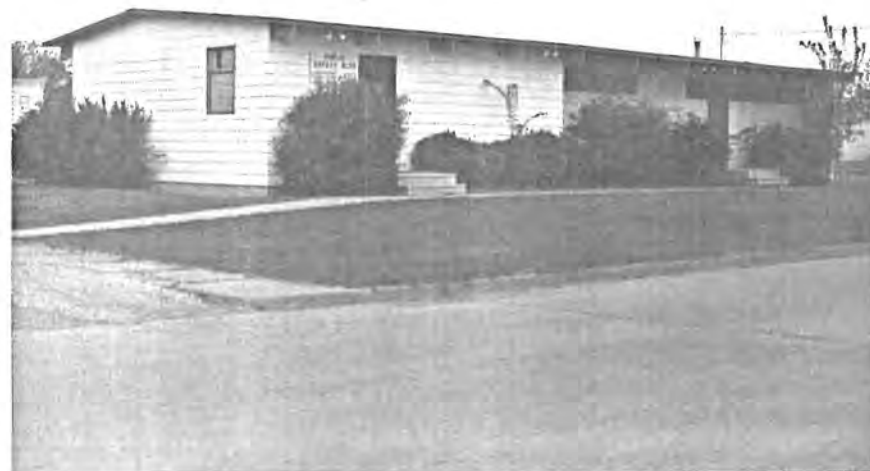
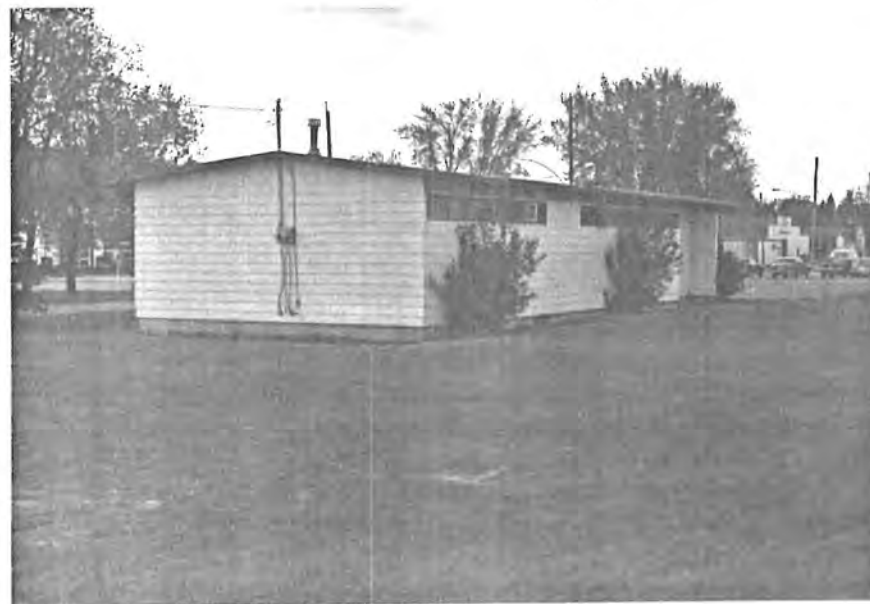
# ALTONA

General Condition of Building: Very good

EXTERIOR: -appears to have been extensively altered

INTERIOR: -specific details unavailable as building closed at time of visit  
-appears to have been extensively renovated

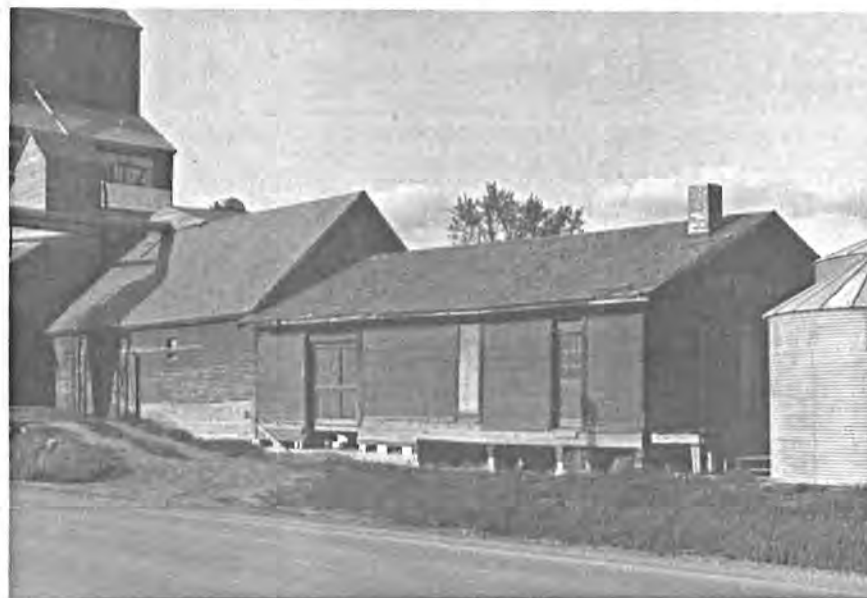
General Condition of Building: Poor

- GENERAL:
- remainder of building was demolished
  - it appears that an area at the end of the freight shed may have once been a customs area. It has a chimney, suggesting "people space," but was separated from the main part of the station by the freight shed

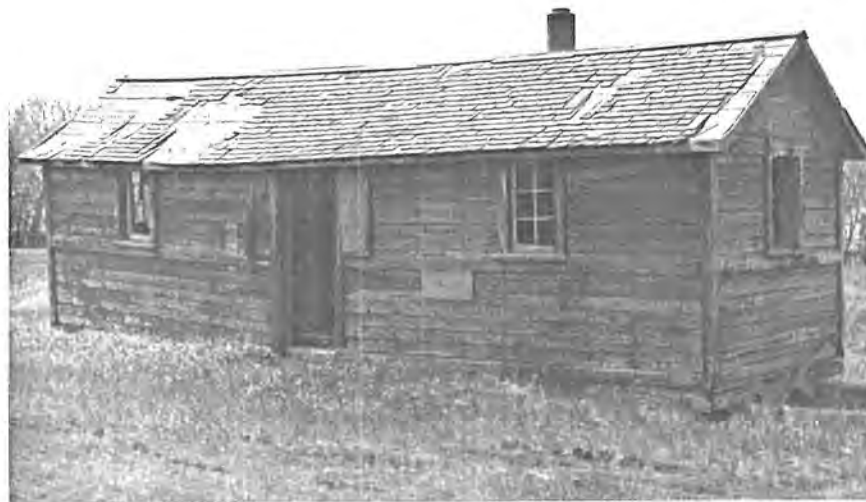
# McTAVISH

General Condition of Building: Very Poor

- GENERAL:
- this station is an example of one design for CP portable stations
  - the track-side wall of the station has literally fallen off the floor and is resting on the ground, though still upright and attached to the roof
  - Mr. Thompson indicated that he was planning to demolish the station building and several other surrounding outbuildings sometime this summer (1983)
  - Mr. Thompson bought the station in 1971. At that time an older resident of McTavish mentioned to him that it had, at some time

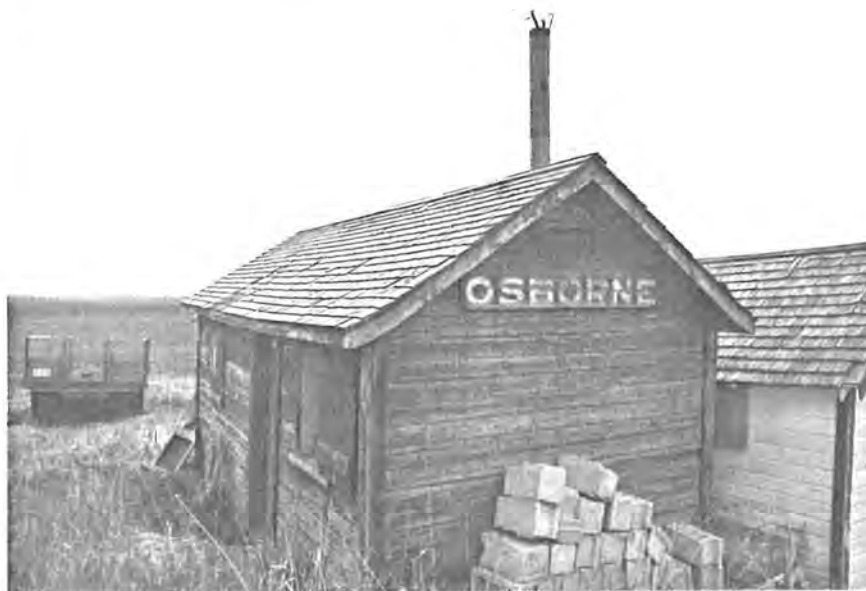
General Condition of Building: Poor

GENERAL: -this station is an example of one  
of CP's smaller standard portable  
designs (compare with other  
standard portables)

INTERIOR: -original bench and graffiti

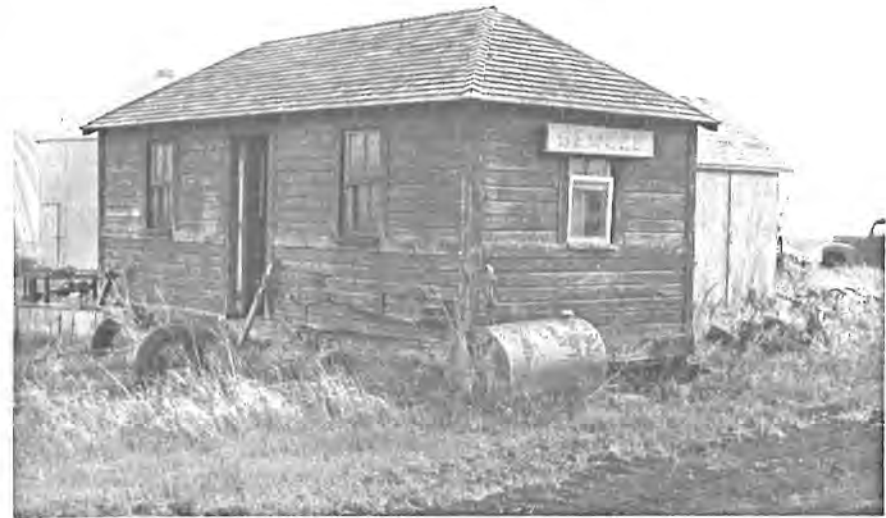
# SEWELL

General Condition of Building: Poor

- GENERAL:
- this station is an example of one of CP's standard portable designs
  - Sewell had two previous stations. Both were old boxcars, and both burned down
  - original curved-wood bench is in good shape, but needs refinishing
- INTERIOR:
- original stove was sold to a man from Morris, Manitoba

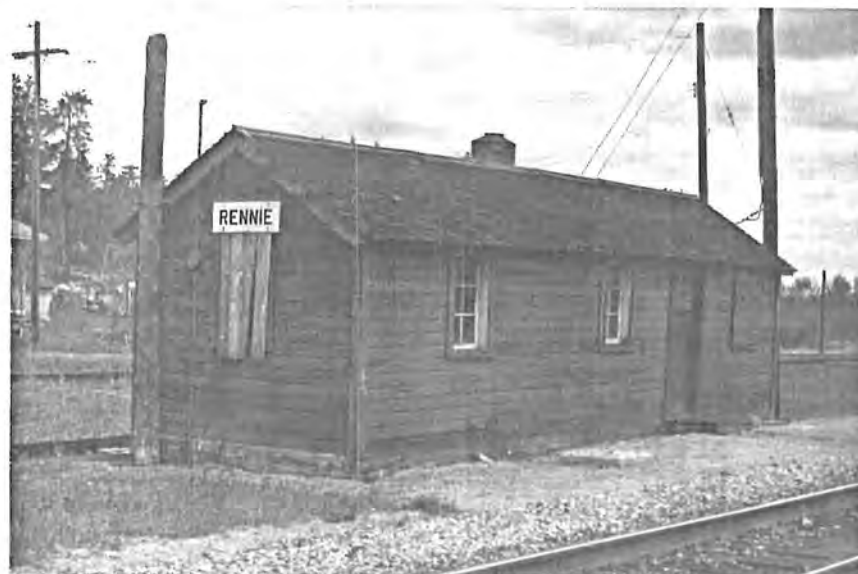
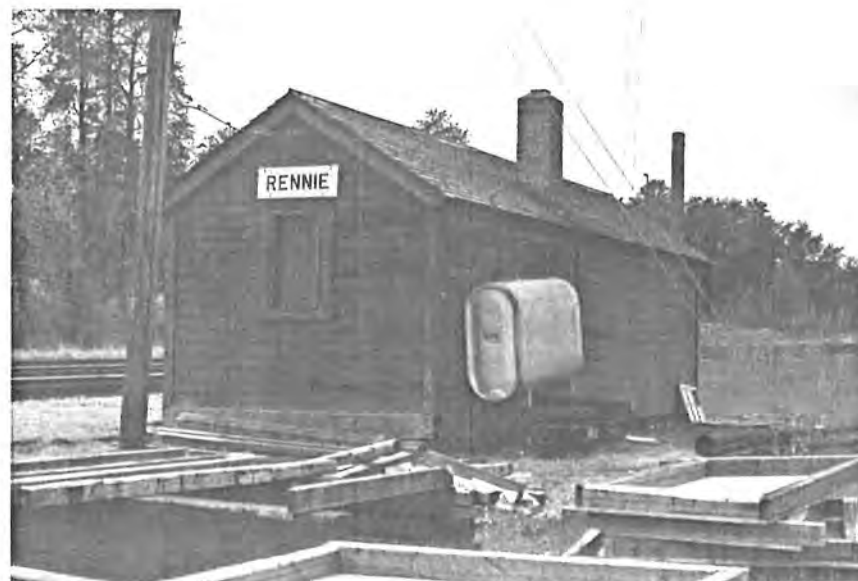
# RENNIE

General Condition of Building: Fair

EXTERIOR: -some windows are broken and/or  
boarded up

INTERIOR: -brick chimney and furnace have  
replaced the pipe chimney and  
stove noted in older CP records

-telegraph (?) equipment visible  
through the window
