# RAILWAY STATIONS OF MANITOBA: A BUILDING INVENTORY

Patricia Trainor  
Farhad Rahbary  
David Butterfield

1987

This report on Manitoba's railway buildings is divided into two sections. The first provides a brief historic background of rail line and specific station design developments in the province. The second, comprehensive, section is a catalogue of extant railway buildings in Manitoba. The first section is organized according to station types, while the information in the second part is grouped according to ownership. For easier reference, this second section will also be subdivided according to specific station types. Photographs of the stations in the catalogue section are accompanied by basic data sheets. Information given for each station includes: date built; past and present locations; present owner and use, as well as facts relative to renovations and noteworthy features.

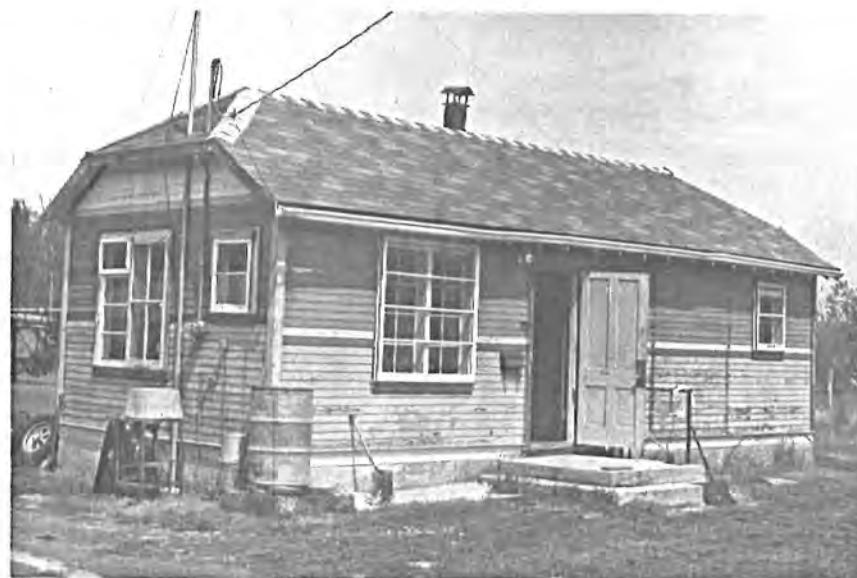
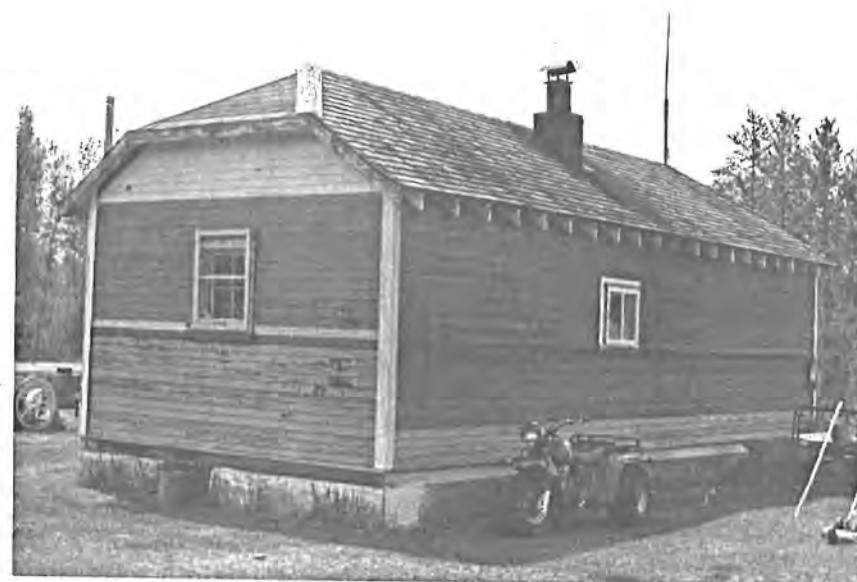
# HADASHVILLE

General Condition of Building: Good

EXTERIOR: -front freight shed door is filled in

-a new window has been cut into the rear of the building

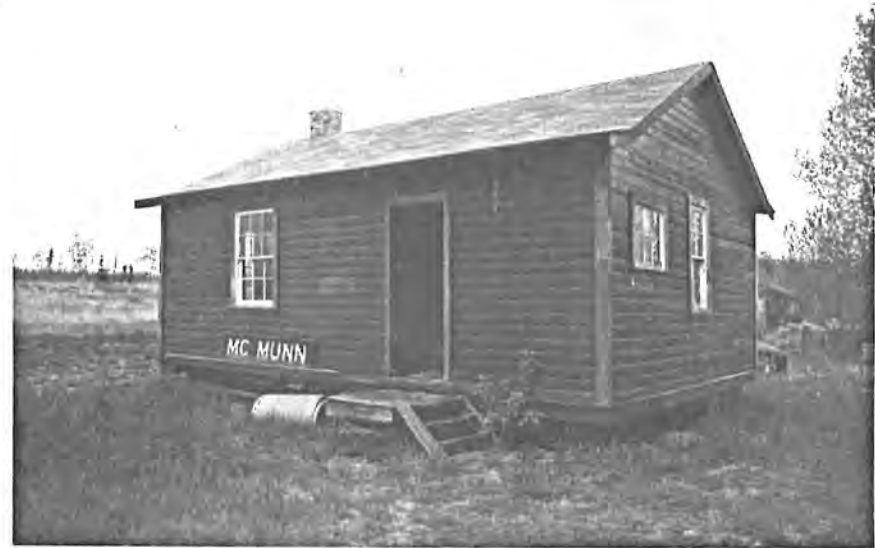
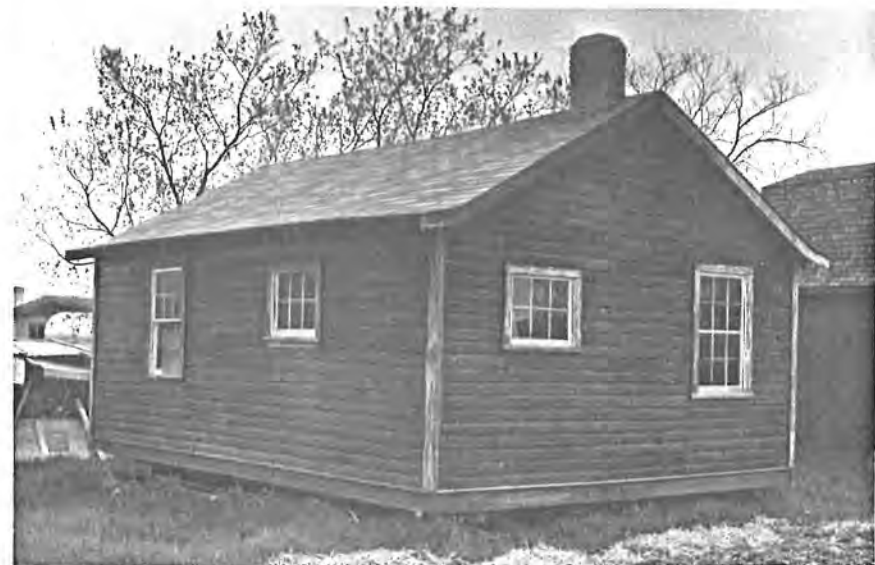
General Condition of Building: Good

EXTERIOR: -unchanged; new paint

INTERIOR: -during WW II, a partition was placed in the waiting room area to form living space for a guard who was to protect the water supply from possible German sabotage. This was common all along the line. 2 x 4 frame of the partition is still in place.

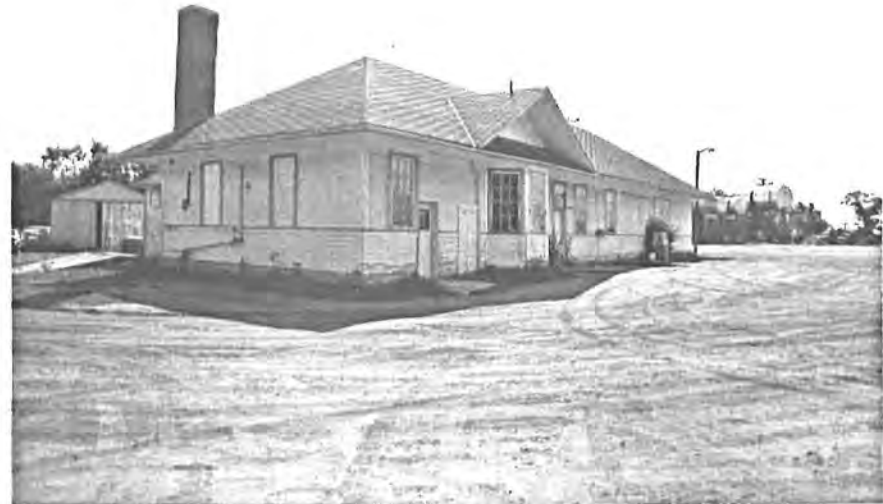
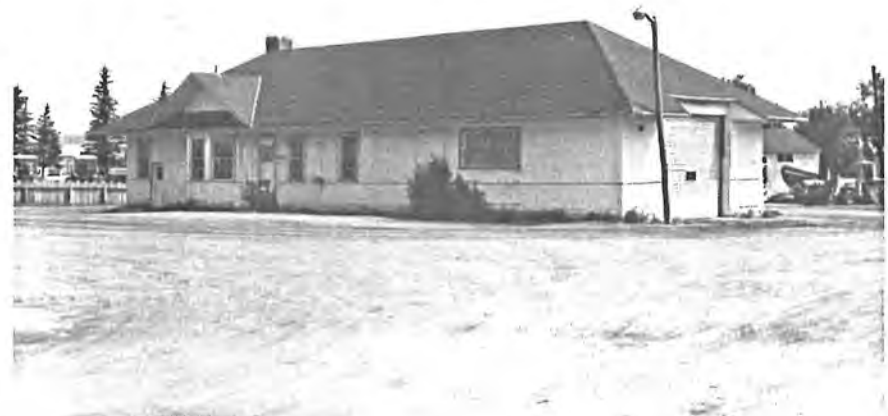
General Condition of Building: Fair

-track side freight shed door  
replaced by window; town side  
by smaller door

- windowless dormer

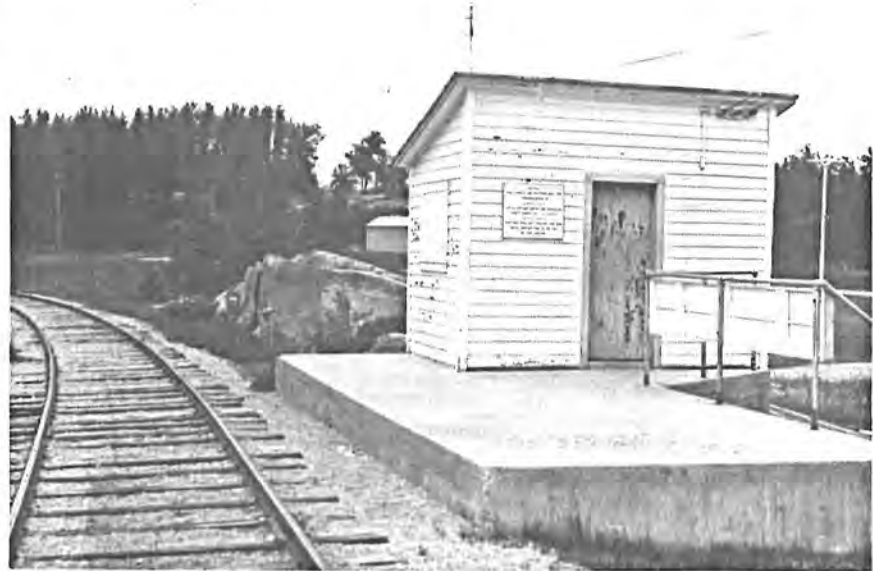
# POINT DU BOIS

General Condition of Building: Good

- GENERAL:
- shelter serves the Slave Falls-Point du Bois bus-like tram service to power dam
  - North Station, which served the Point du Bois-Lac du Bonnet line (abandoned when the highway came through) is no longer there

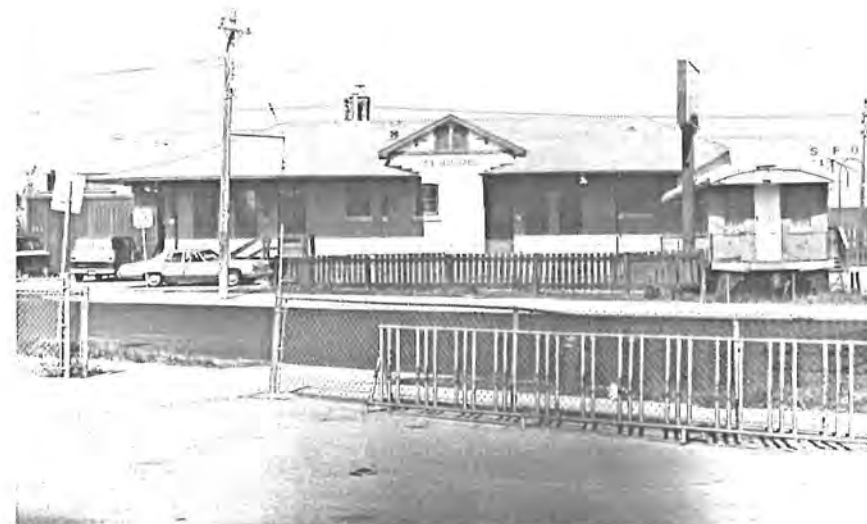
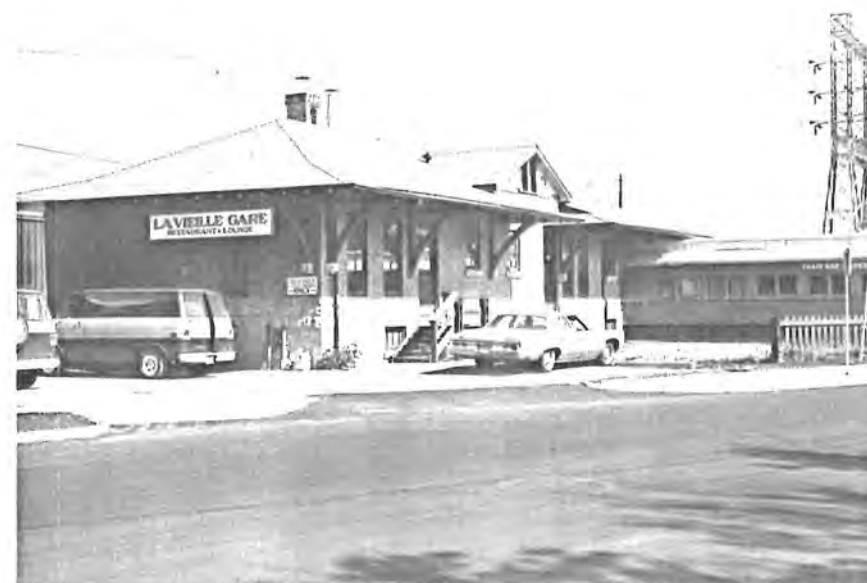
# ST. BONIFACE

General Condition of Building: Excellent

-brick construction

-segmental-arched window  
 openings

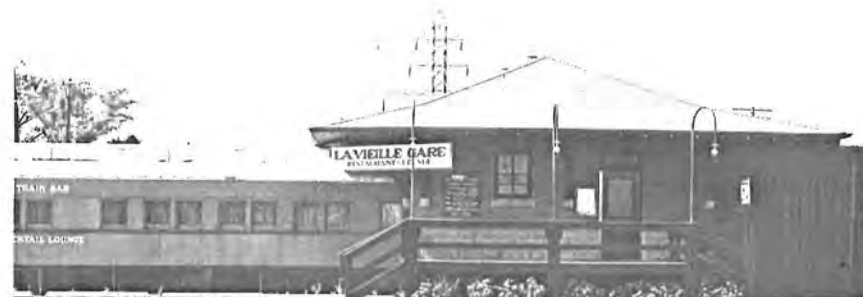
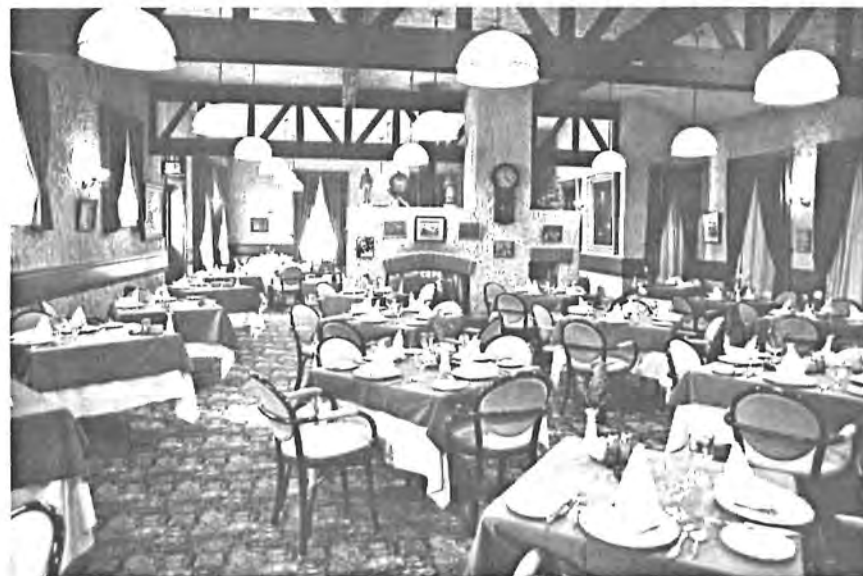
ST. BONIFACE, Man. & SE Rwy. (cont'd)

-wide tyndallstone plinth
